## Property Condition Assessment Report

### St Mary's Catholic Church

449 West Wisconsin Avenue  
Pewaukee, Wisconsin 53072

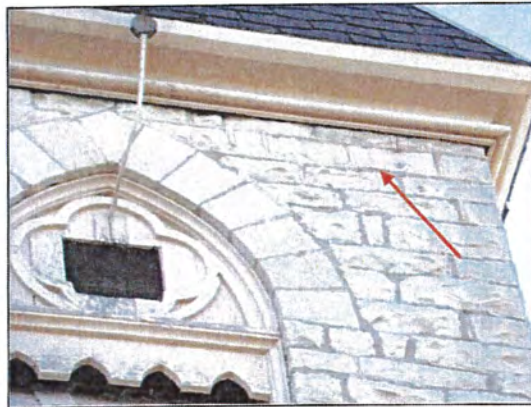
The exterior stone facades appear to be in overall fair condition. General tuckpointing is recommended throughout the field of the façade, with the chimney requiring more acute attention. Sealants throughout the building facades appear to be in overall good condition. Costs associated with repairing the belfry openings are included in the steeple roof repairs. An opinion of costs associated with replacing the basement windows are included in the table found in Section 1.3 Summary of Cost Data. Other costs fall below the given threshold of \$3,500.00 and are not itemized in this report.

9. Steeple mortar deficiencies.

- Repoint deficient masonry joints using a lime rich-low Portland content mortar. TRC recommends using lime-rich pre-manufactured mortar mixes over hand mixing. In addition, TRC recommends the testing of existing historic mortars to determine a match with the dominant color and correct ratio of lime to Portland to sand. Test using ASTM C1324 Standard Test Method for Examination and Analysis of Hardened Masonry Mortar.
- Replace basement windows.
- Repair and paint the Cedar belfry openings.
- Repair and paint the wood perimeter case moulding around the main entrance.

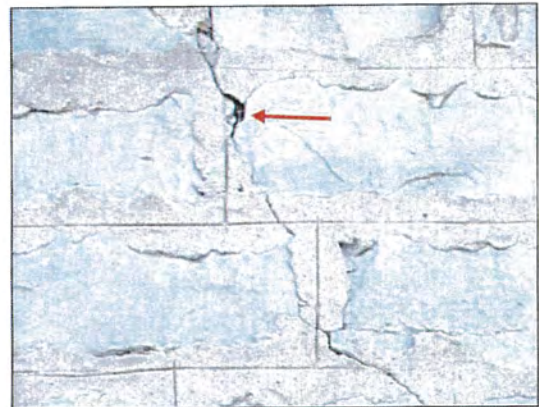
10. Step cracking in mortar at west elevation.

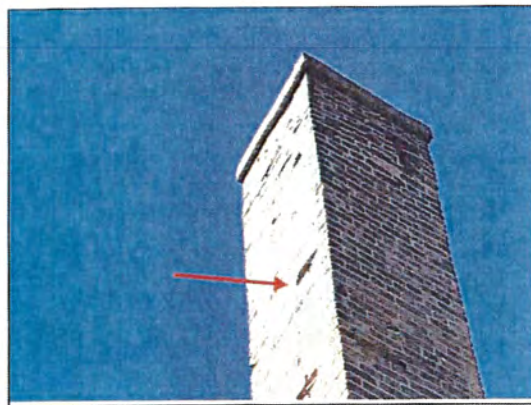
11. Masonry deficiencies on chimney.

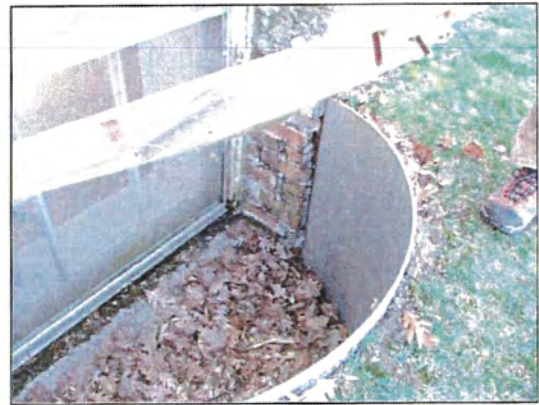
The wood-framed window and entry systems appear to be in overall good condition. However, the basement windows are in relatively poor condition due to moisture damage. There is exterior wood perimeter case moulding surrounding the main entrance that is in fair to poor condition. Observation showed severely deteriorated wood; splitting, and water damaged at the interface of wood moulding and concrete. The wood soffit elements are generally in good condition the exception being the gable ends where severe peeling of the paint was observed. In addition, the Cedar vented belfry openings showed were observed to be in poor condition with signs of wood weathering/deterioration due to severe peeling paint.

12. Rotted wood window. West elevation of church.

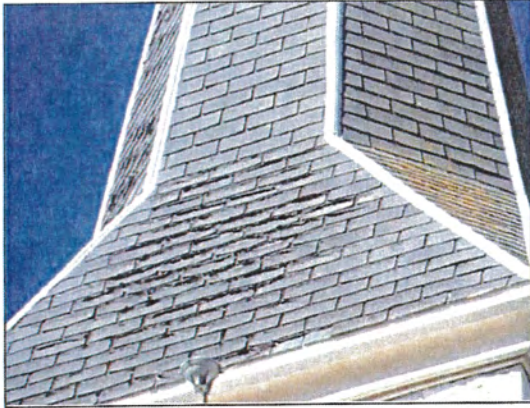
The main roof system on the building consists of a steep-sloped granule surfaced 3-tab asphalt shingle with copper gutters and downspouts. The main church building roof slopes to external gutters which are piped to out into the front lawn via down spouts on the west elevation and discharge out over the lawn on the east elevation. (The outlet onto the lawn was plugged by the current tenant which most likely caused the recent basement flooding.) On the office annex, the roof system consists of a similar more moderately sloped shingle system with gutters on the south side of the roof discharging into the municipal storm sewer system and the north side gutters discharging out onto the lawn. The EUL of this type of shingle system is typically 15 years depending upon the quality of installation and how well it is maintained. Observations showed wind damage to the south slope of the office annex roof due, to substandard installation methods and severe weathering of the shingles found on the steeple. TRC recommends full tear-off and replacement off these roofs.

13. Shingle deterioration on steeple, east elevation.

- Replace the steeple and office annex roofs.
- Repair replace below grade masonry and install new drain tile.

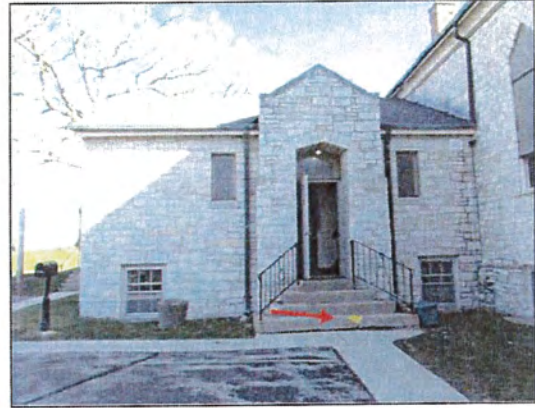
14. Annex entrance, south elevation. Note the trip hazard painted yellow.

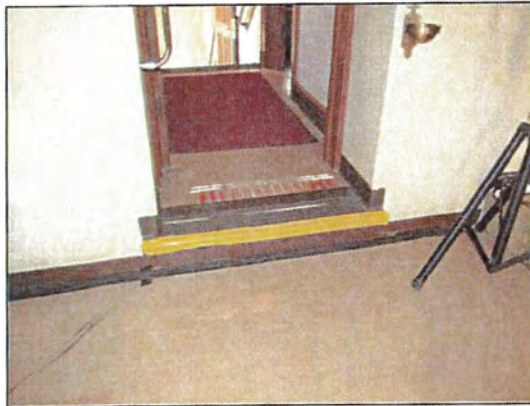
It was observed that there are varying floor elevations in the transition from the main church building to the coffee lounge and to restrooms and parish kitchen. This condition is not ADA compliant. An opinion of costs associated with adjusting these floor elevations to meet ADA requirements. are included in the table found in Section 1.3 Summary of Cost Data.

15. Change in floor elevation from church into annex.

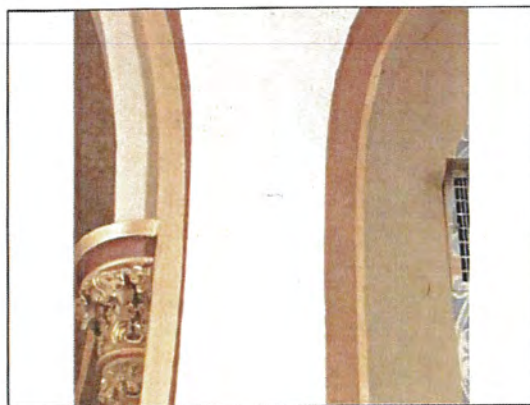
It is TRC's opinion that the cracks in the plaster are not related structural movement of the building as it sits today. They are most likely associated with the addition to the basement during the 1953 construction. Plaster of this kind is applied by craftsman to a lightweight wood lattice system. Once the plastering is complete, it in effect becomes monolithic and quite rigid. From the arches out into the field of the ceiling the entire plaster system is supported by the wood lattice system which is mechanically secured to hidden timbers using nails. Due to the weight of cured plaster, additional reinforcement is needed in the transition from vertical wall out into the arches to prevent collapse of the ceiling. This is usually accomplished in several ways using a combination of heavy gauge wire, galvanized rod and vertical wood slats secured to horizontal trusses within the scissor truss system in the attic space. When the building was jacked-up to facilitate installation of the new basement and it's supporting foundation and walls; it is likely there was some minor sway in the ceiling and arches, some of the vertical reinforcement may have broken, stretched or become miss aligned and it is also very likely there was some settling of the new foundation after the church building was lowered. These were all possible contributing factors to the cracking observed in the plaster, particularly the plaster was not supported diagonally in the attic space

or at the transition from vertical to arches and ceiling. Due to the nature of the client's requirements for immediate cost, TRC does not recommend further investigation. Suspected mold and lead contamination are addressed in the following sections: 3.2.25 Limited Visual Lead Assessment and 3.2.26 Limited Mold Assessment.

17. Typical of cracks in plaster.

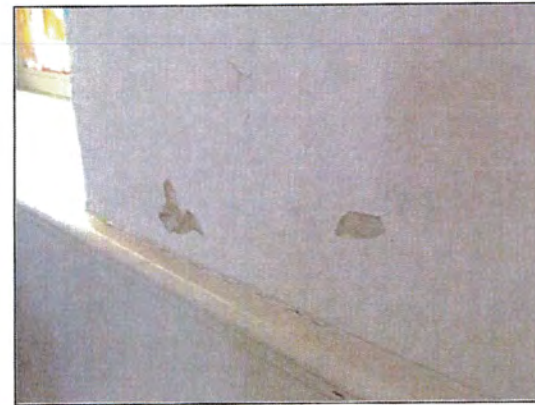
18. Typical of paint peeling from plaster surface

Remove and abate suspected lead paint from plaster surfaces. An opinion of costs associated with lead abatement is included in the table found in Section 1.3 Summary of Cost Data.

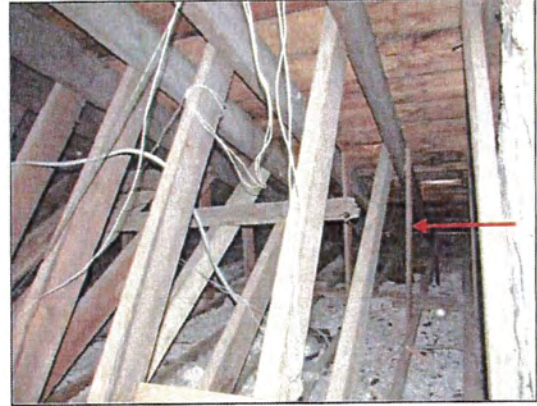
20. View into attic perimeter. Note vertical plater supports.

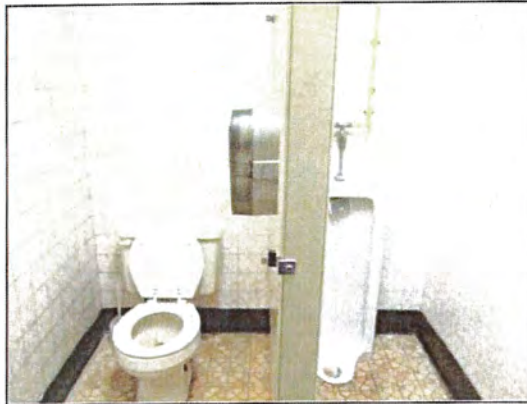
Public restrooms observed appear to be generally noncompliant with ADA requirements.

21. Existing men's room.

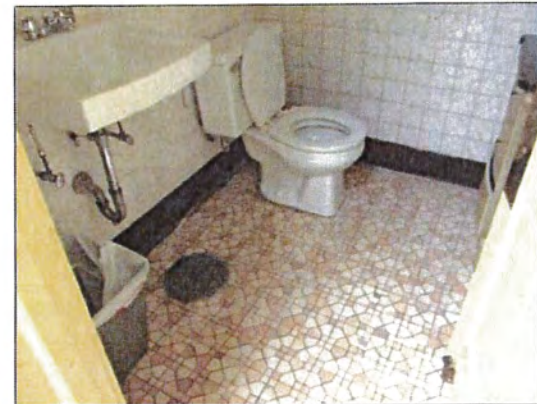
22. Existing ladies room.

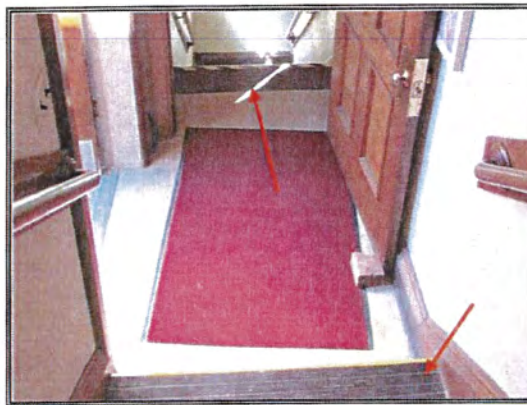
23. Annex entry is below floor line of church (foreground) with stairs leading to basement.

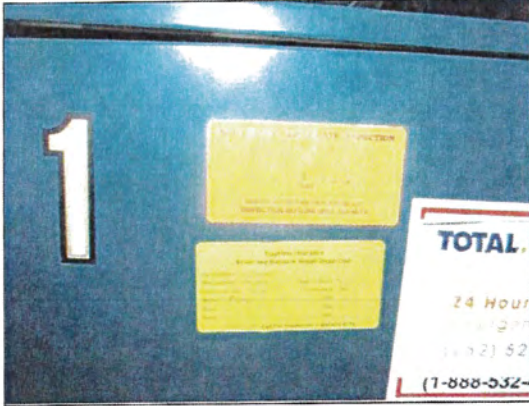
The EUL of gas-fired boilers generating hot water for building heat is typically 30-years depending on how well they are maintained. Based on the age, current condition, and EUL, replacement is not anticipated during the term. A current inspection sticker was observed mounted to the boiler.

25. Boiler #1 inspection date.

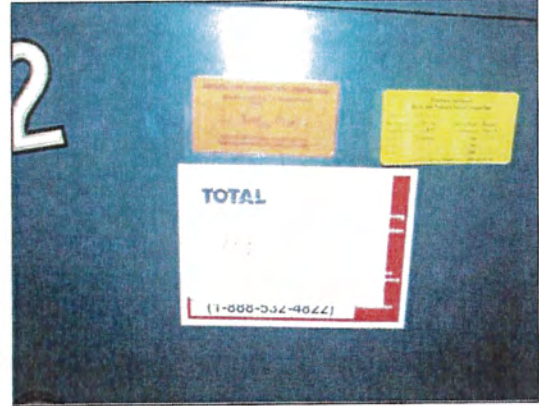
26. Boiler #2 inspection date.

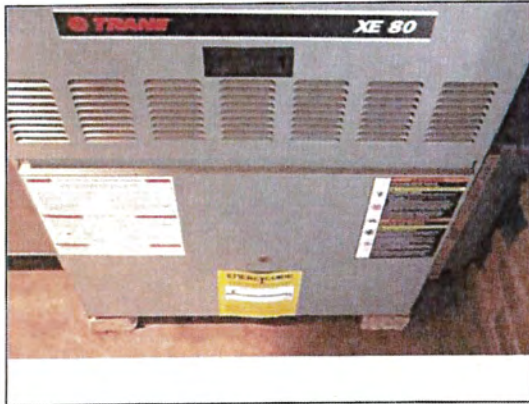
The EUL of gas-fired furnaces generating hot air for building heat is typically 50-years depending on how well they are maintained. Based on the age, current condition, and EUL, replacement is not anticipated during the term.

27. TRANE gas fired furnaces (2).

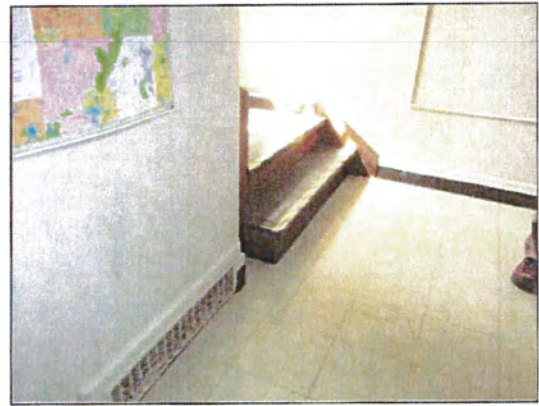
30. Stairs as only access to basement level.

No vertical transportation or elevators were observed during the site visit. In order to achieve the client's accessibility goals, TRC recommends installing new two-stop hydraulic elevator, an elevator pit to accommodate the hydraulic workings and an elevator room. An opinion of costs associated with the installation of a new hydraulic elevator system are included in the table found in Section 1.3 Summary of Cost Data.
