# Water System Master Plan

*April 2022*

**PREPARED FOR:**  
**Village of Pewaukee**  
235 Hickory Street  
Pewaukee, WI 53072

**PREPARED BY:**  
**Ruekert & Mielke, Inc.**  
W233 N2080 Ridgeview Parkway  
Suite 300  
Waukesha, WI 53188

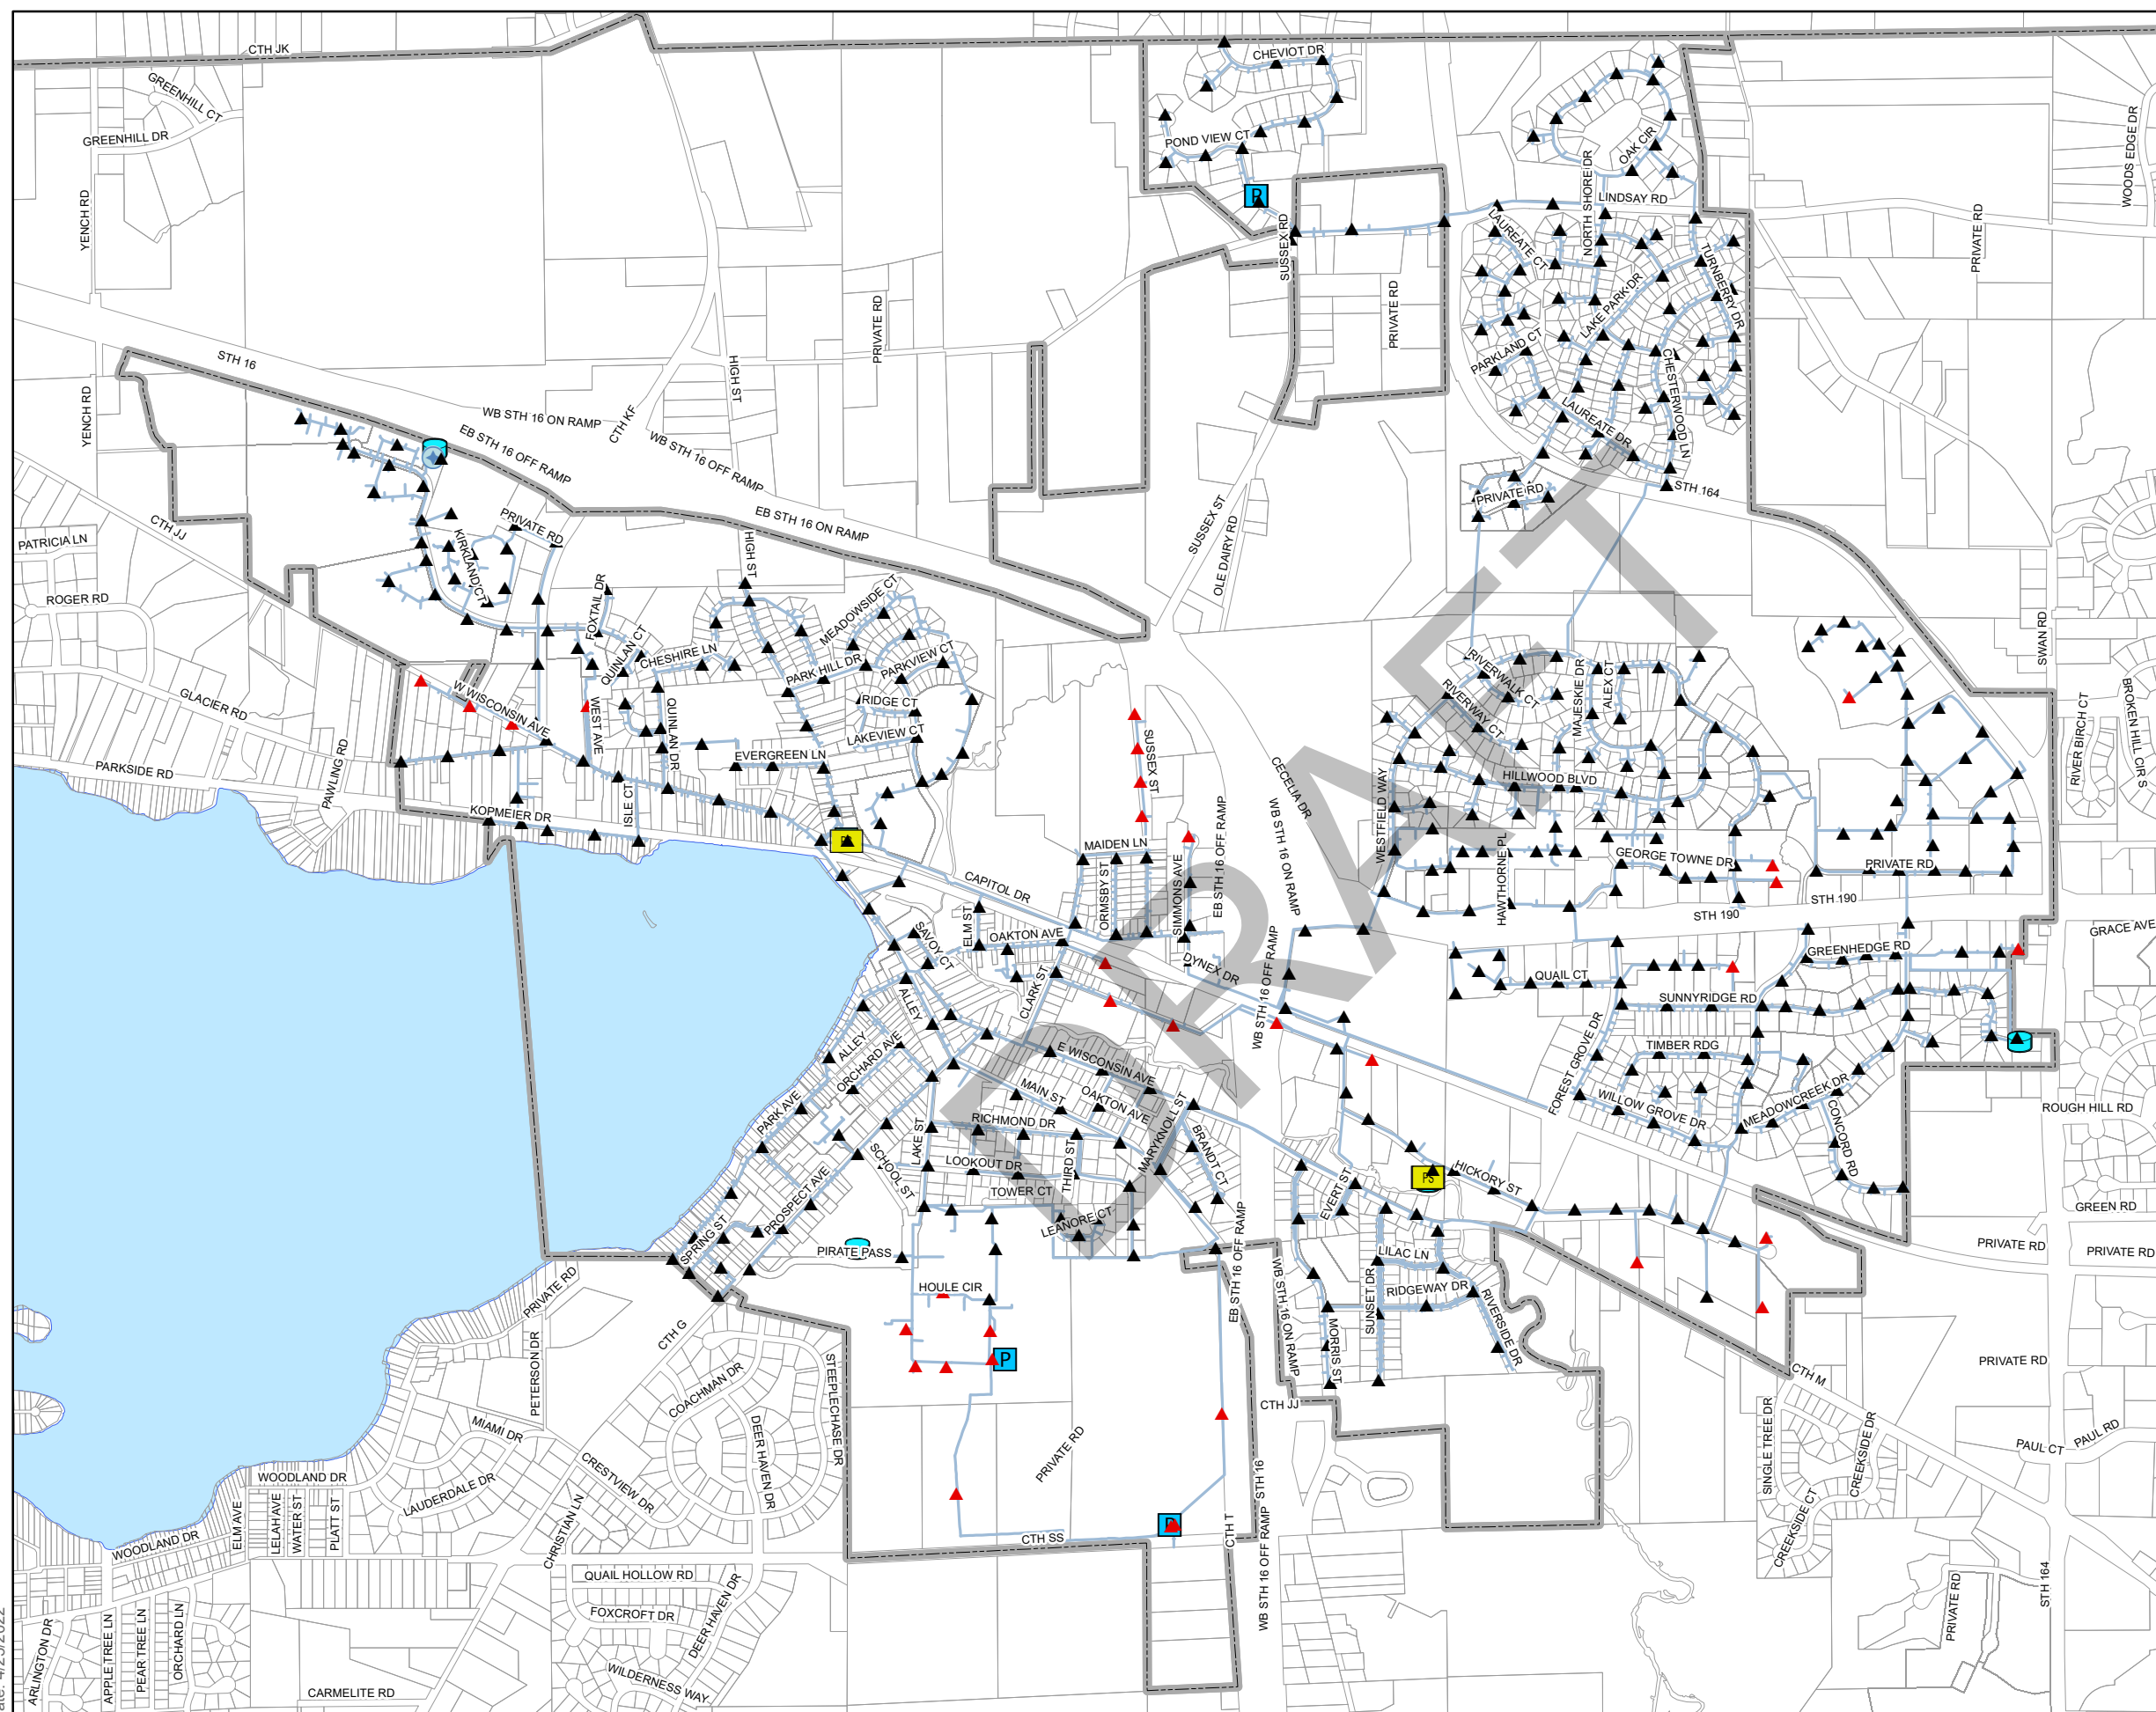
Figure VI-6 identifies areas where potential fire flow deficiencies currently exist. Deficiencies were identified where the assumed fire flows identified in Table VI-1 were not met for a particular land use as determined from the available land use data.

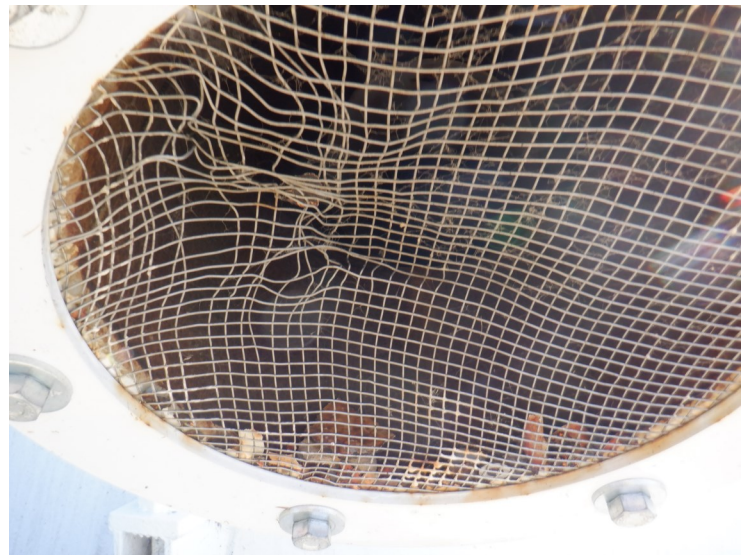
5) The screen at the overflow discharge is intact but deformed and oversized.

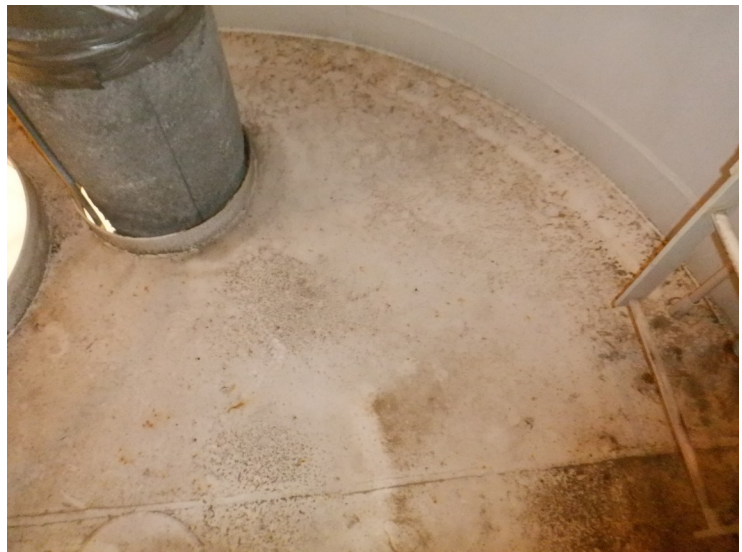
31) Minor coating failures on the condensate platform.

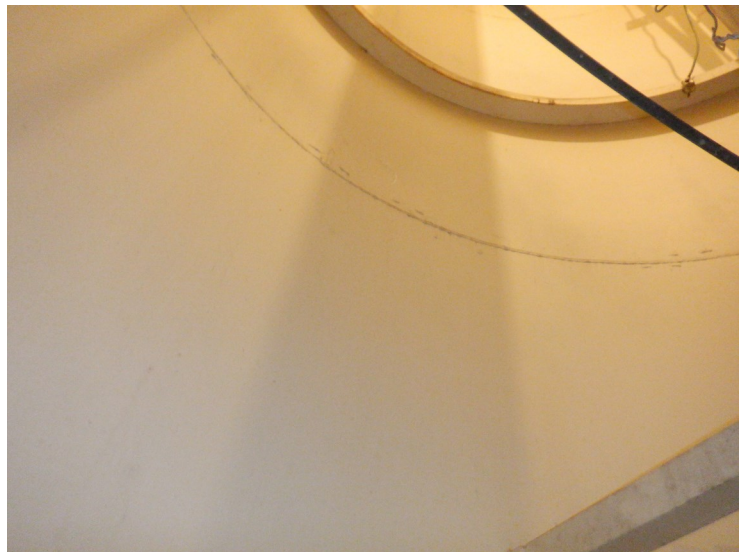
33) Coating failures along a stiffener in the dry riser.

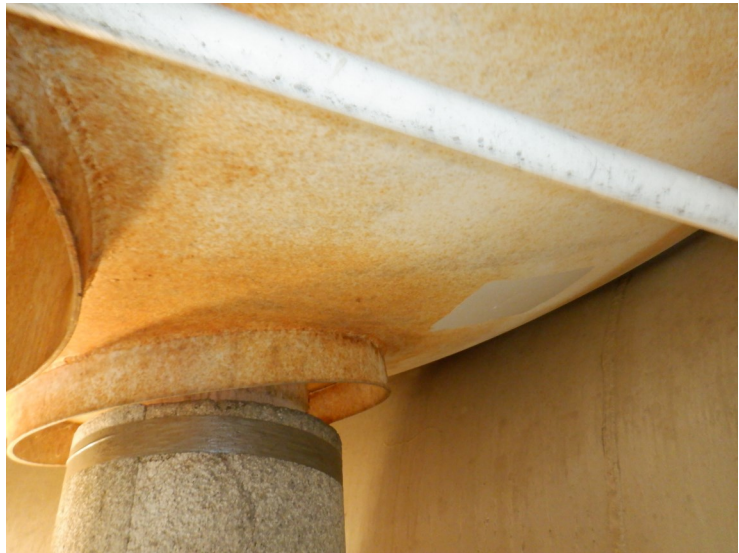
44) Extensive rust bleedthrough on the bowl.

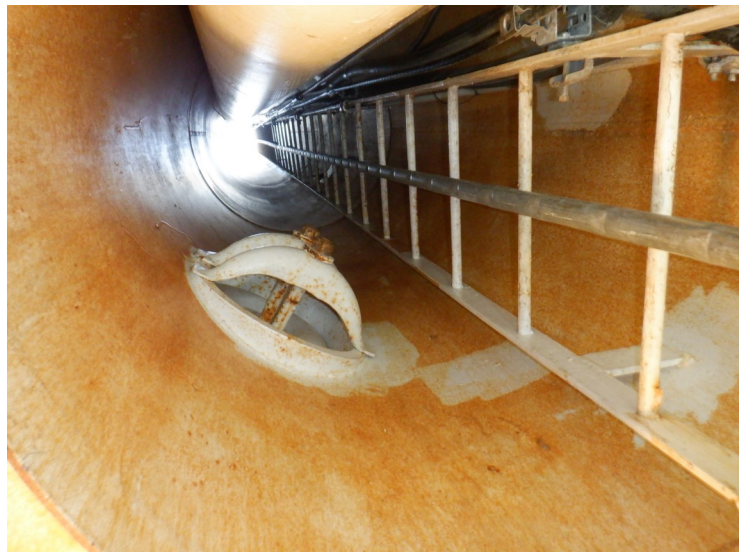
46) Extensive rust bleedthrough in the access tube.

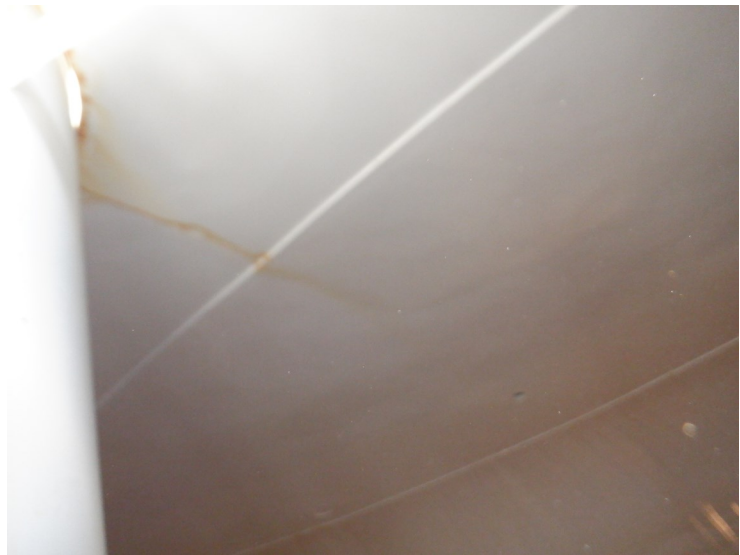
48) Coating failures on the wet interior manway.

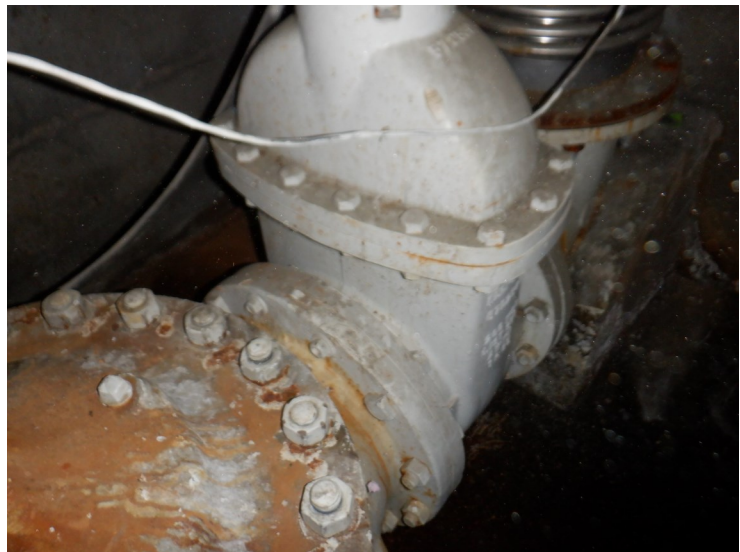
67) Minor coating failures on the pit piping.

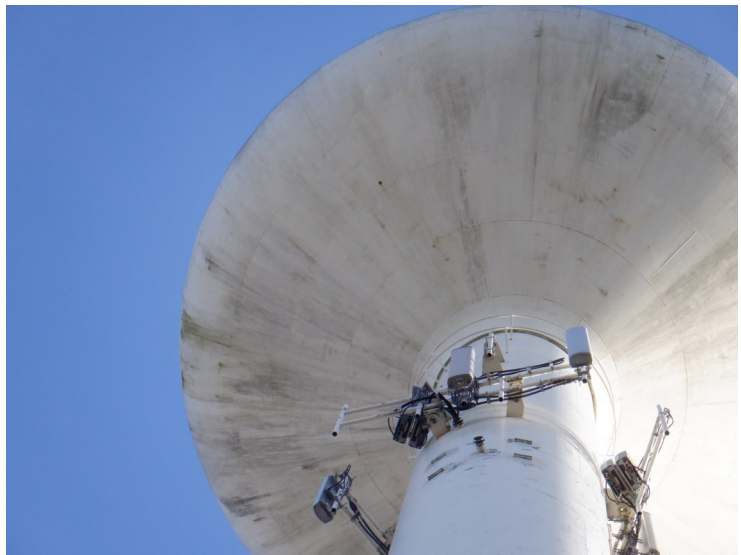
11) Coating failures on the riser.

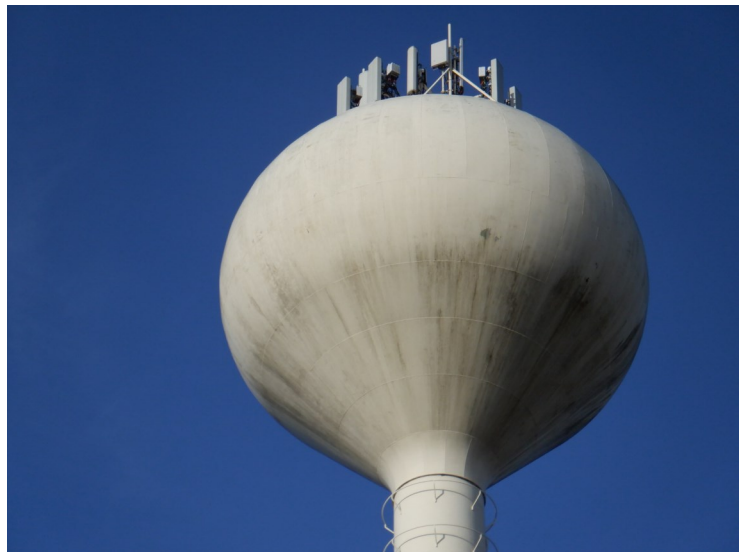
14) A few coating failures on the bowl.

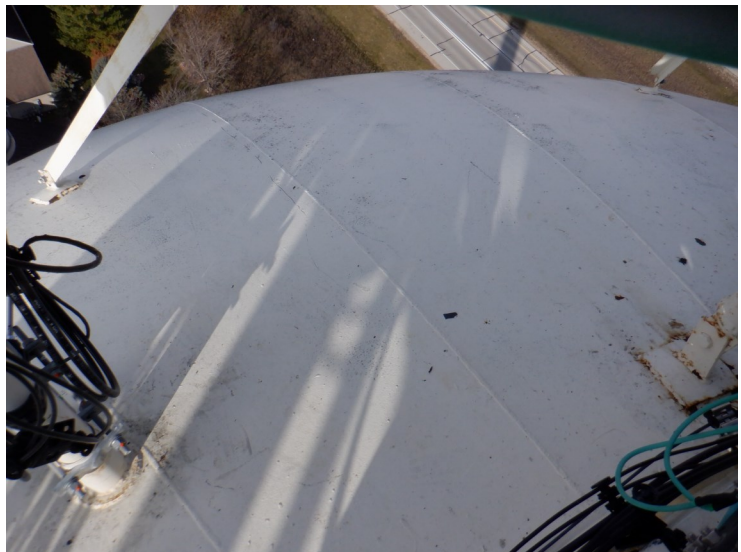
17) Coating failures on the sidewall.

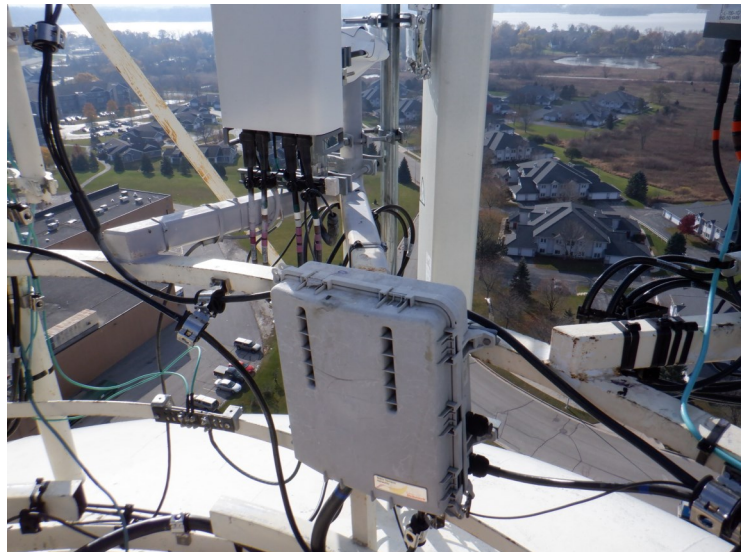
20) Coating failures on the roof.

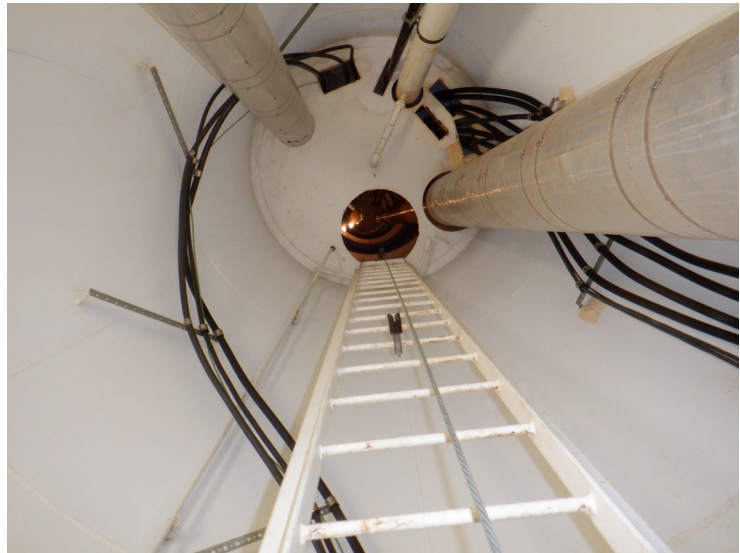
29) Coating failures on the baseplate in the dry interior.

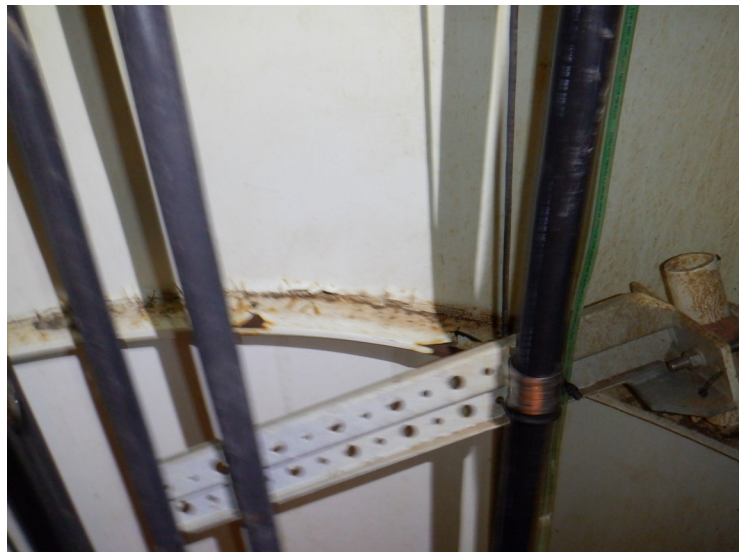
35) Coating failure on the condensate platform.

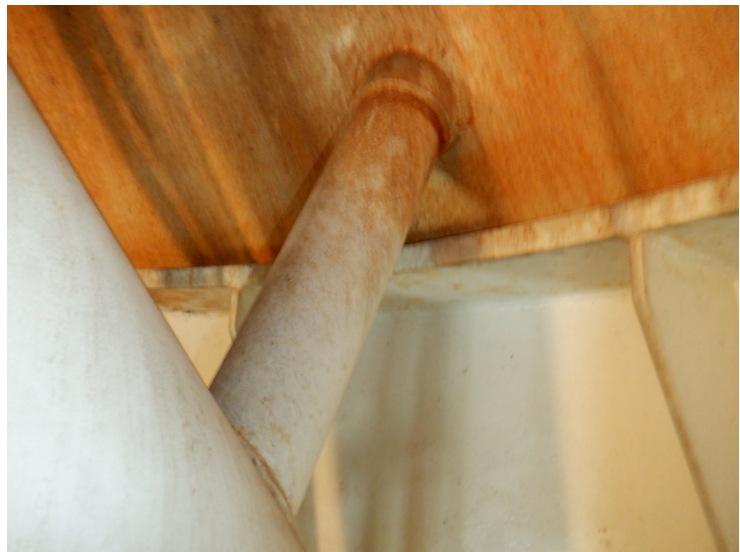
45) Rust bleedthrough on the transition cone.

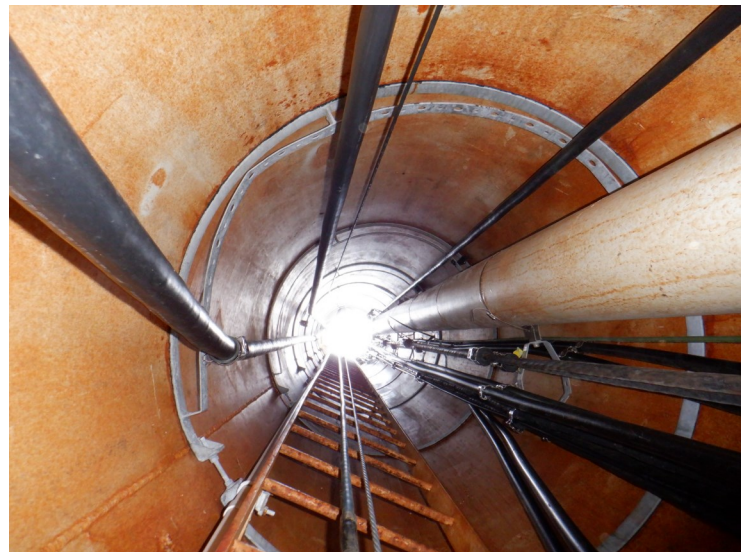
48) Rust bleedthrough in the access tube.

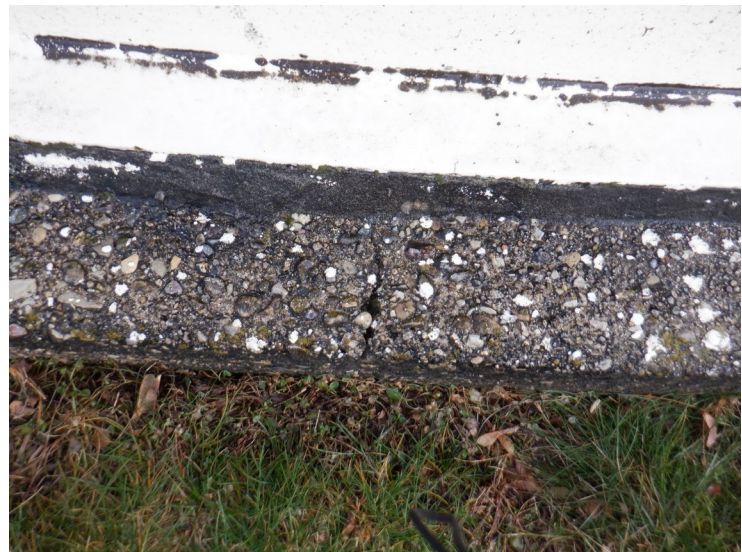
2) There are minor cracks and exposed aggregate on the foundation.

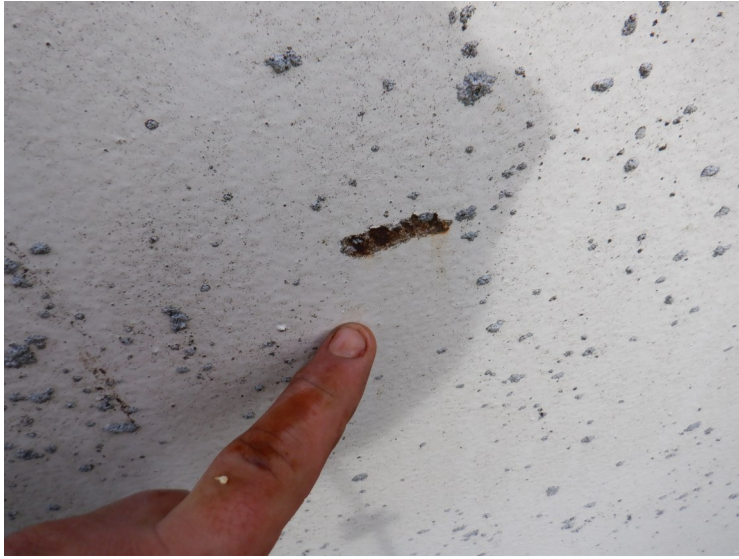
15) There is a small spot of delamination on the baseplate.

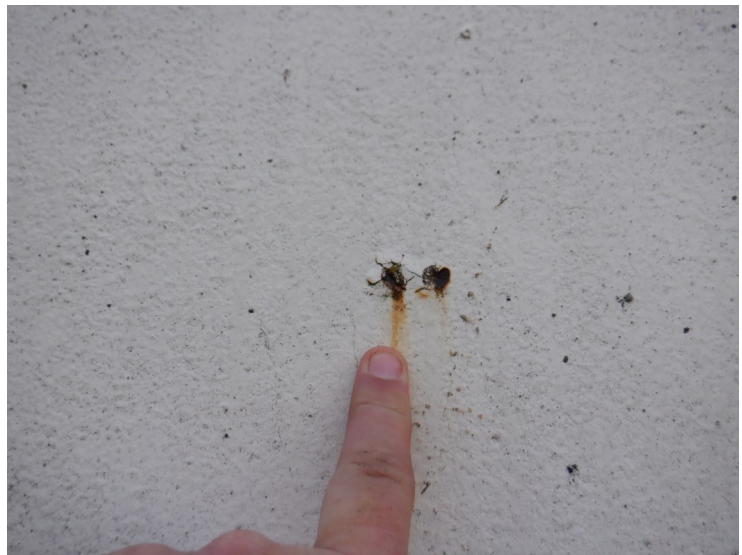
16) There are several small spot coating failures on the sidewall.

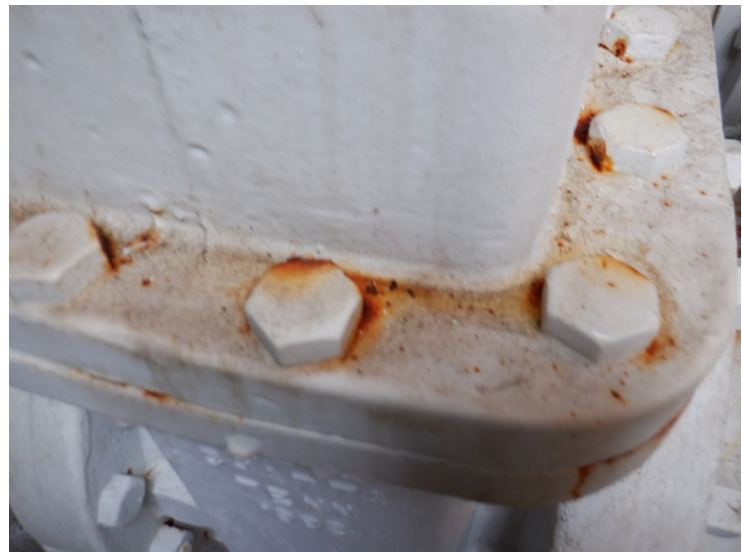
65) There are spot coating failures on the bolts and flanges.
