Water System Master Plan

April 2022

PREPARED FOR:
Village of Pewaukee
235 Hickory Street
Pewaukee, WI 53072

PREPARED BY:
Ruekert & Mielke, Inc.
W233 N2080 Ridgeview Parkway
Suite 300
Waukesha, WI 53188

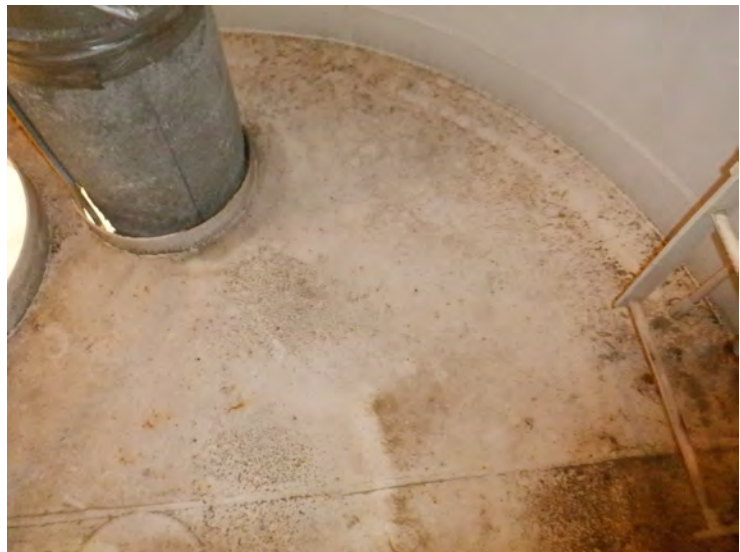
31) Minor coating failures on the condensate platform.

32) Same.

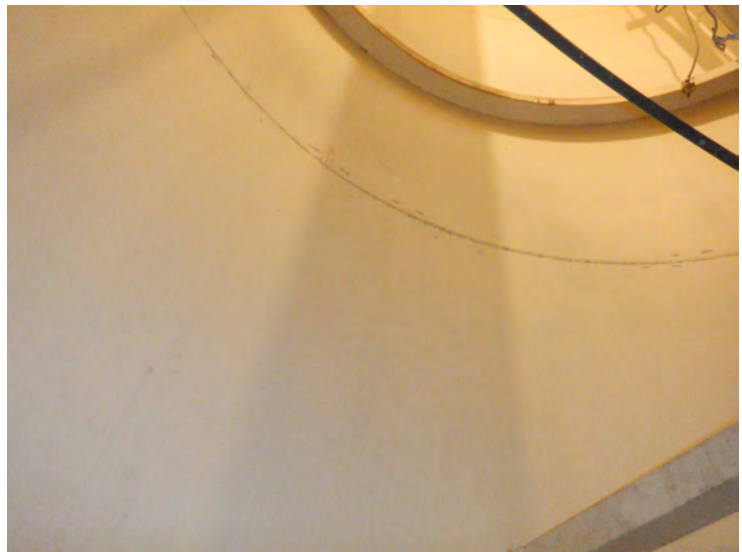
33) Coating failures along a stiffener in the dry riser.

34) Same.

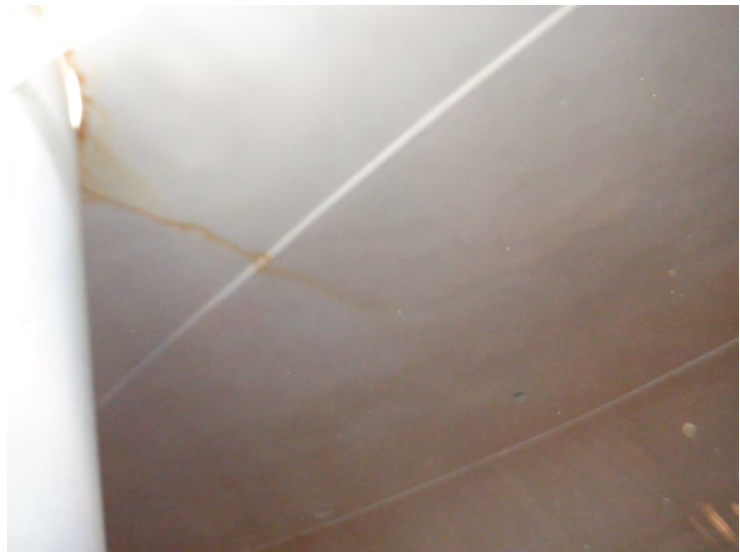
48) Coating failures on the wet interior manway.

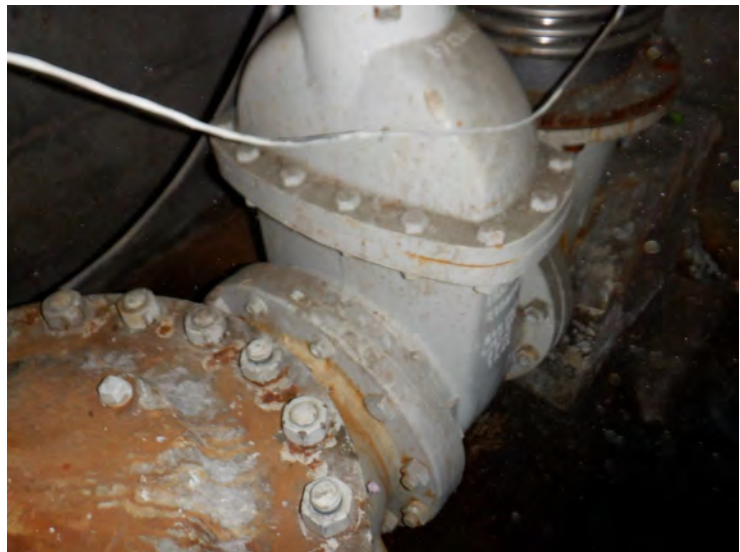
67) Minor coating failures on the pit piping.

68) Same.

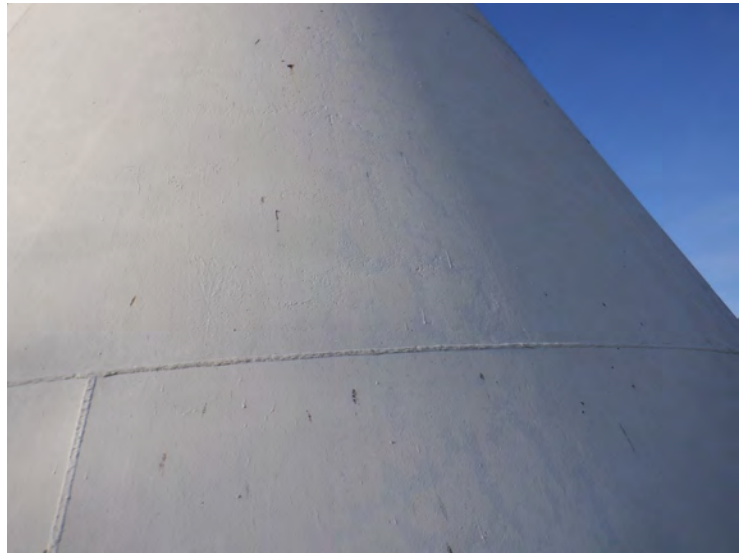
6) Coating failures on the baseplate.

7) Coating failures on the basebell.

8) Same.

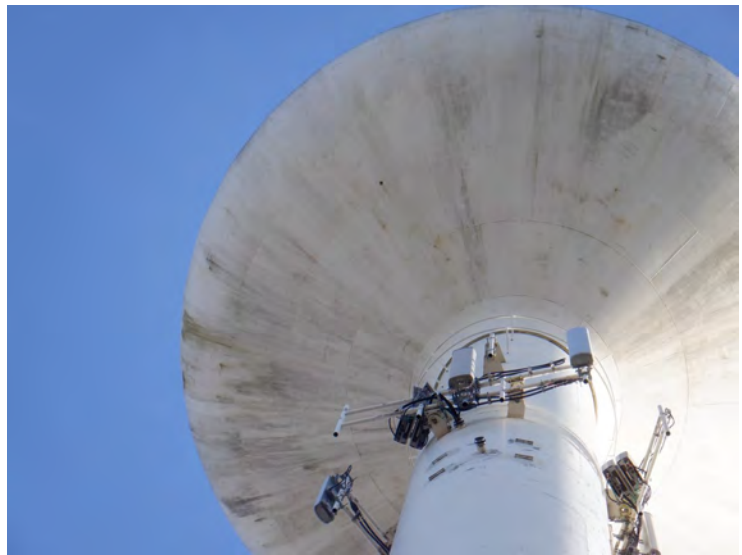
11) Coating failures on the riser.

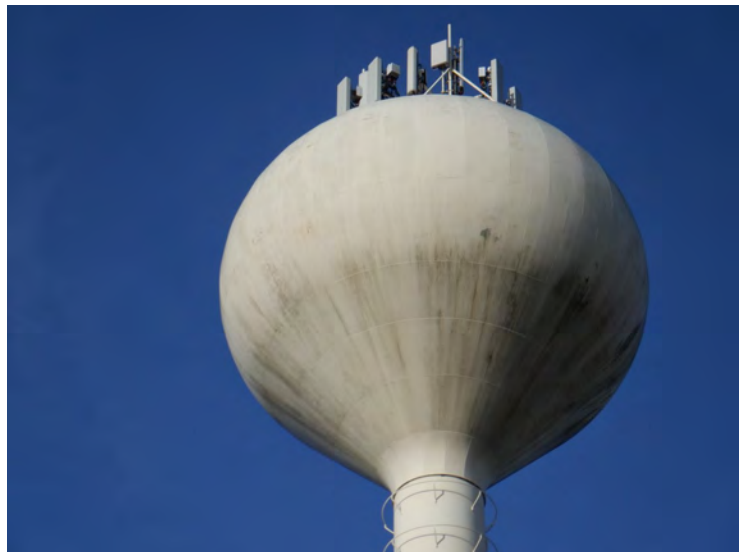
14) A few coating failures on the bowl.

15) Same.

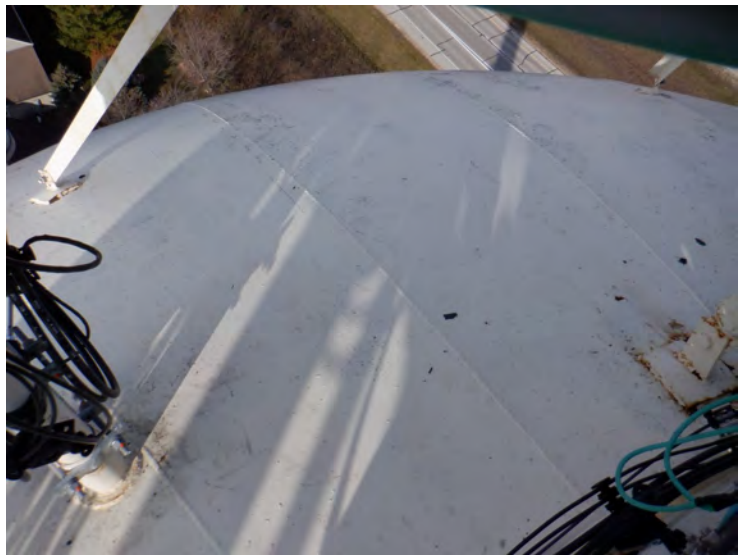
17) Coating failures on the sidewall.

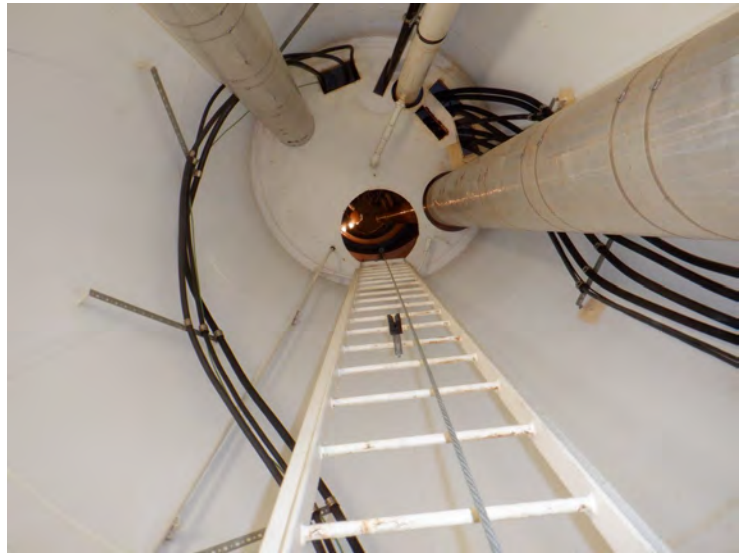
29) Coating failures on the baseplate in the dry interior.

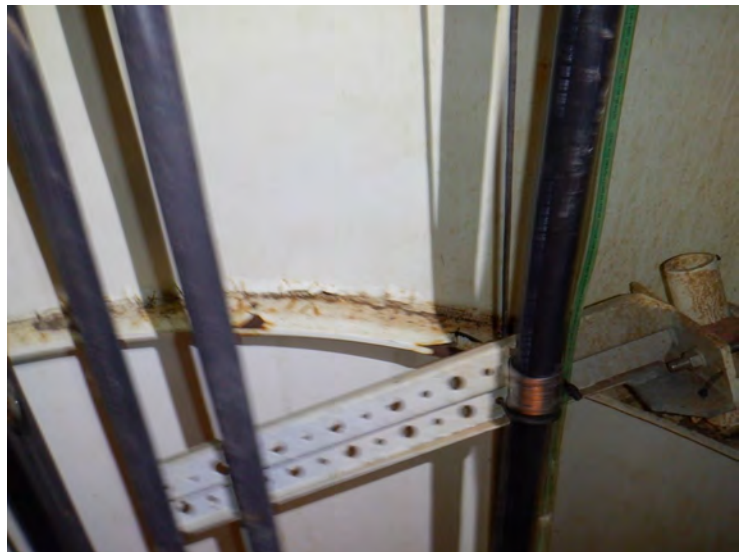
35) Coating failure on the condensate platform.

36) Same.

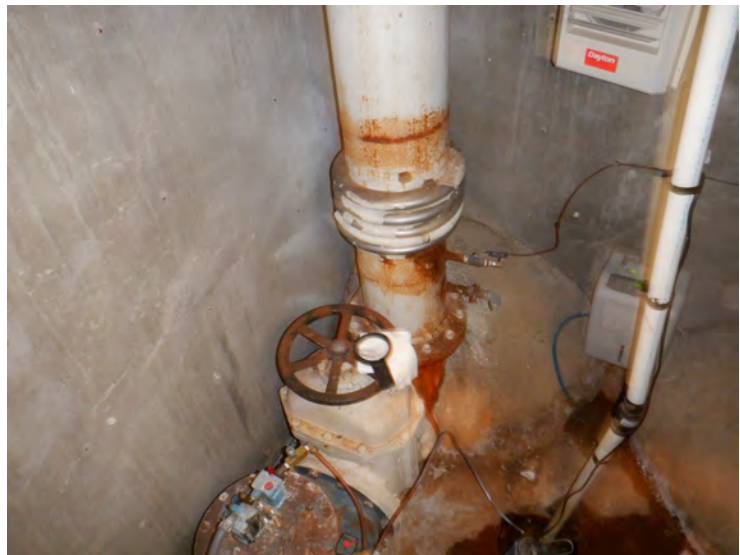
66) Coating failures on the pit piping.

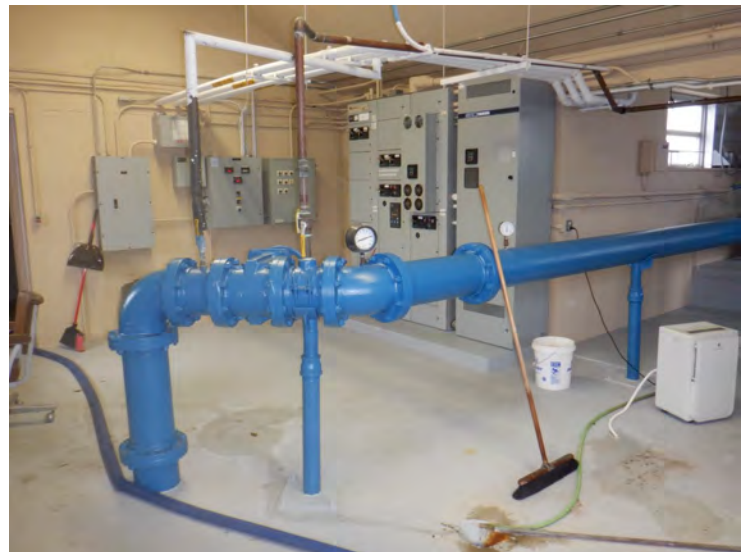
18) There is some erosion of the elastomeric coating on the floor.

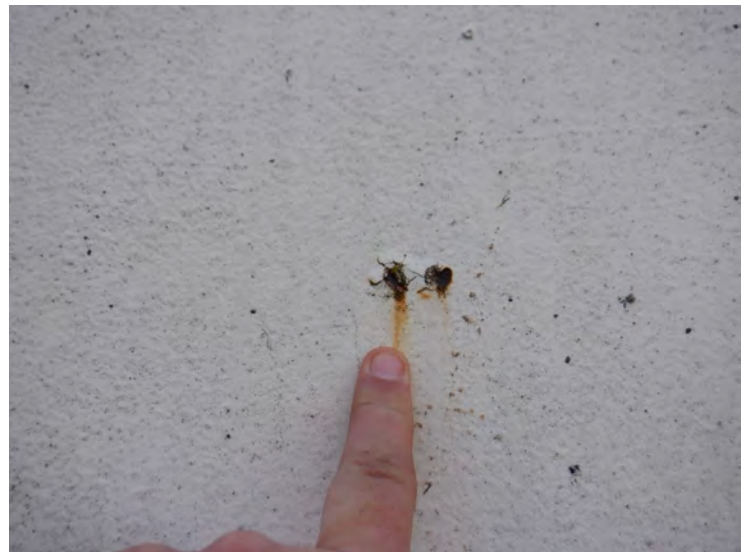
16) There are several small spot coating failures on the sidewall.

17) Same.

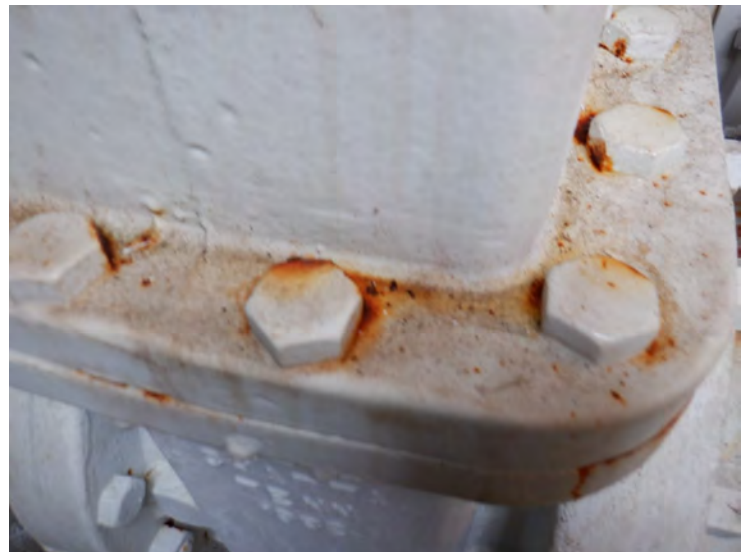
65) There are spot coating failures on the bolts and flanges.

66) Same.
