Regular Village Board Meeting Agenda

July 19, 2022 – 7:00 pm
Village Hall, 235 Hickory Street, Pewaukee, WI 53072

250,000 gallon spheroid (Lake Street) elevated water storage tank owned by the Village of Pewaukee, Wisconsin.

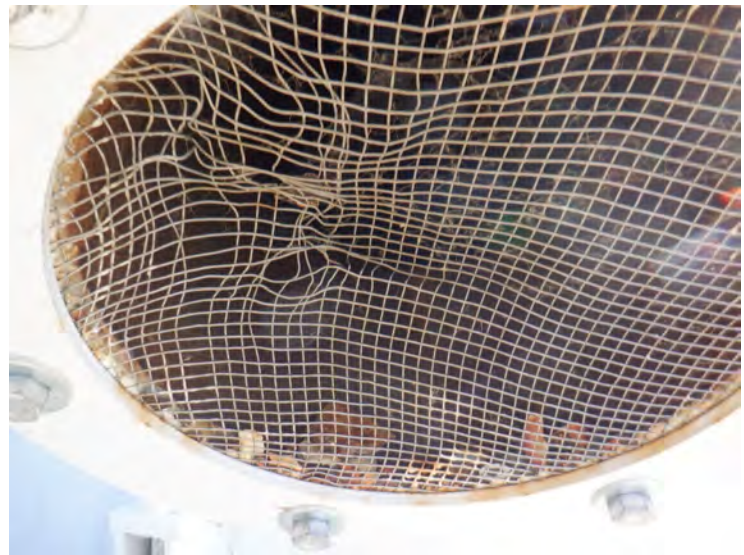
5) The screen at the overflow discharge is intact but deformed and oversized.

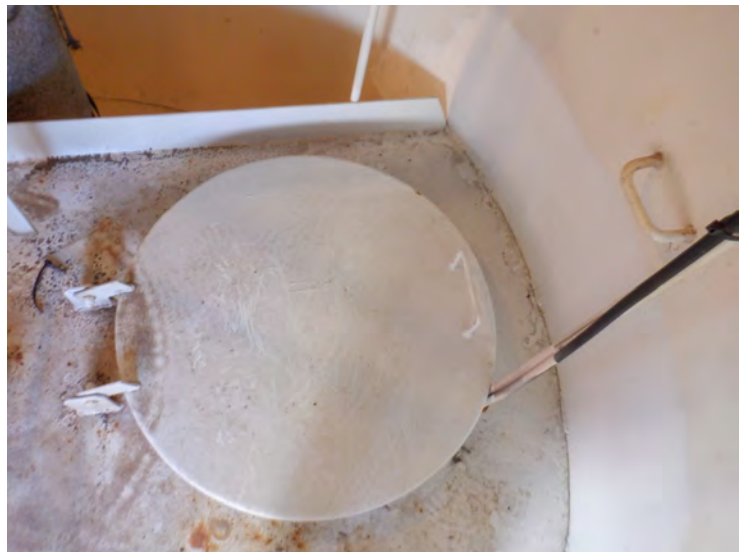
39) Minor coating failures on the top platform.

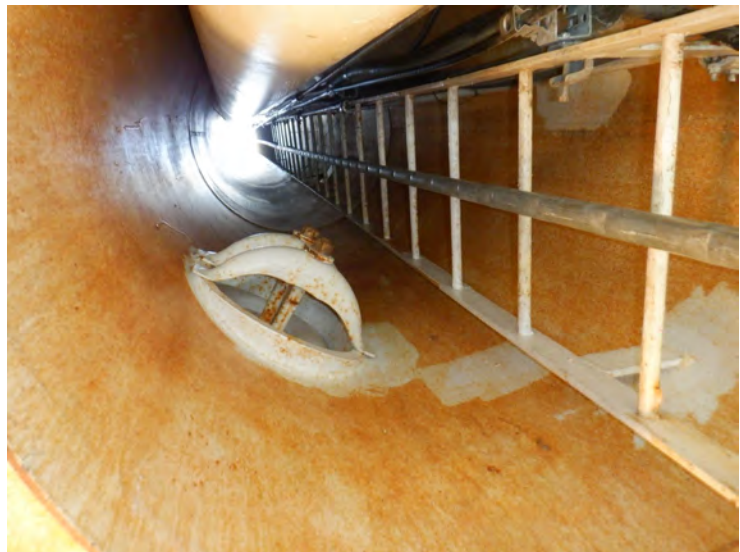
48) Coating failures on the wet interior manway.

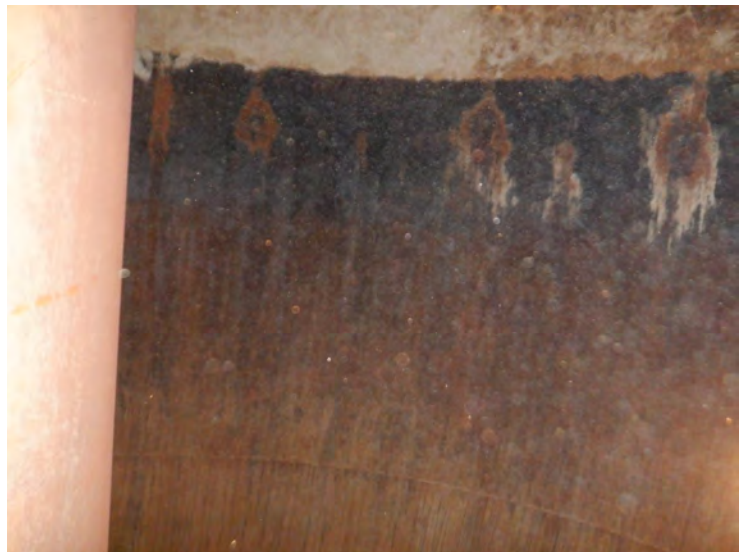
53) There is heavy mineral staining on the wet interior sidewall but no coating failures.

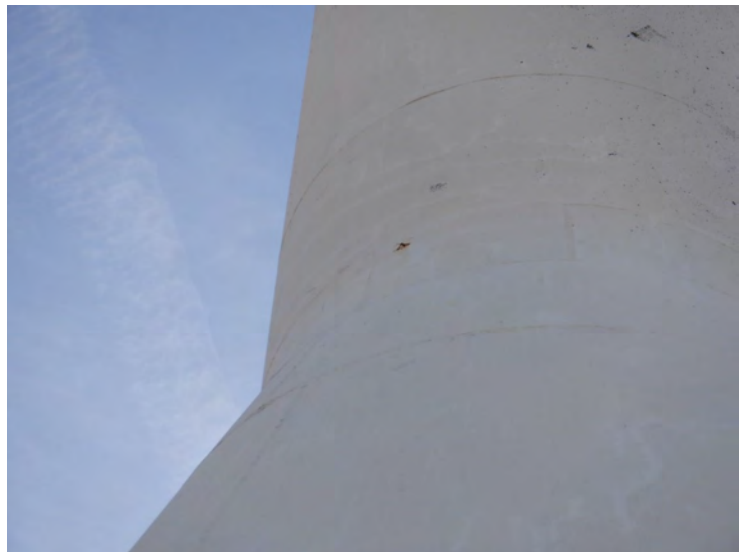
11) Coating failures on the riser.

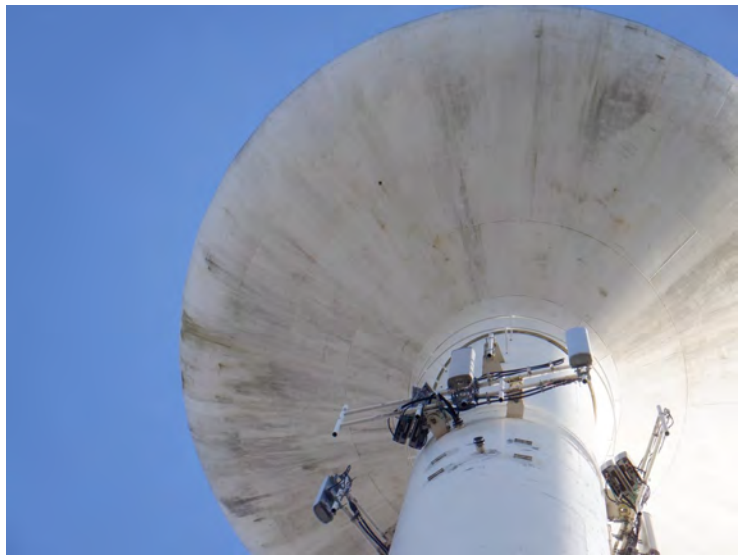
14) A few coating failures on the bowl.

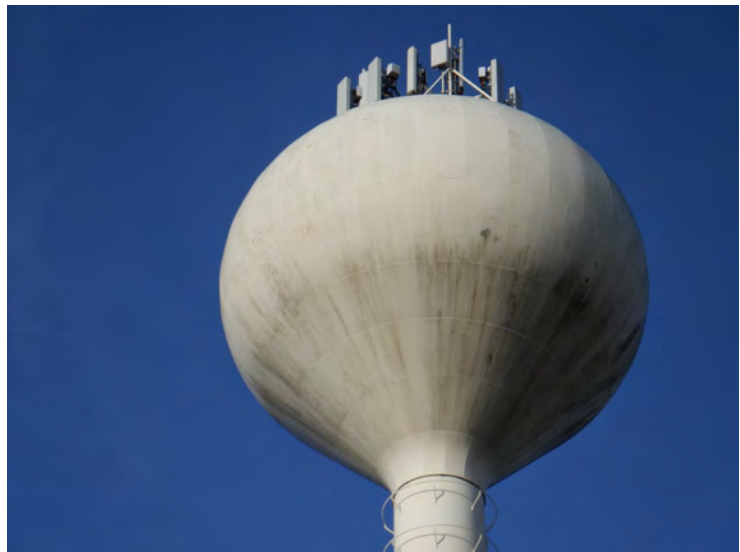
17) Coating failures on the sidewall.

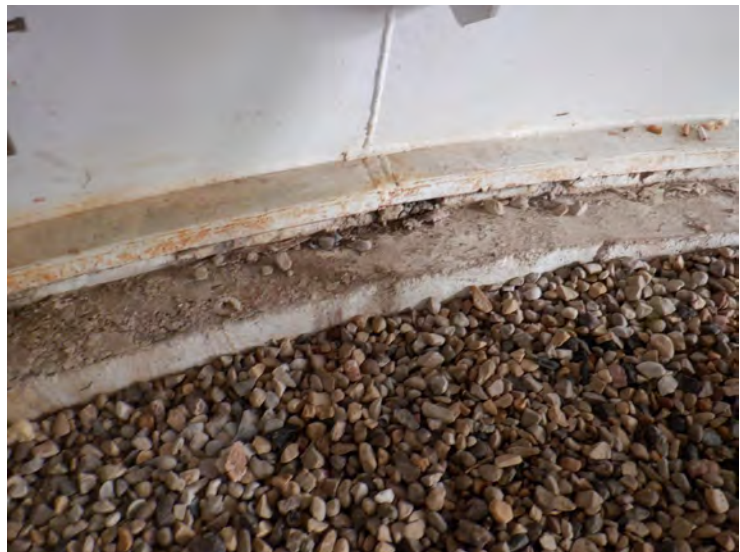
29) Coating failures on the baseplate in the dry interior.

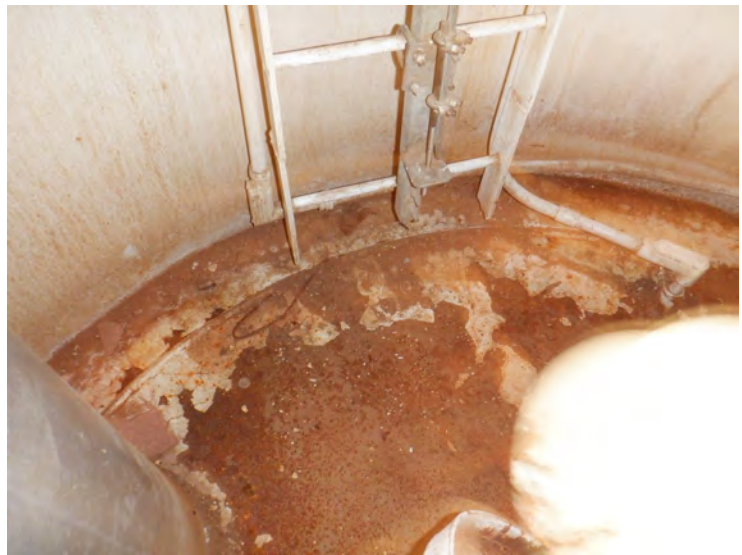
35) Coating failure on the condensate platform.

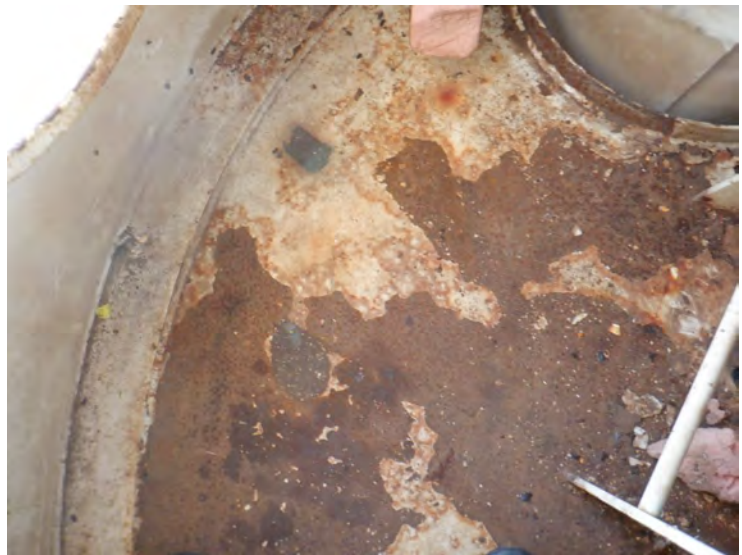
45) Rust bleedthrough on the transition cone.

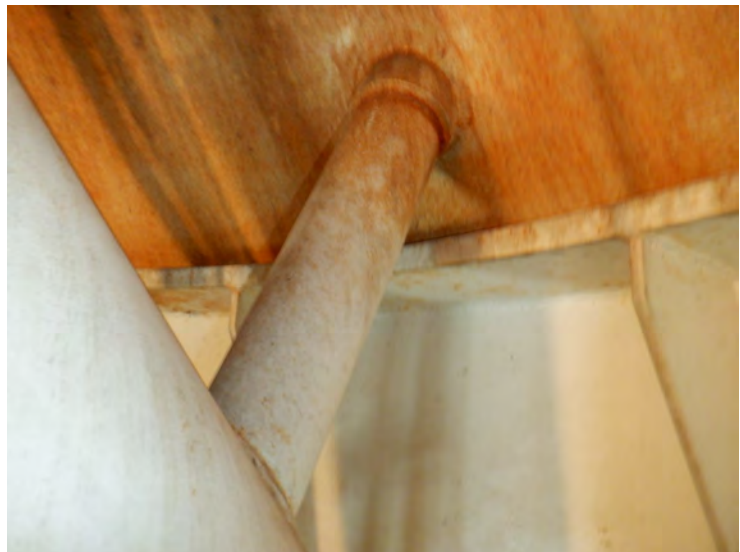
48) Rust bleedthrough in the access tube.

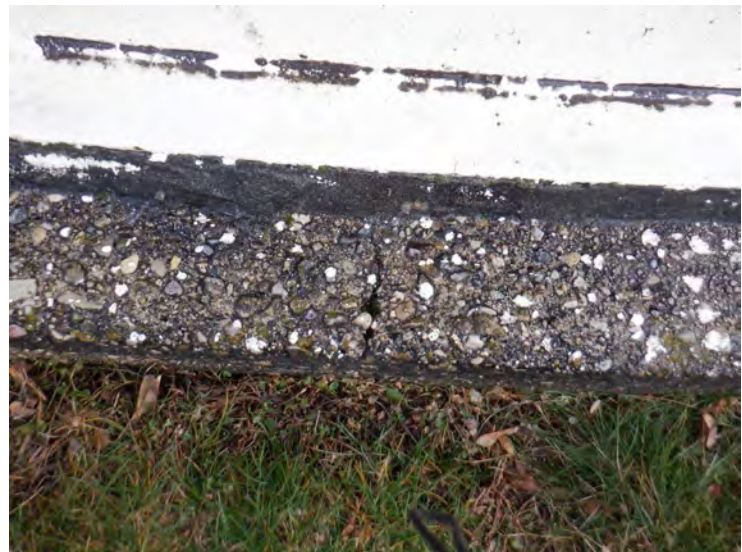
2) There are minor cracks and exposed aggregate on the foundation.

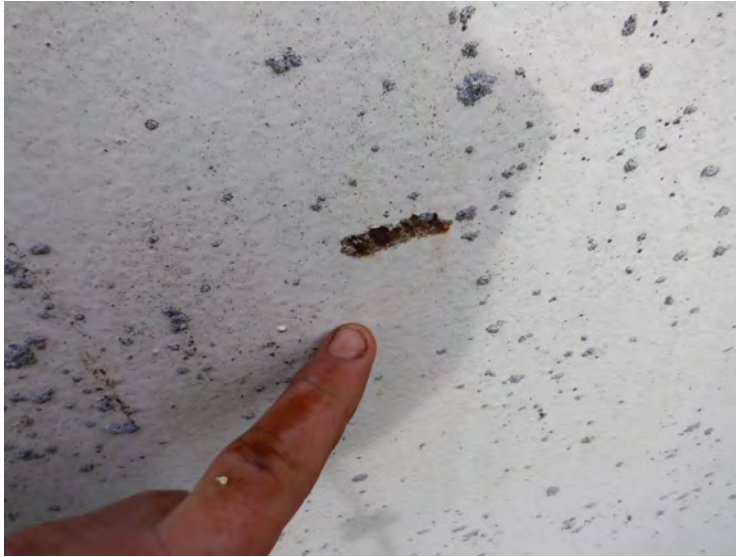
15) There is a small spot of delamination on the baseplate.

16) There are several small spot coating failures on the sidewall.

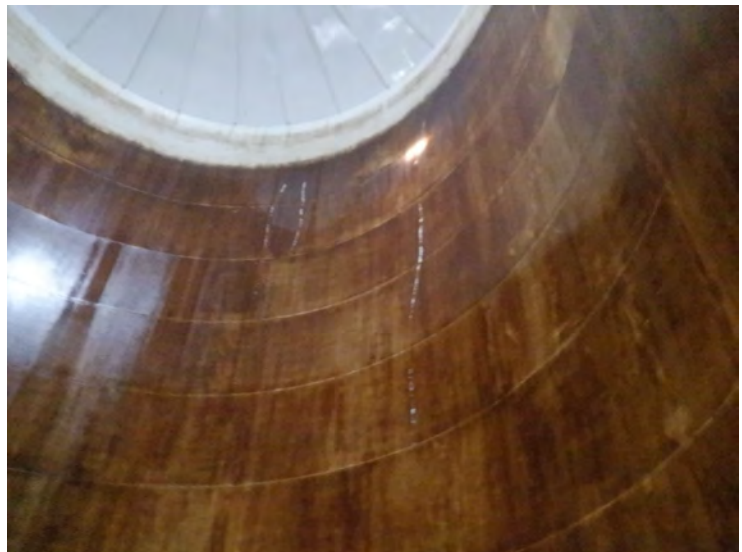
47) There is heavy mineral staining on the sidewall.

48) There are scratches in the mineral staining near the high-water level.
