Water System Master Plan

June 7, 2022

PREPARED FOR:
Village of Pewaukee
235 Hickory Street
Pewaukee, WI 53072

PREPARED BY:
Ruekert & Mielke, Inc.
W233 N2080 Ridgeview Parkway
Suite 300
Waukesha, WI 53188

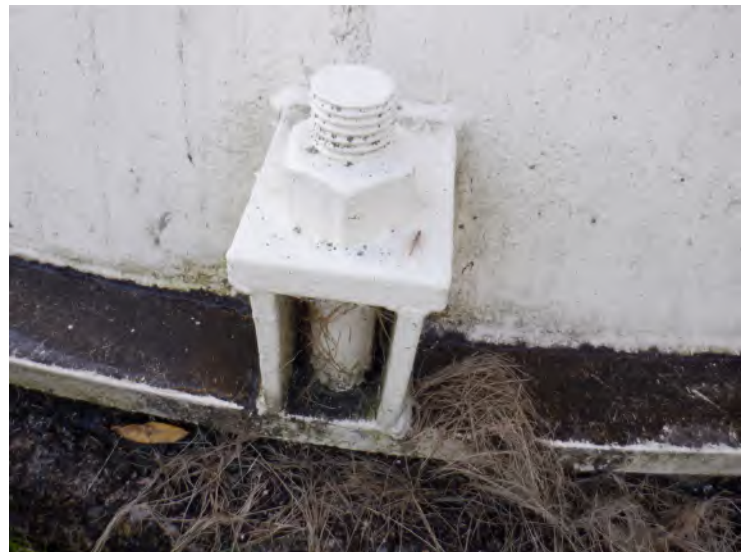
1) The concrete foundation is in good condition with no significant deterioration.

2) The anchor bolts are in good condition. There is no missing grout between the baseplate and foundation.

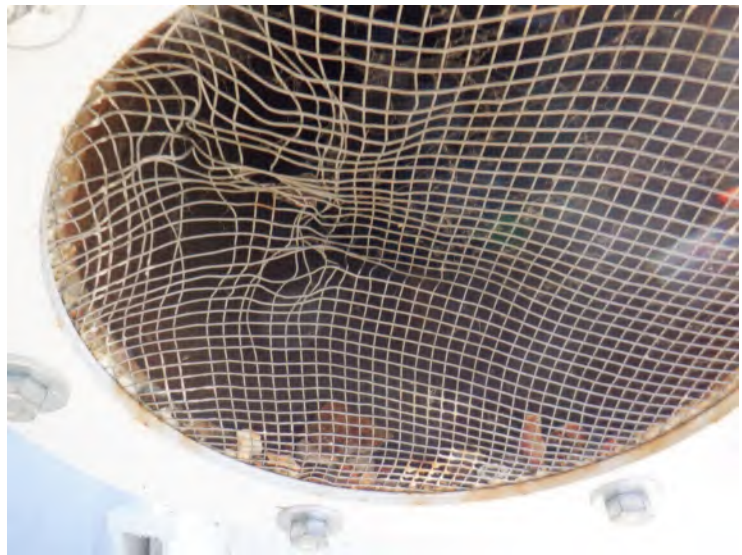
4) The overflow pipe discharges to a concrete splash pad.

5) The screen at the overflow discharge is intact but deformed and oversized.

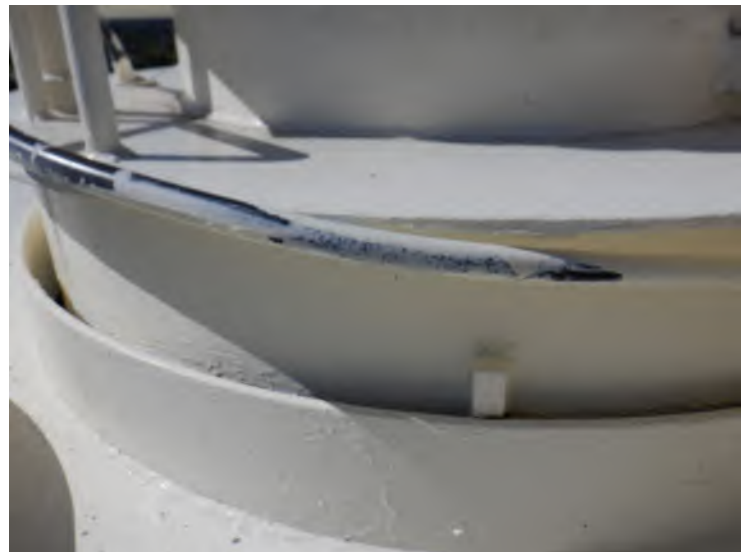
20) There is no cover over the access tube air gap.

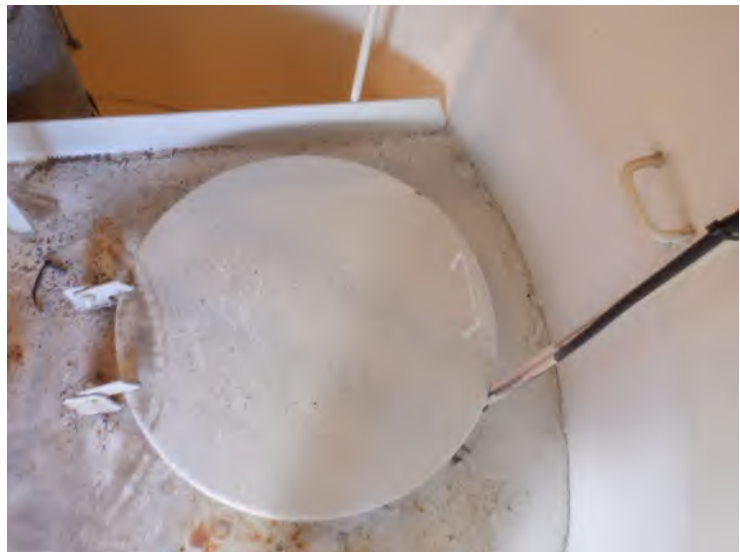
39) Minor coating failures on the top platform.

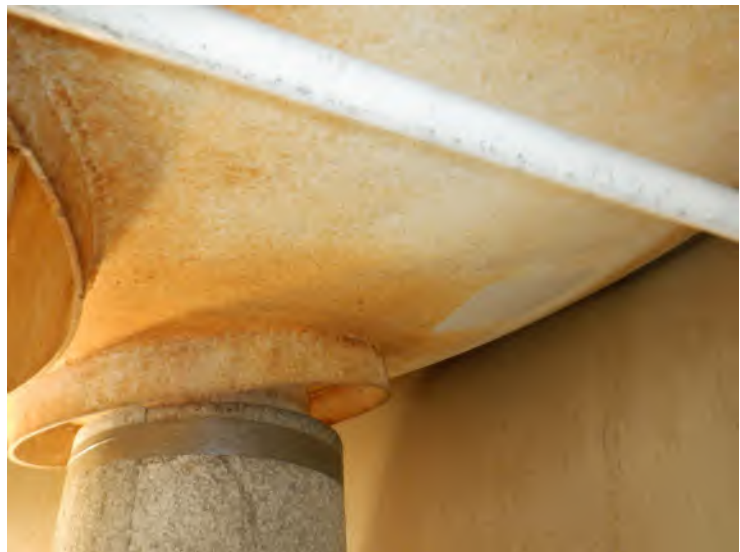
44) Extensive rust bleedthrough on the bowl.

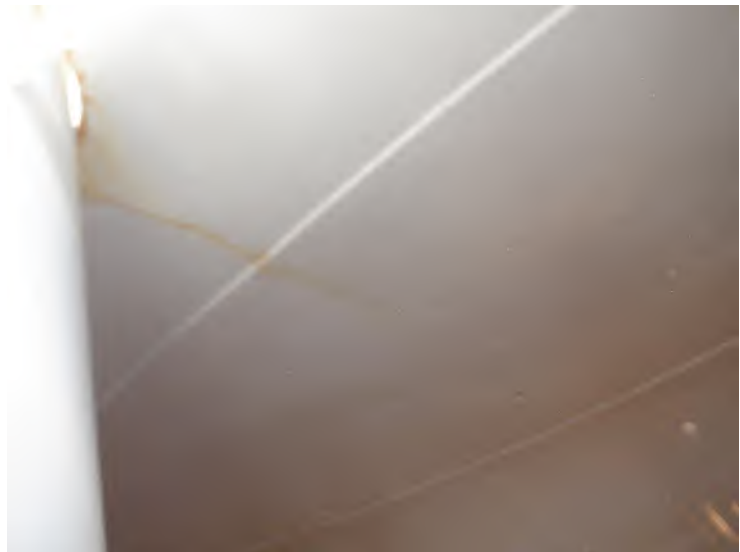
50) Coating on the wet interior roof is in good condition with no significant deterioration.

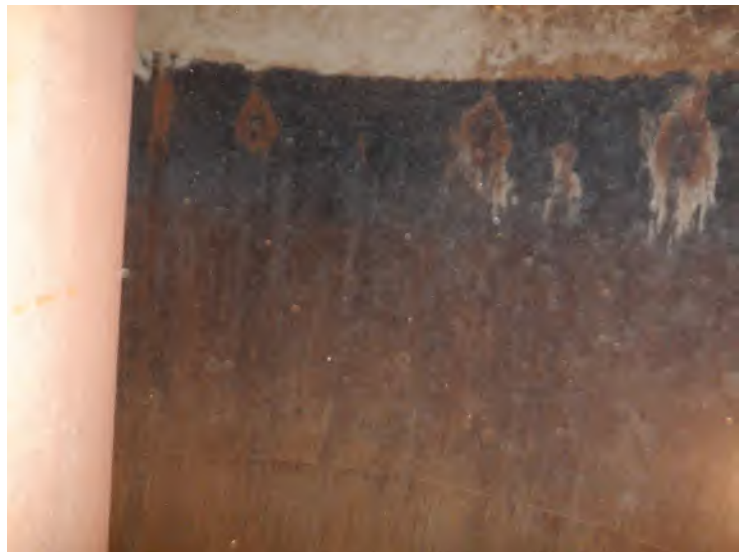
53) There is heavy mineral staining on the wet interior sidewall but no coating failures.

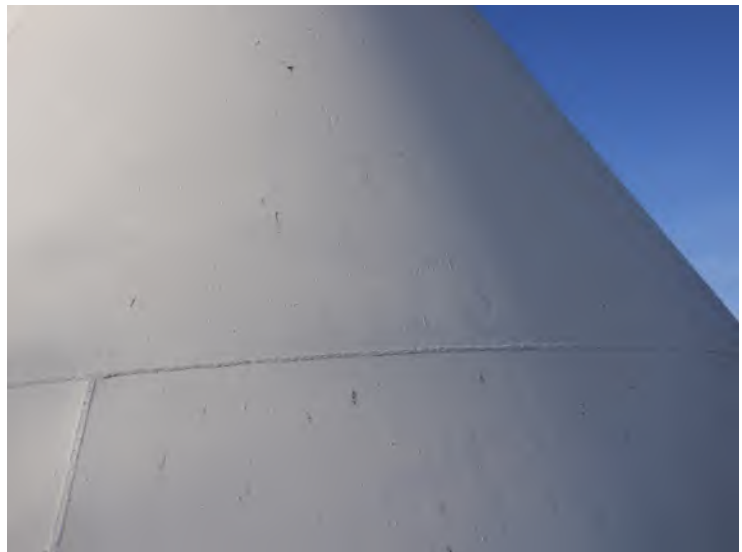
6) Coating failures on the baseplate.

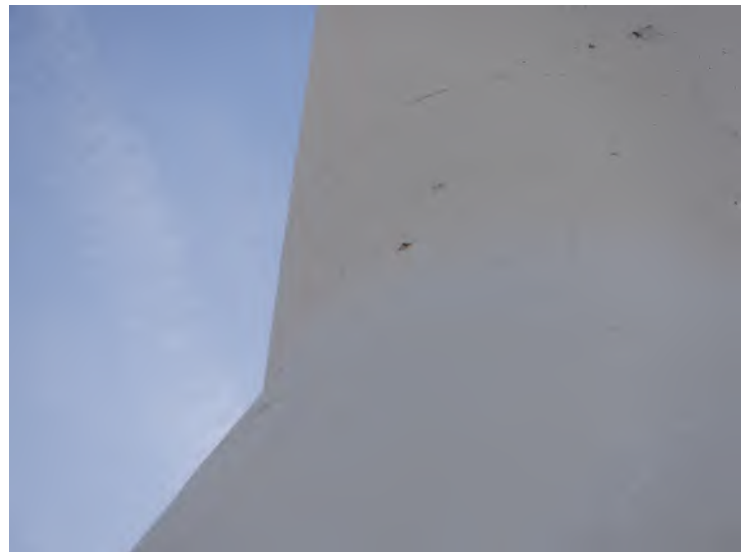
11) Coating failures on the riser.

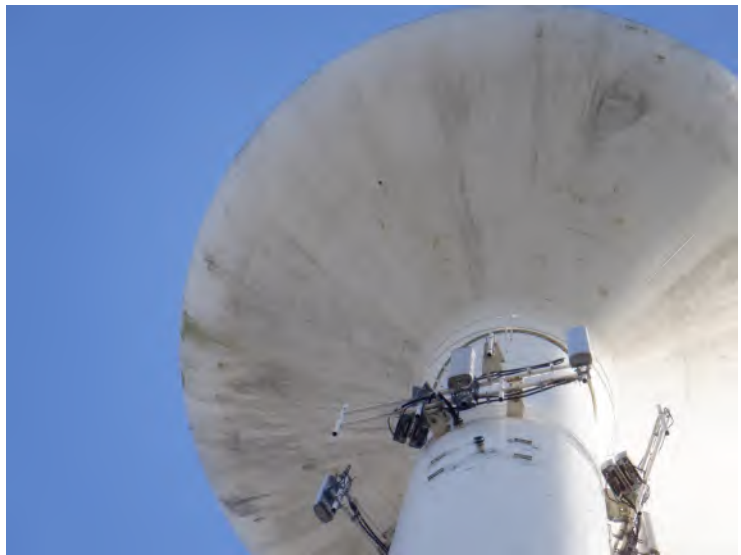
14) A few coating failures on the bowl.

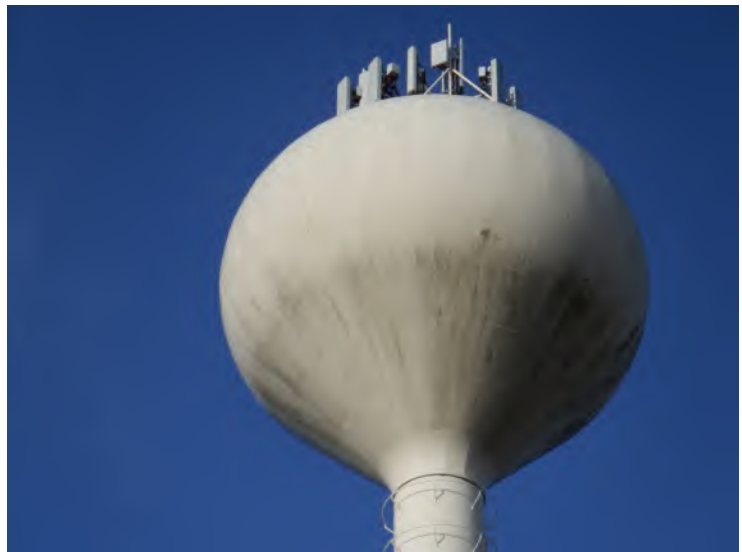
17) Coating failures on the sidewall.

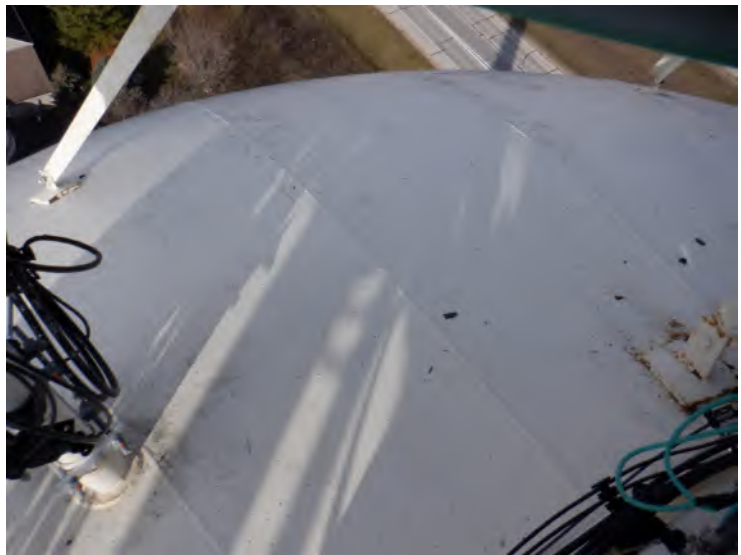
20) Coating failures on the roof.

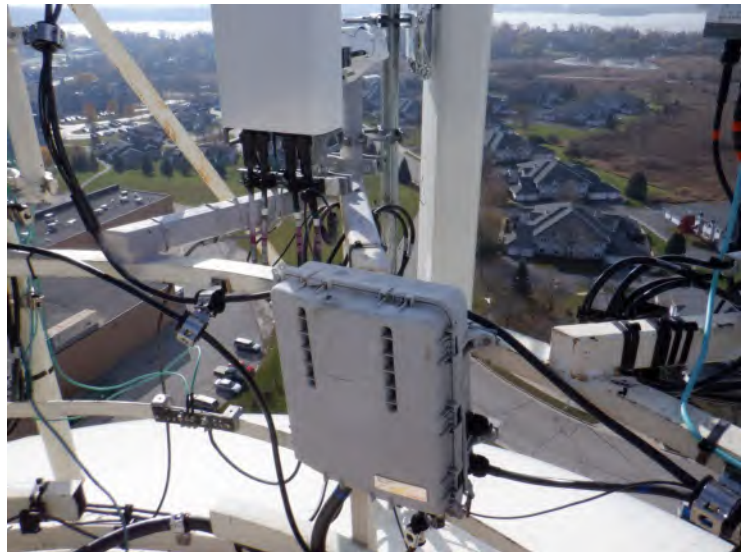
23) The roof handrail is in good condition. There are antennas attached to the roof handrail. There is not a painter's railing on the roof

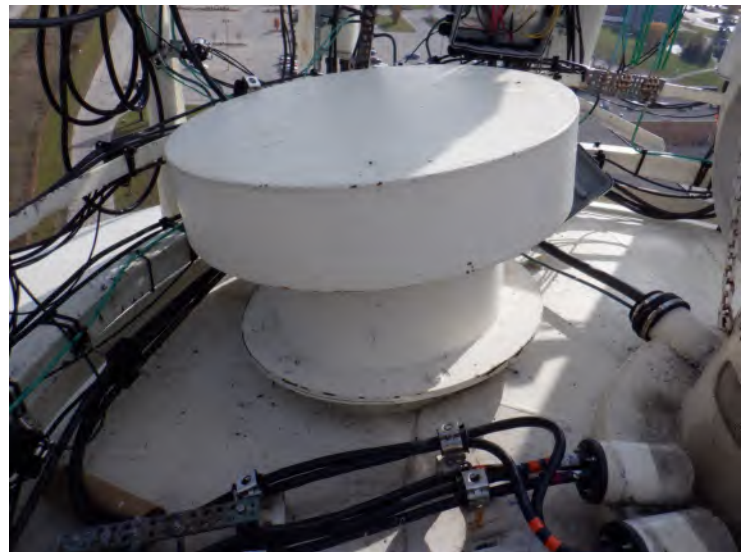
24) There is not a gasket on the wet interior roof hatch.

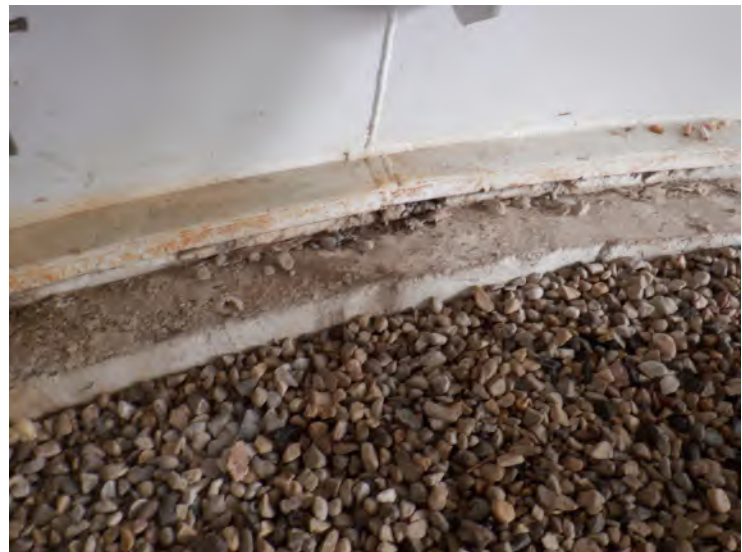
29) Coating failures on the baseplate in the dry interior.

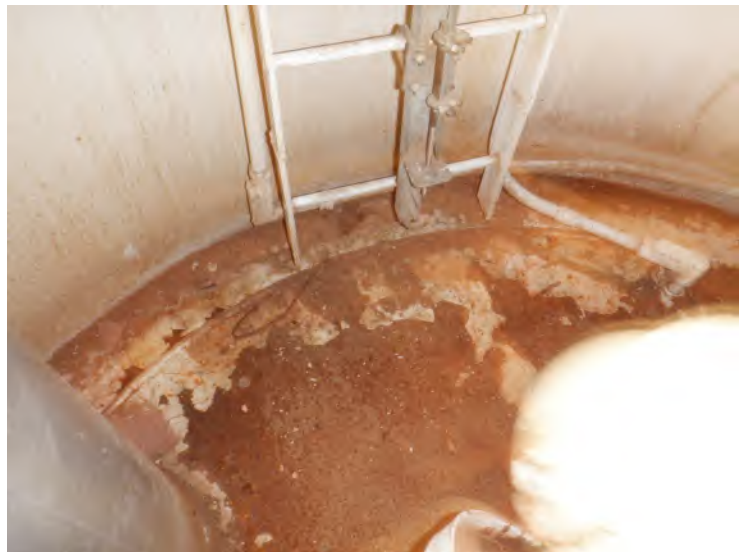
35) Coating failure on the condensate platform.

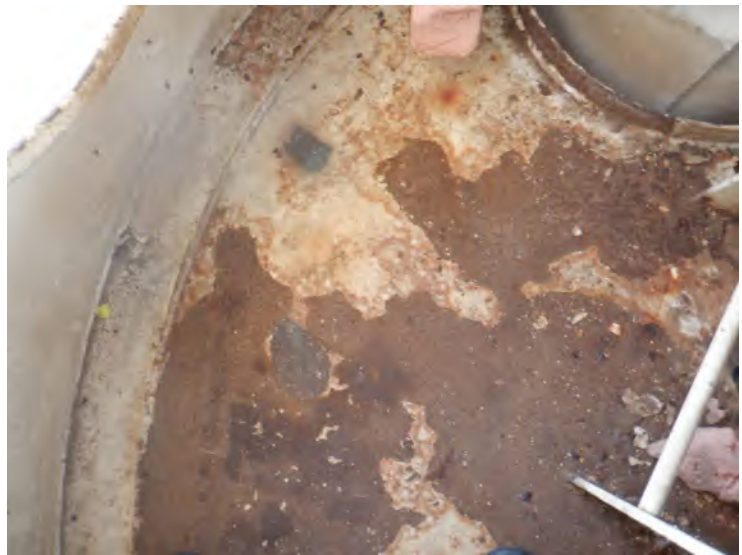
45) Rust bleedthrough on the transition cone.

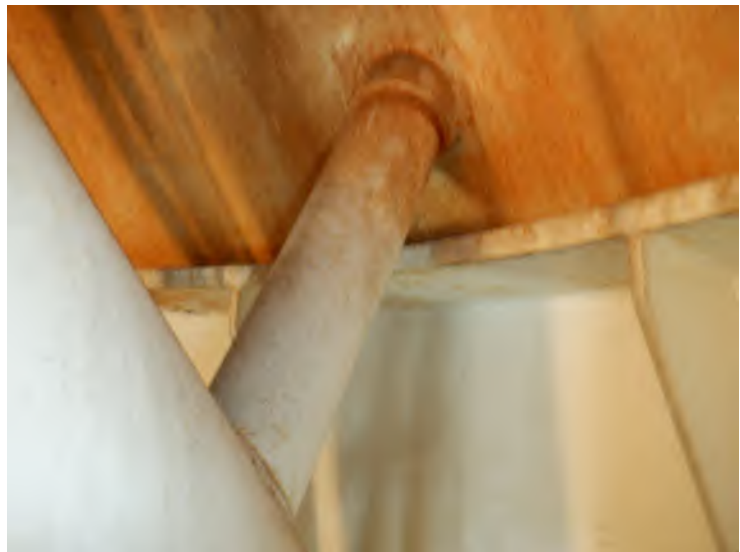
48) Rust bleedthrough in the access tube.

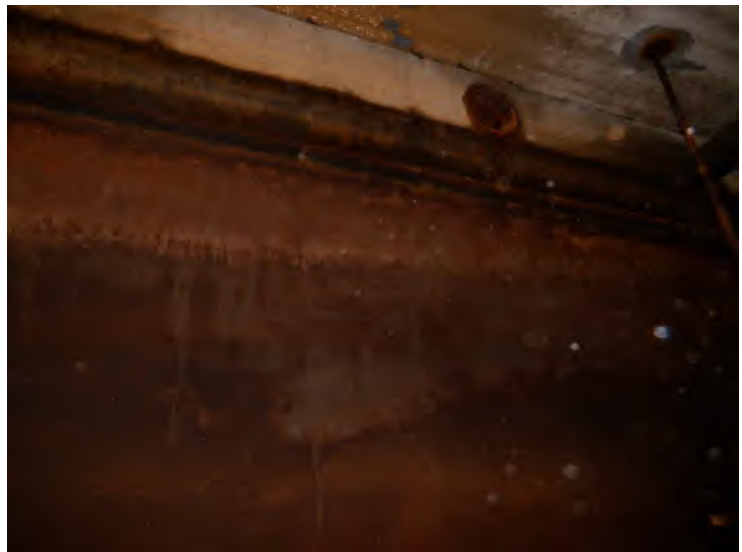
15) The metal wet interior appurtenances are not coated.

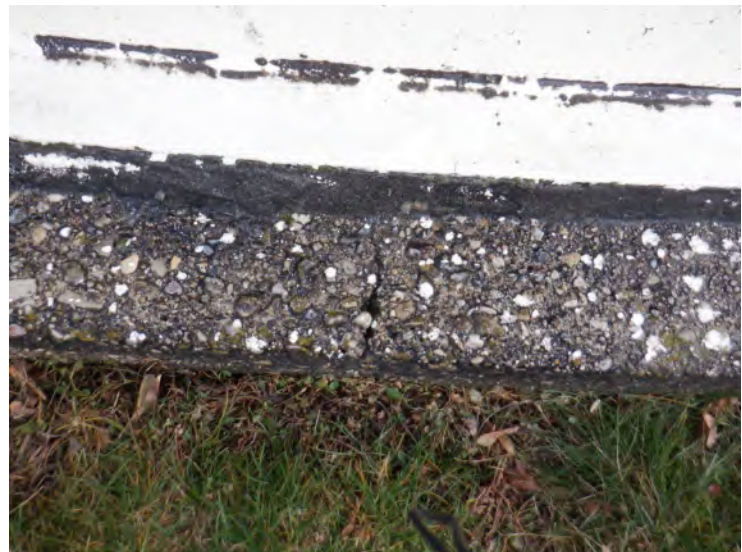
2) There are minor cracks and exposed aggregate on the foundation.

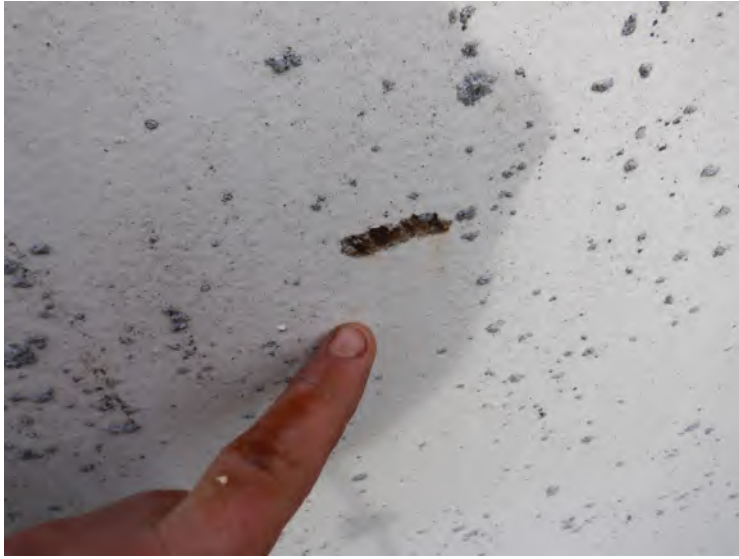
16) There are several small spot coating failures on the sidewall.

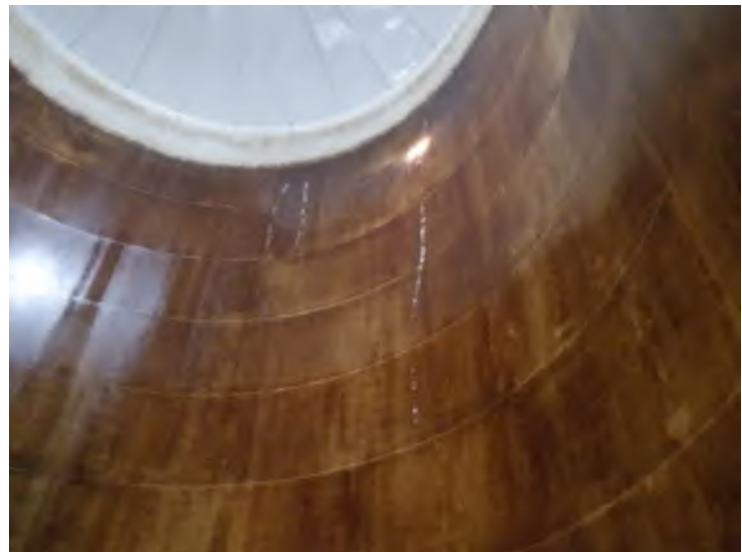
47) There is heavy mineral staining on the sidewall.

48) There are scratches in the mineral staining near the high-water level.
