# Water System Master Plan

*April 2022*

**PREPARED FOR:**  
**Village of Pewaukee**  
235 Hickory Street  
Pewaukee, WI 53072

**PREPARED BY:**  
**Ruekert & Mielke, Inc.**  
W233 N2080 Ridgeview Parkway  
Suite 300  
Waukesha, WI 53188

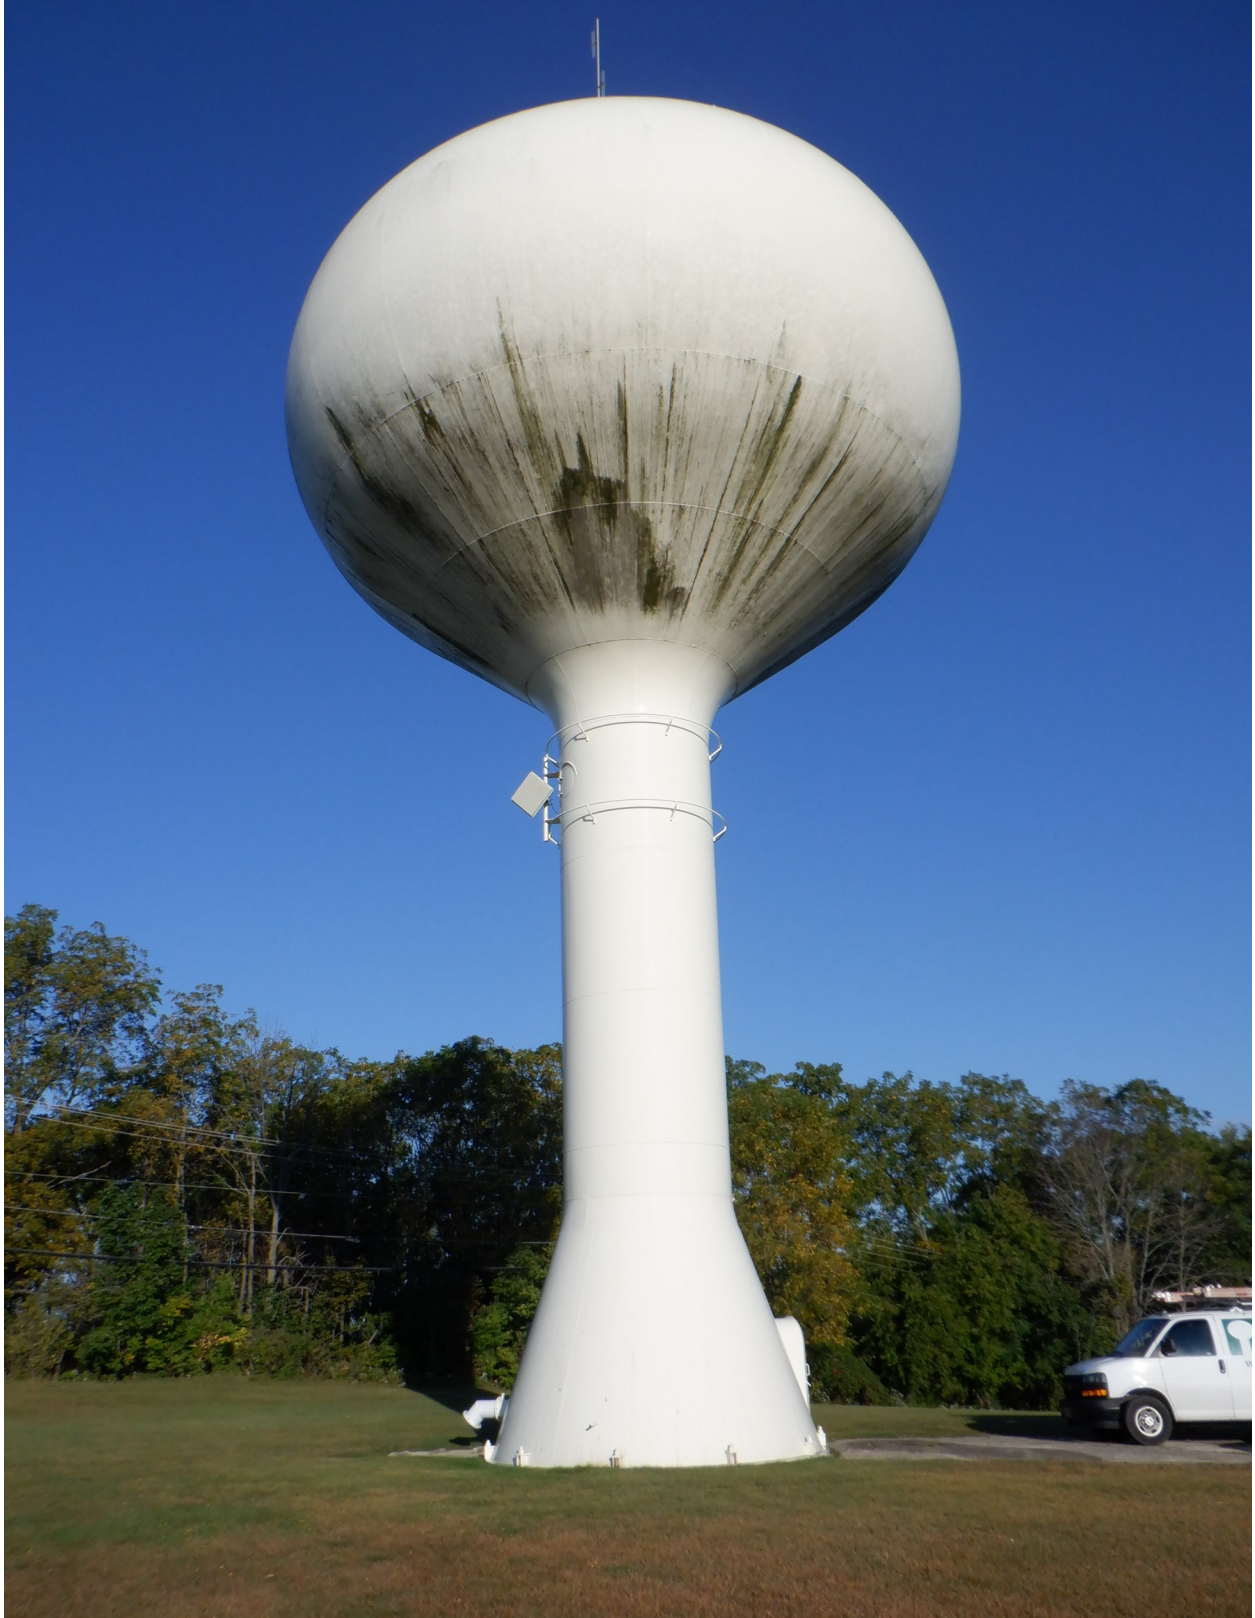
250,000 gallon spheroid (Lake Street) elevated water storage tank owned by the Village of Pewaukee, Wisconsin.

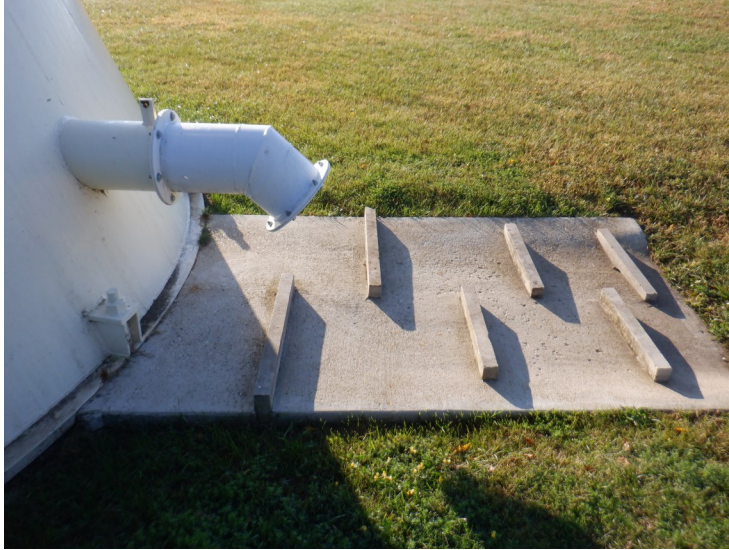
4) The overflow pipe discharges to a concrete splash pad.

5) The screen at the overflow discharge is intact but deformed and oversized.

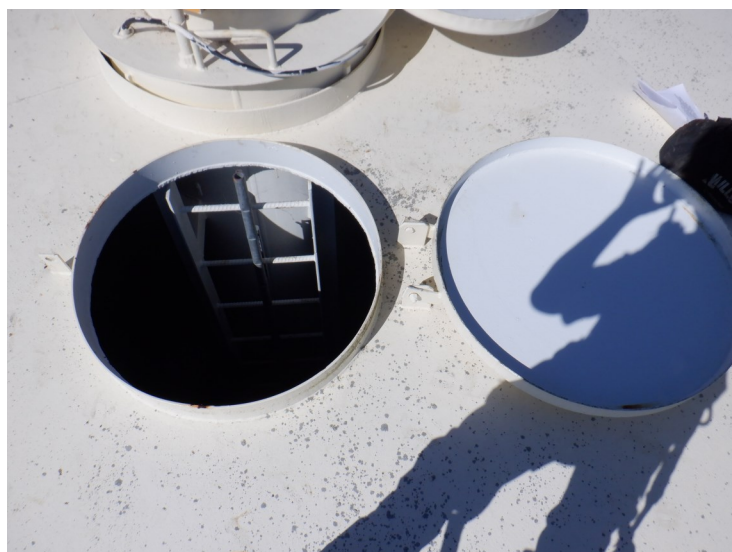
17) The roof handrail and painter's railing are in good condition.

18) The wet interior roof hatch is in good condition. A gasket was installed on the hatch during the inspection.

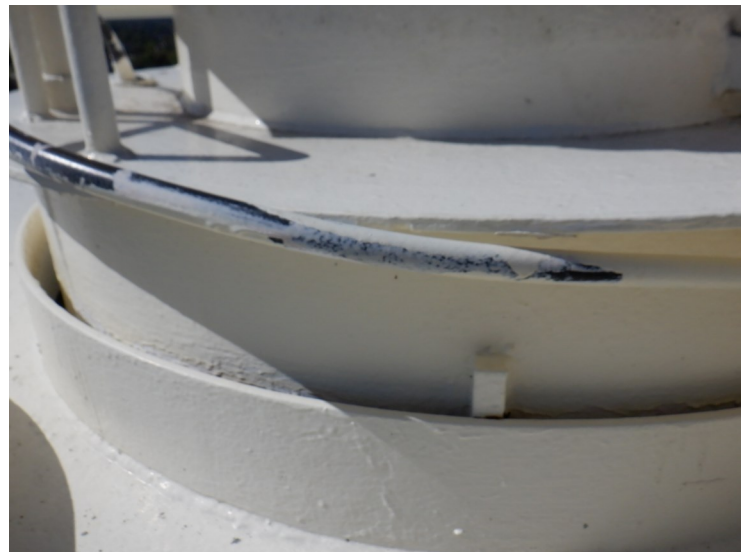
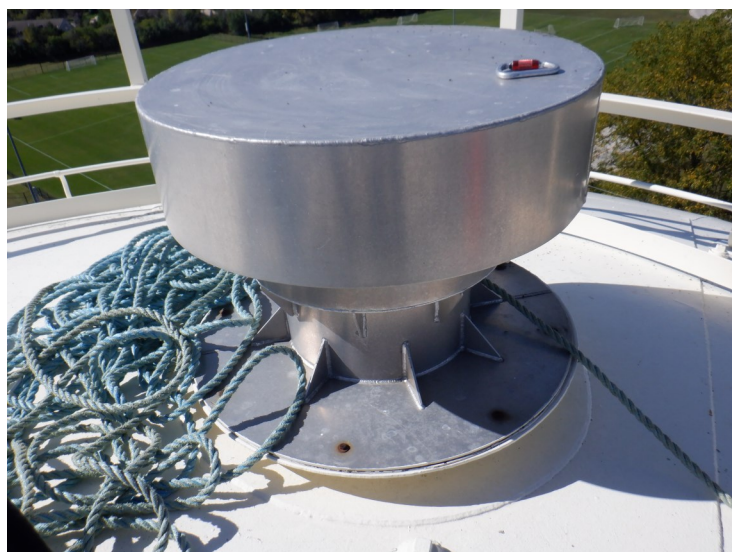
20) There is no cover over the access tube air gap.

21) The roof vent is in good condition.

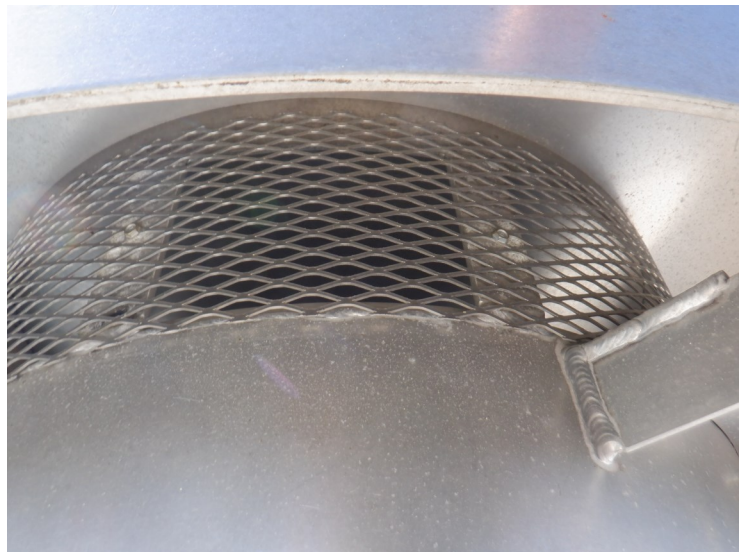
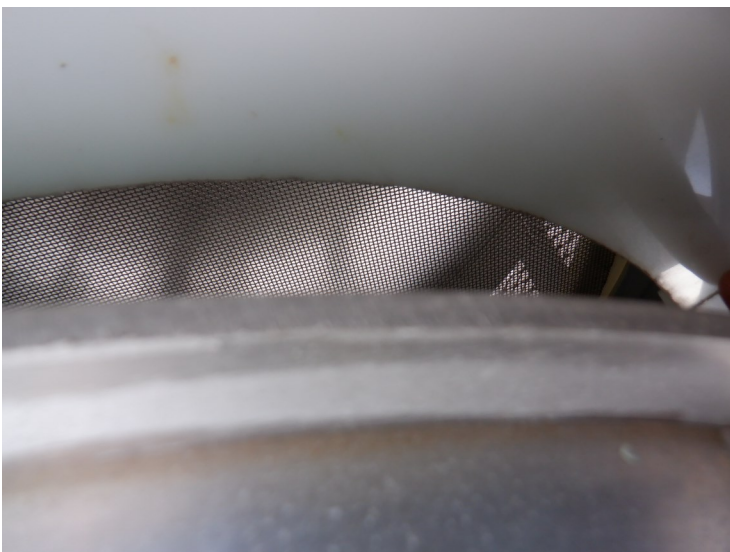
23) The vertical roof vent screen is in good condition.

24) The interior roof vent screen is intact with no gaps.

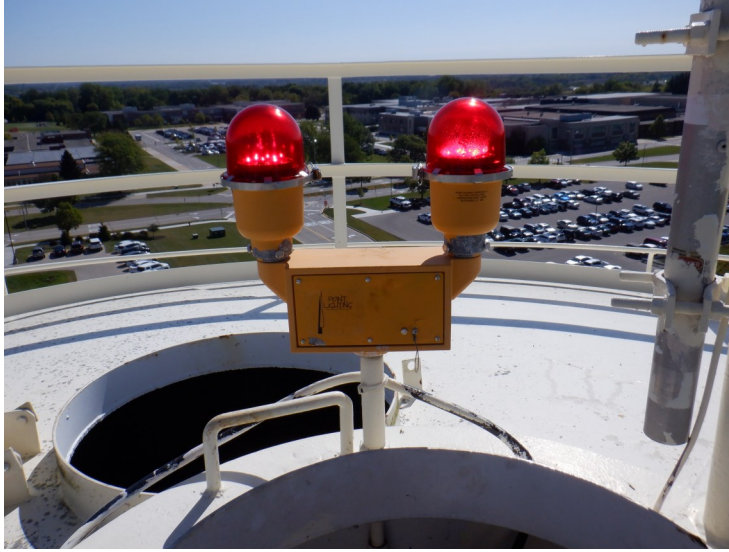
25) The double aviation light was operating properly during the inspection.

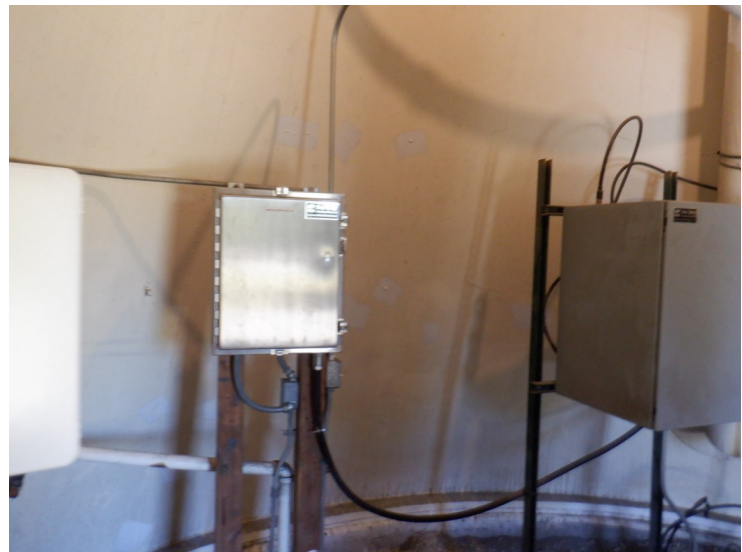
26) The dry interior basebell coating is in good condition overall with no significant deterioration.

27) Same.

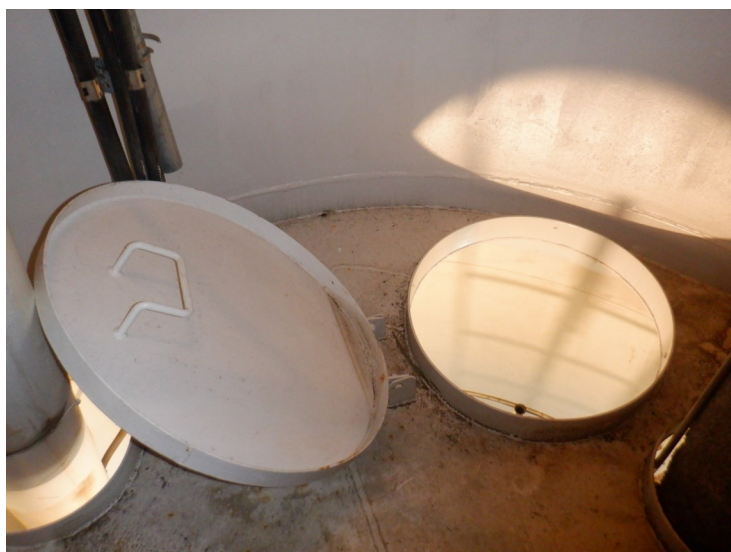
29) The baseball ladder is in good condition. The ladder is equipped with a fall prevention device.

30) The ladder opening at the condensate platform is equipped with a hinged cover.

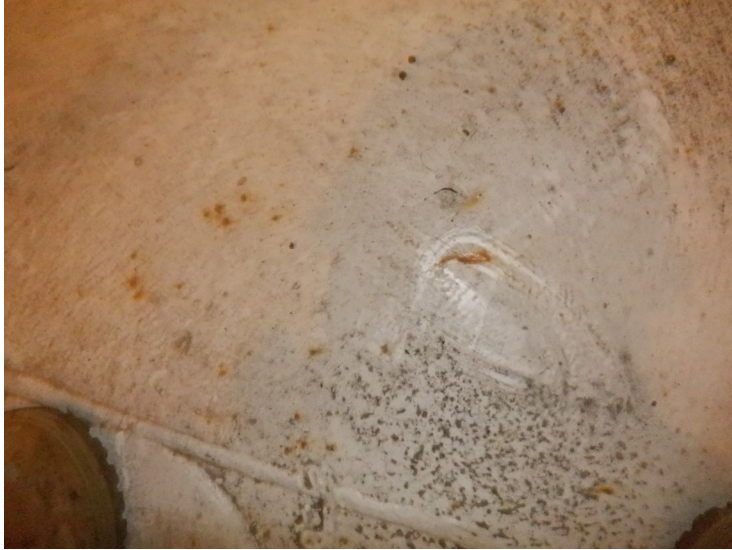
31) Minor coating failures on the condensate platform.

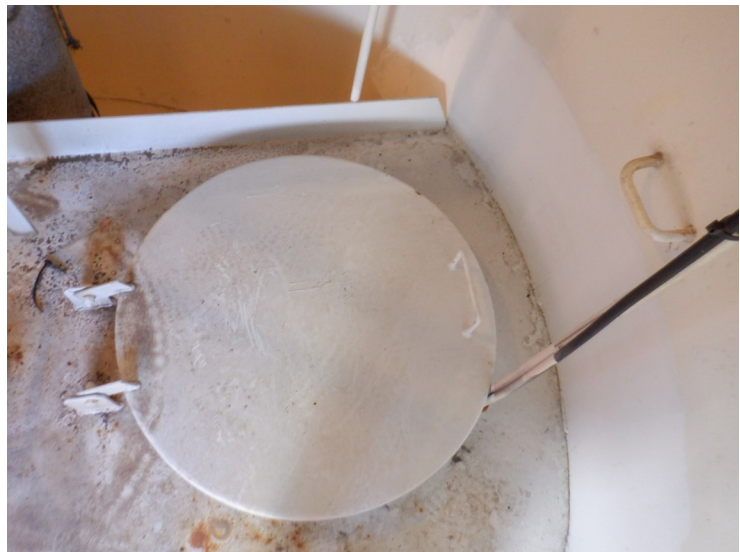
37) The riser ladder is in good condition. The ladder is equipped with a fall prevention device.

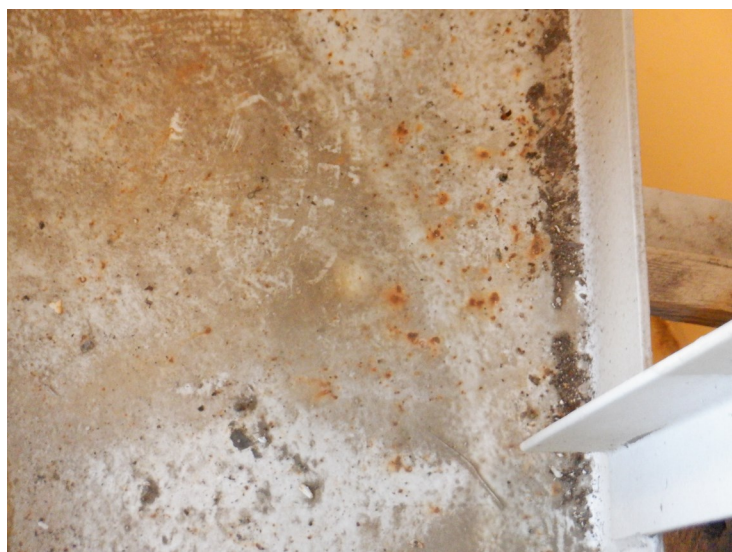
38) The ladder opening at the top platform is equipped with a hinged cover.

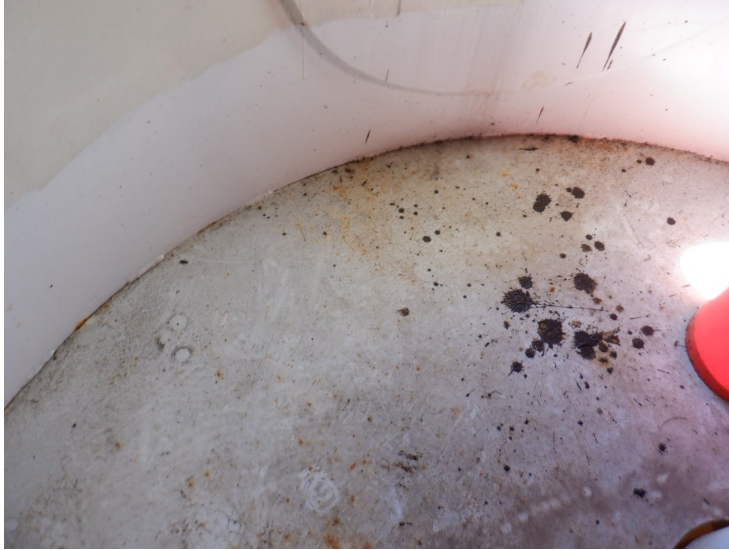
39) Minor coating failures on the top platform.

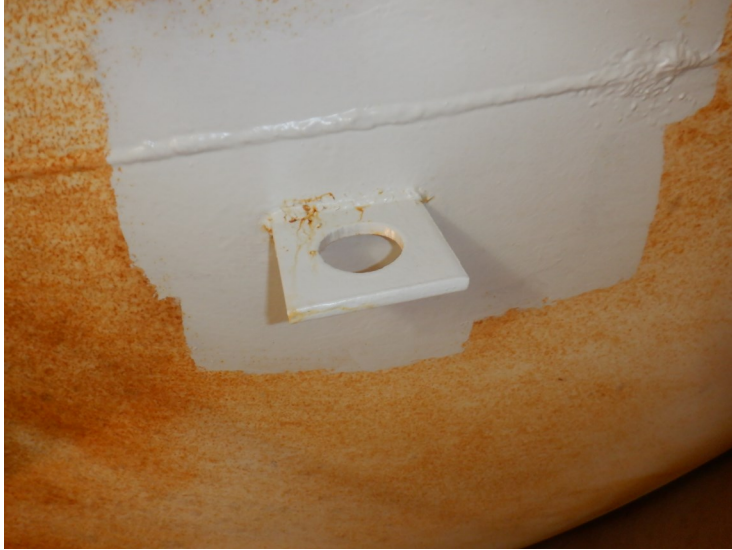
42) The mud valve operated properly during the inspection.

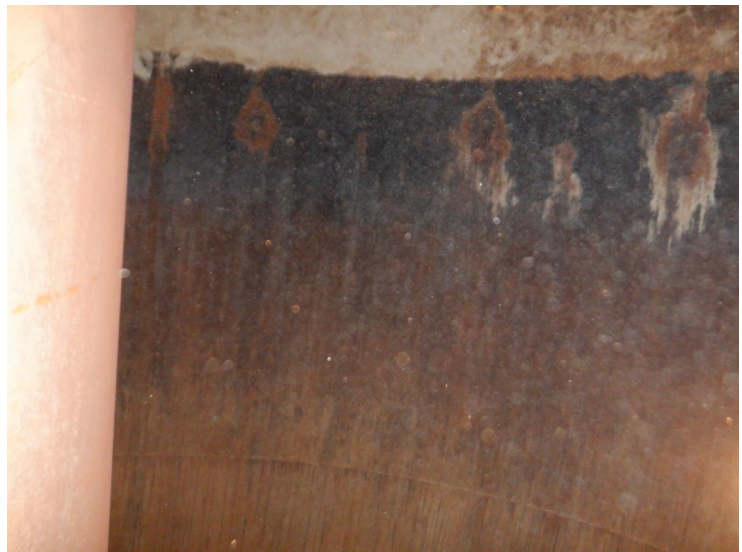
53) There is heavy mineral staining on the wet interior sidewall but no coating failures.

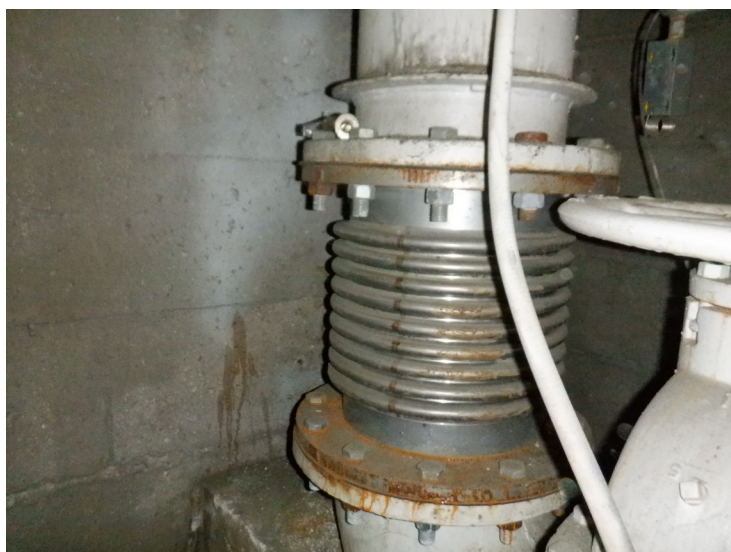
68) Same.

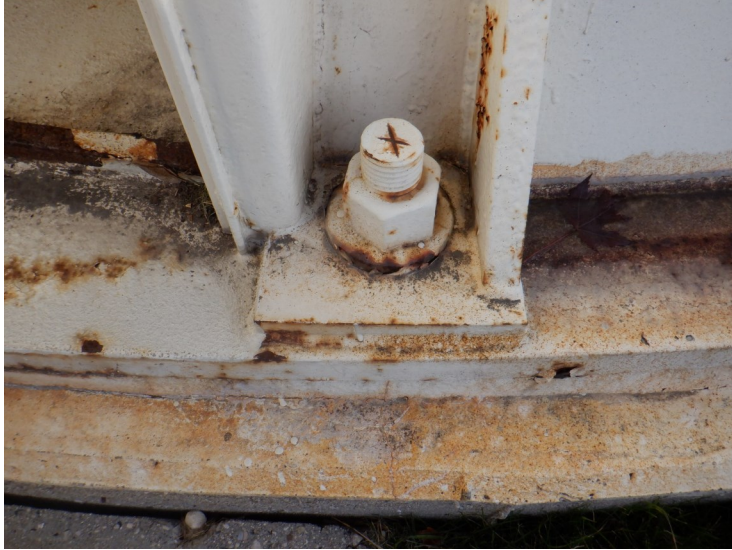
1) The foundation, grout, and anchor bolts are in good condition.

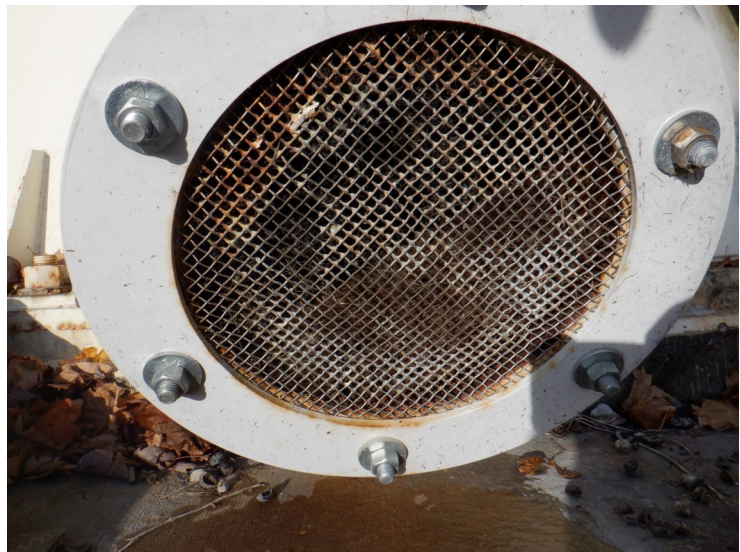
4) The overflow pipe discharges to a splash pad.

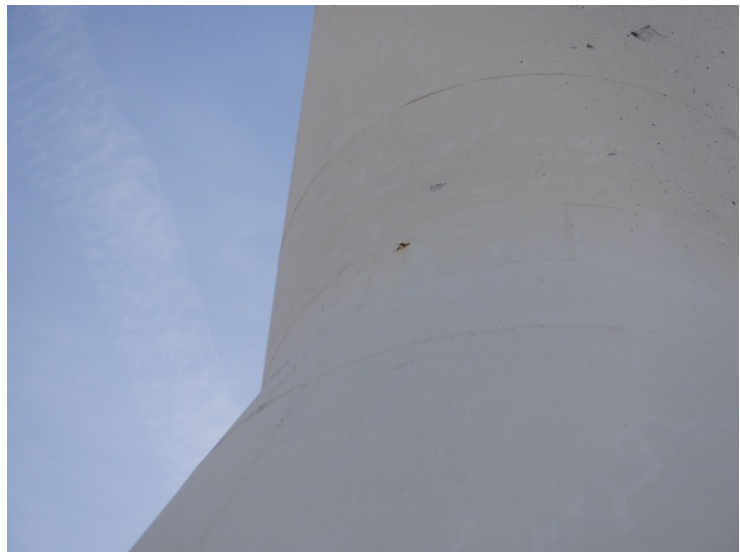
10) The basebell coating is in fair condition overall.

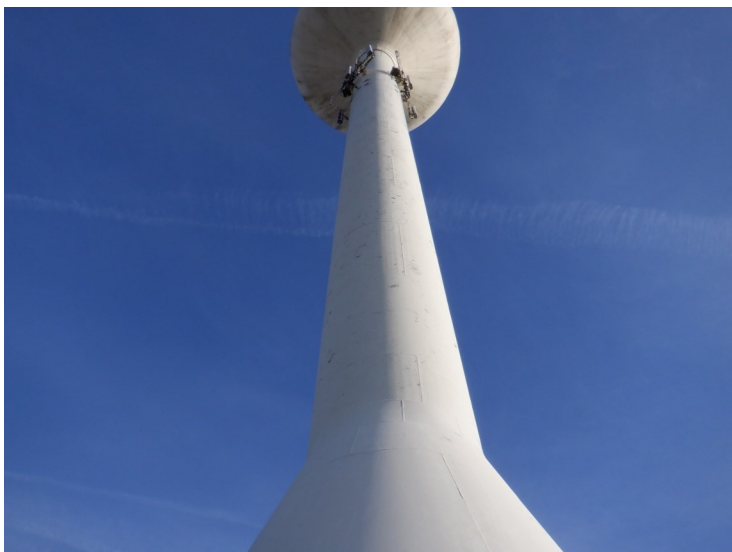
11) Coating failures on the riser.

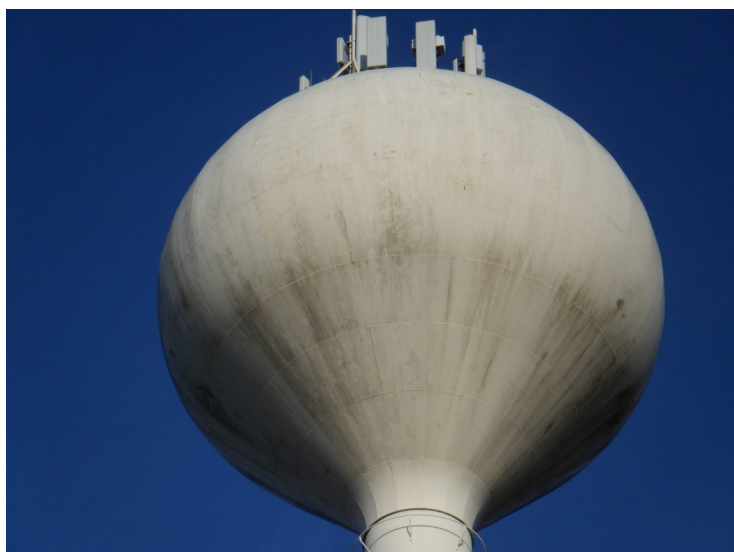
18) The sidewall coating is in good condition overall.

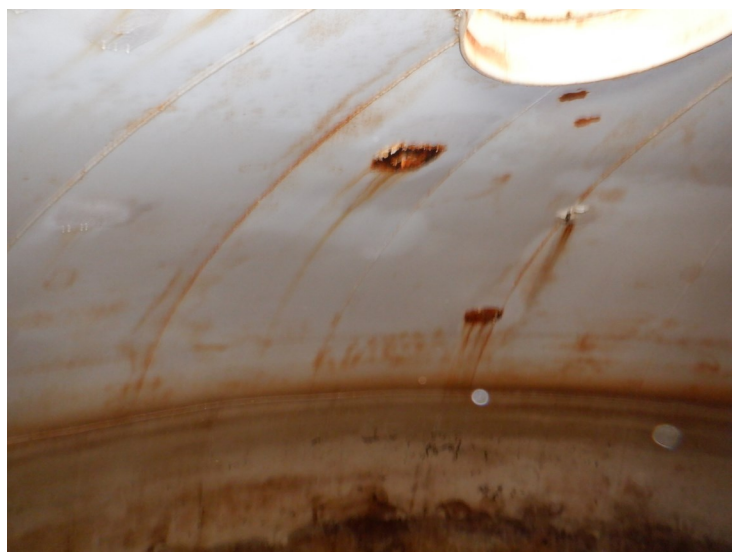
51) Coating failures on the wet interior roof.

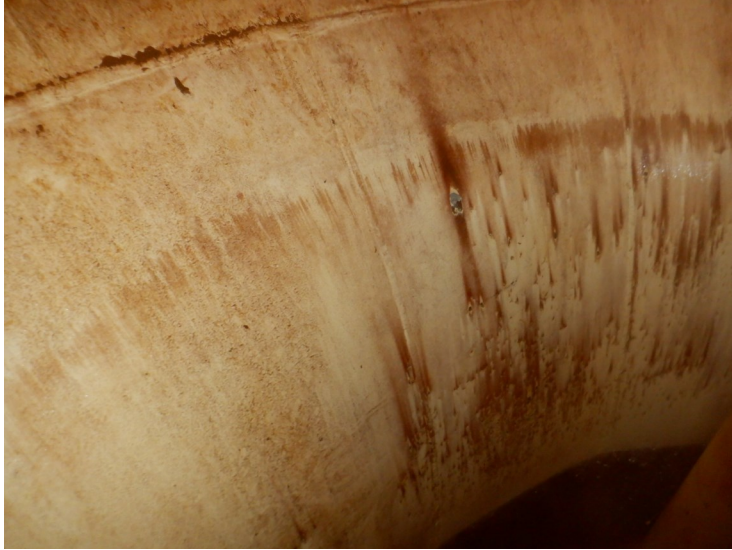
61) Coating failures in the transition cone.

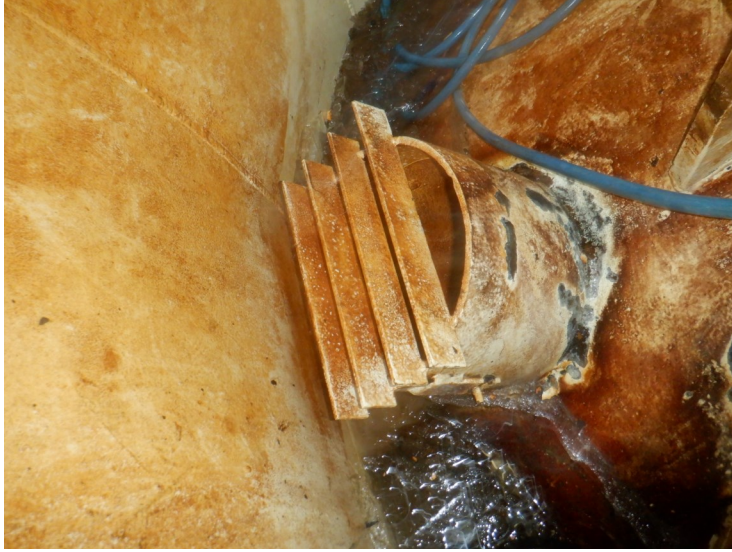
64) There are deflector bars over the fill/draw pipe in the wet interior.

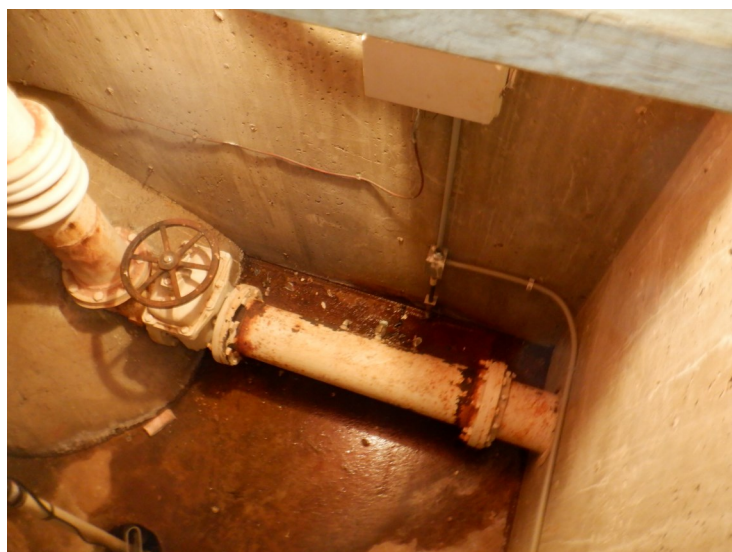
66) Coating failures on the pit piping.

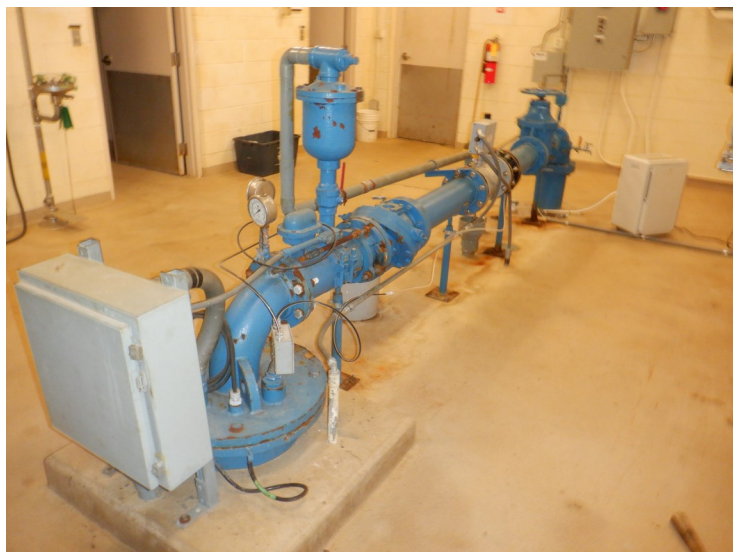
69) Coating on the piping in the building is in fair condition.

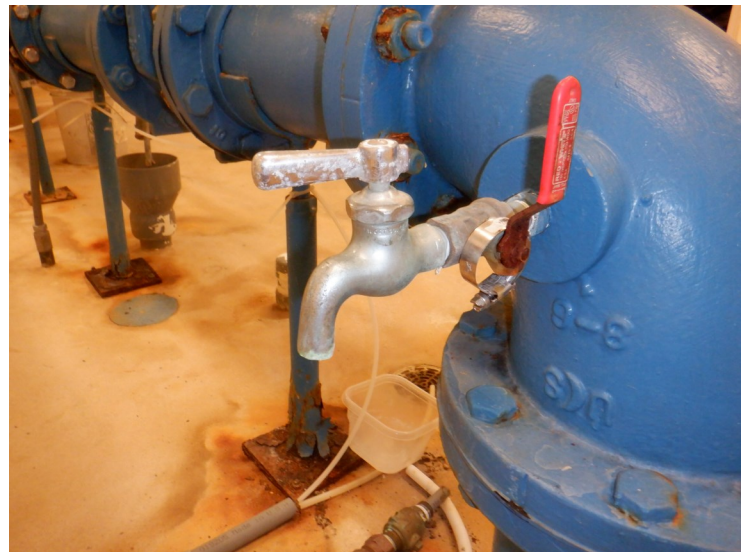
71) The sample tap in the building is in good condition.

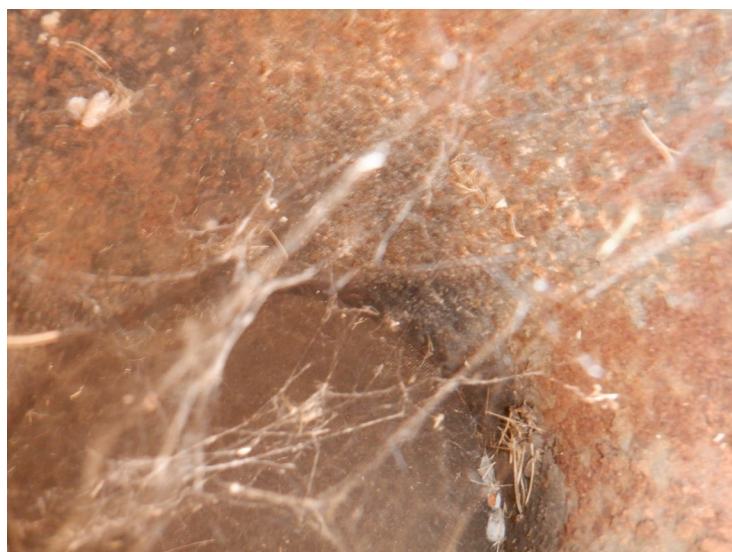
3) The screen at the overflow discharge is intact with no gaps or holes.

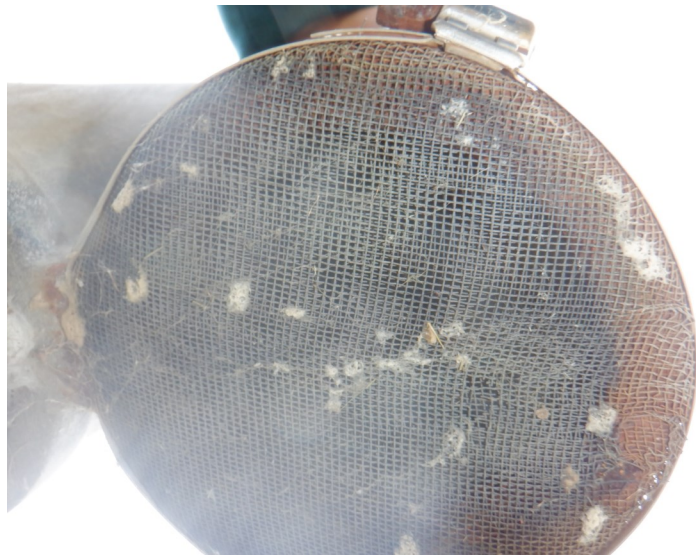
5) The roof vent screen is intact.

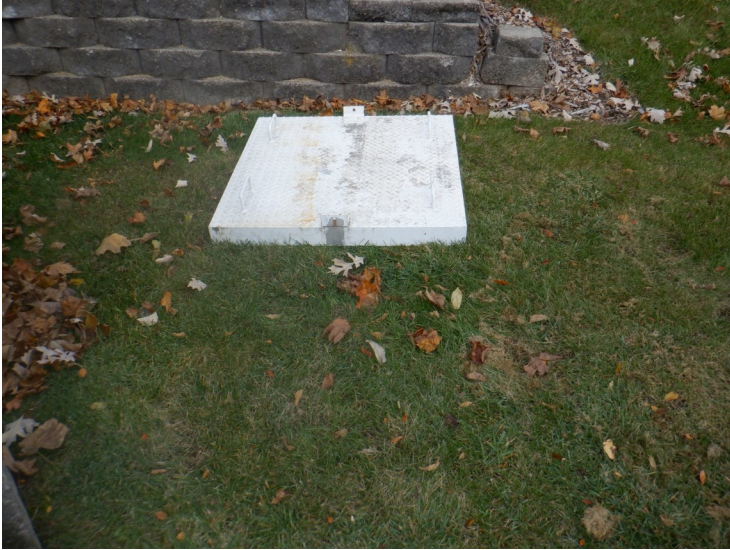
7) The roof hatch covers are in good condition with some coating erosion.

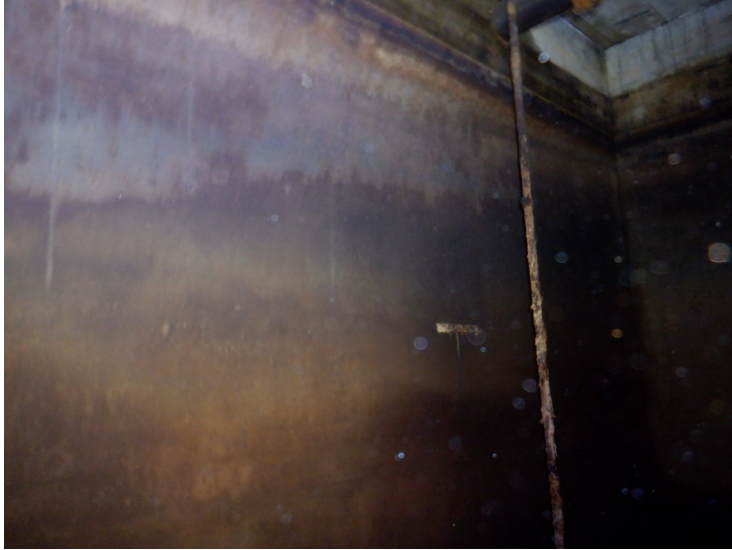
It is not known when the wet interior was last coated. The coating is likely an elastomeric system. The coating is located on the floor and sidewalls and is in fair condition. There are areas of delamination, spot failures, and erosion.

13) Elastomeric coating failures on the wet interior sidewall.

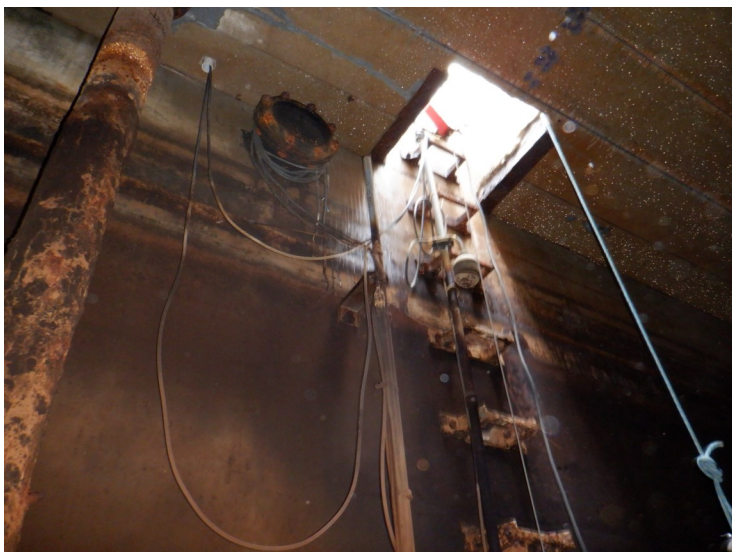
15) The metal wet interior appurtenances are not coated.

Abrasive blast clean the wet interior piping and repaint with an epoxy system. The piping could be allowed to deteriorate and then be replaced once it no longer operates properly, replacement could be performed by in-house personnel. The estimated to repaint the piping is \$10,000.

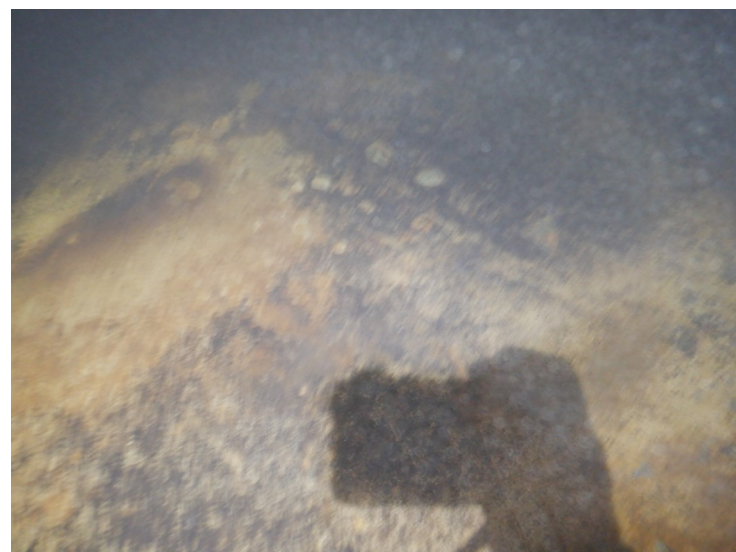
18) There is some erosion of the elastomeric coating on the floor.

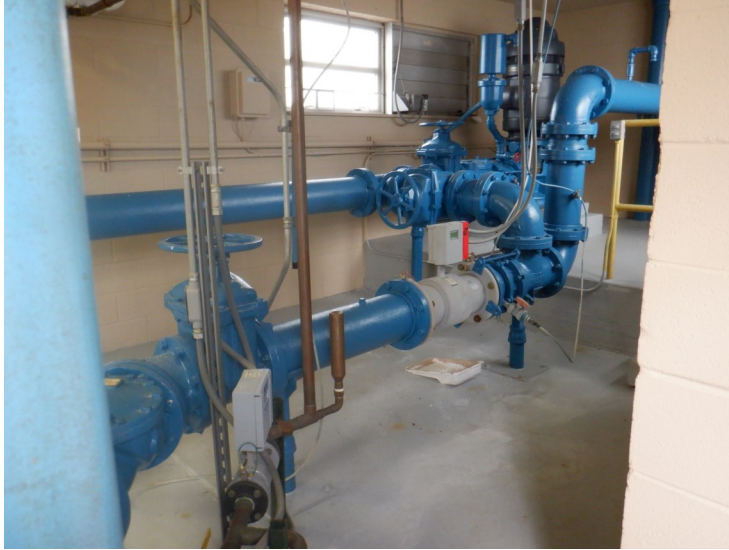
19) Coating on the piping in the pumphouse is in good condition overall.

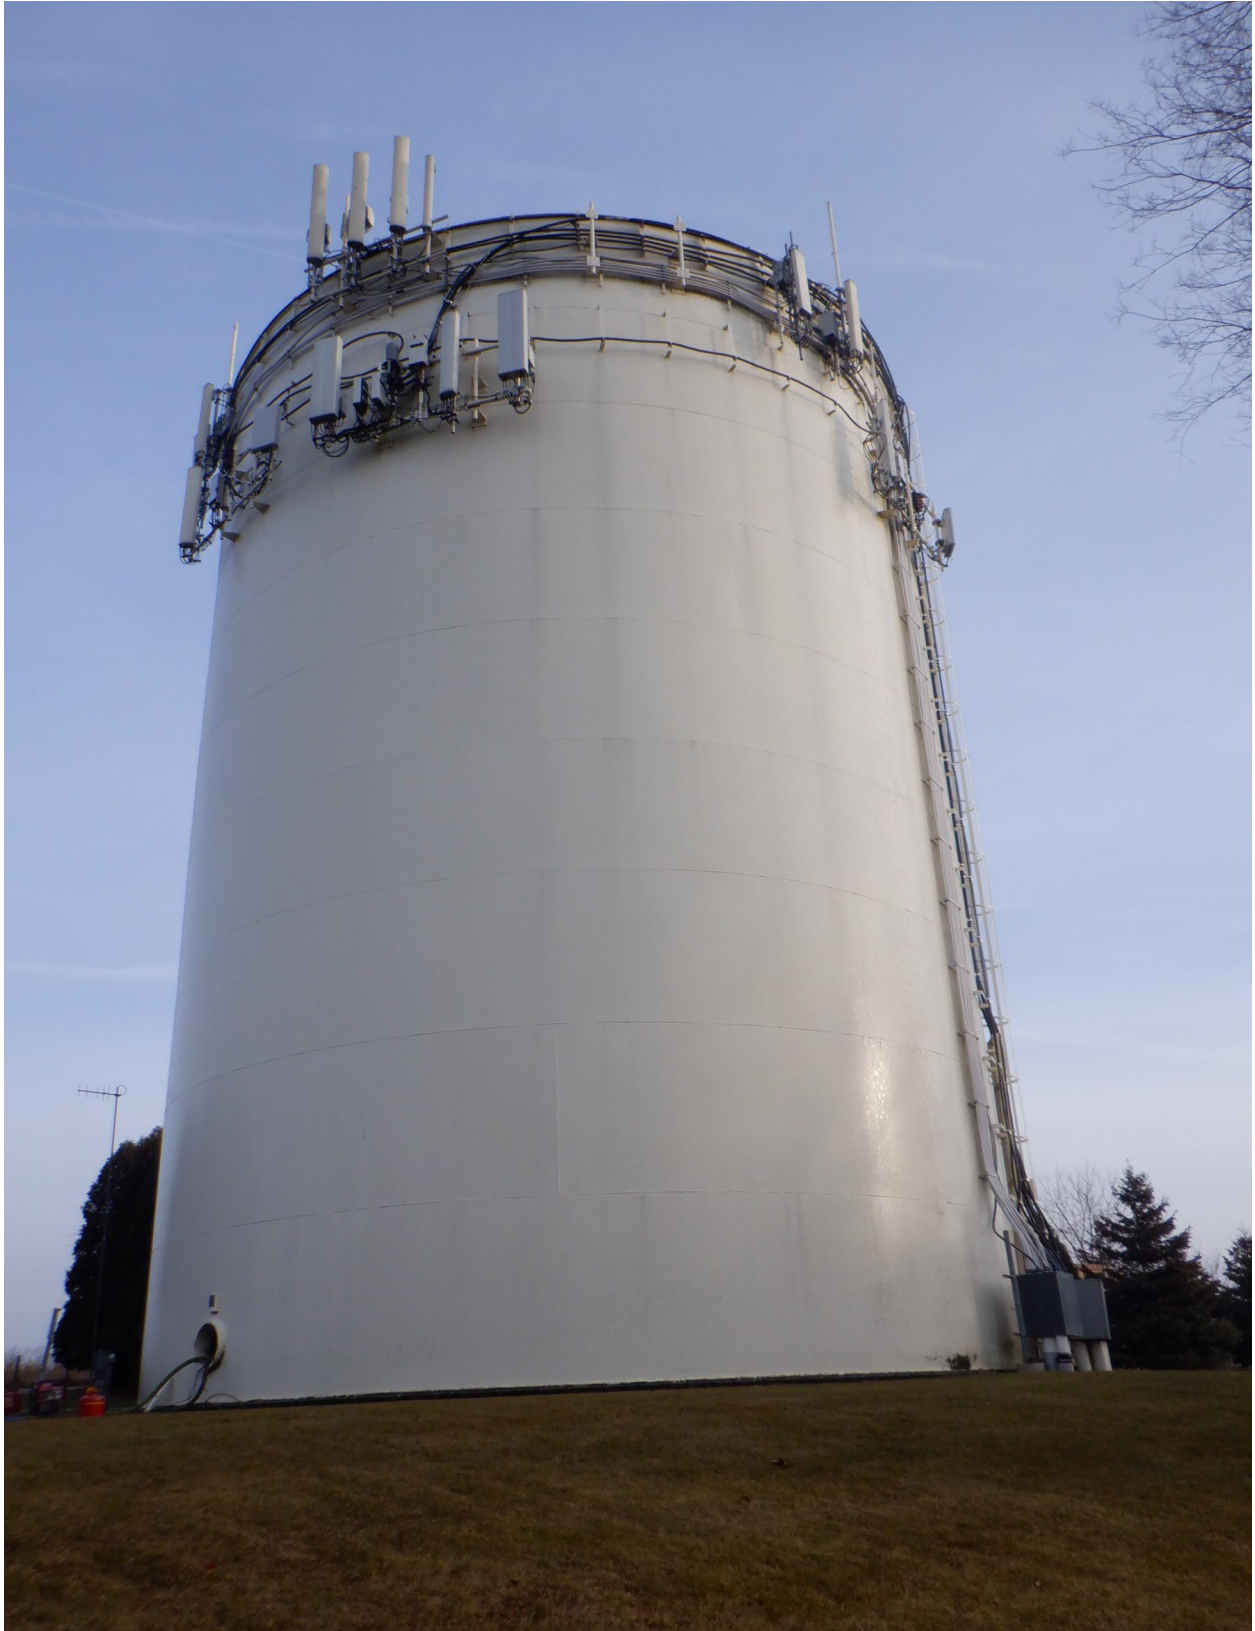
1,000,000 gallon standpipe (Sunnyridge) located in the Village of Pewaukee, Wisconsin.

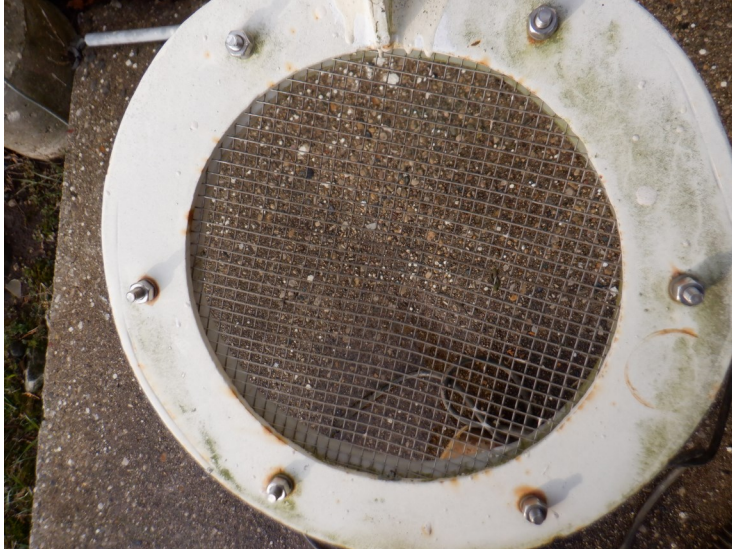
7) The screen is in good condition.

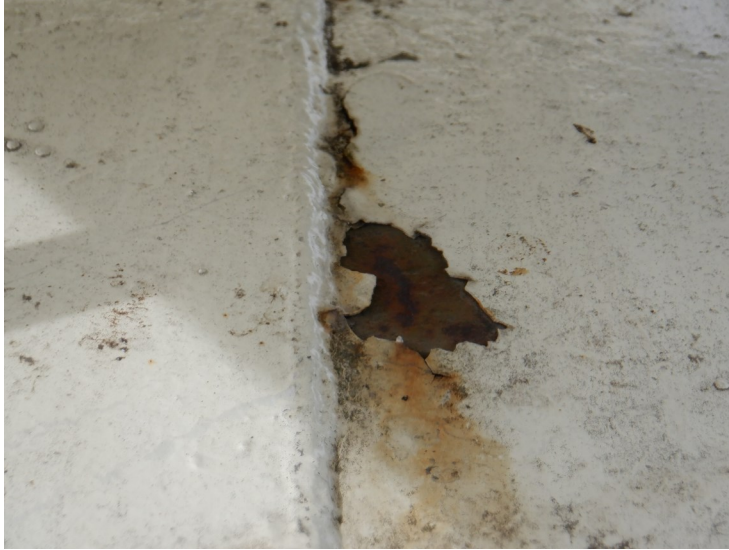
20) The coating on the roof is in good condition overall.

21) Same.

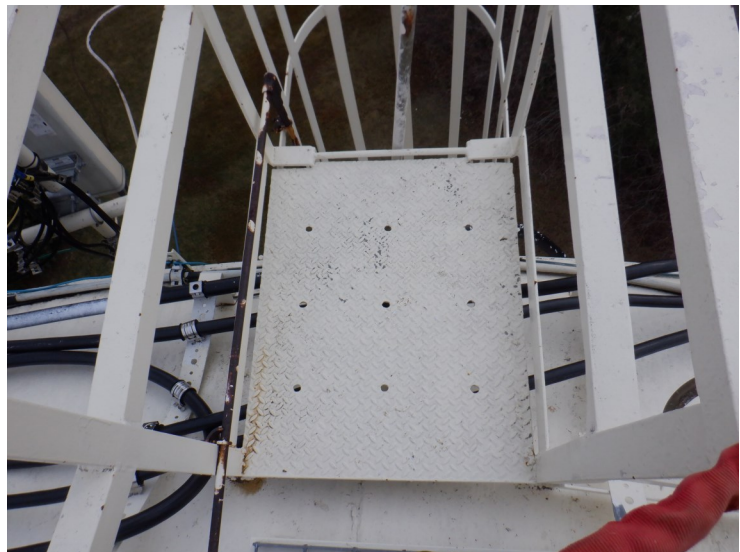
Roof comments: **There is delamination on the center handrail, several scratches in the topcoat at roof edge, antenna spot coating failures that are 1-2 inch diameter under the step off platform**

22) Spot coating failures on the roof.

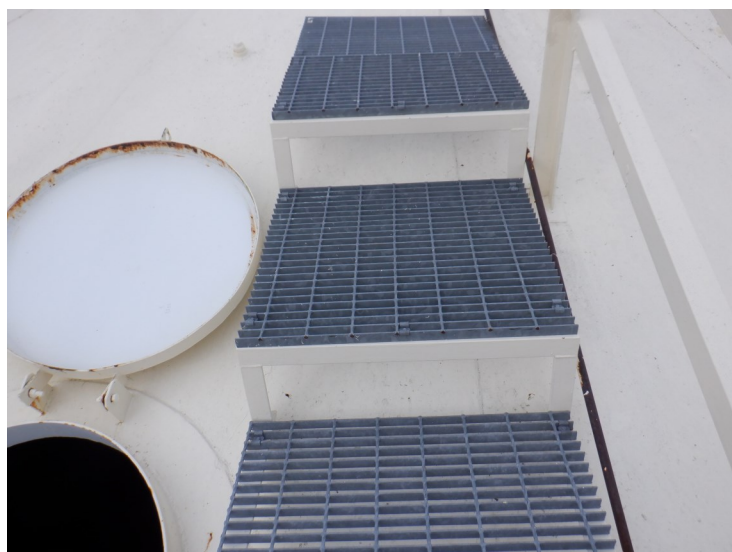
23) The step-off platform is in good condition.

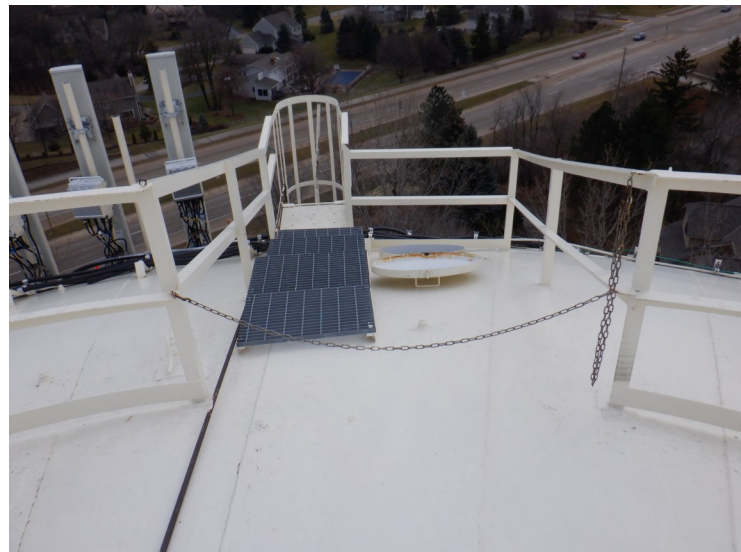
25) There are safety chains at the opening to the center handrail.

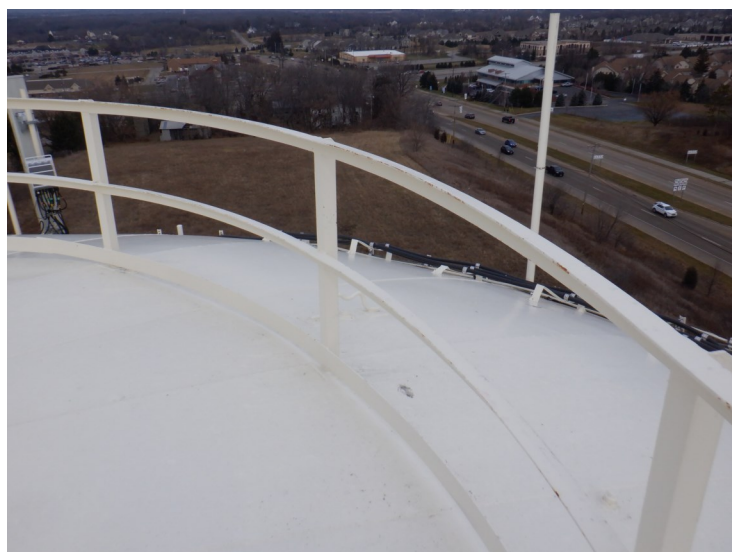
26) The step-off platform and roof hatch are surrounded by a handrail that is in good condition.

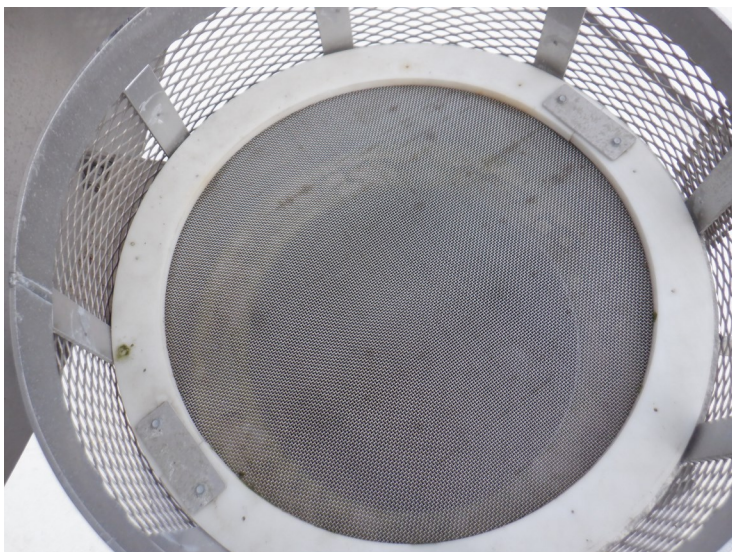
35) The pressure plate is in good condition.

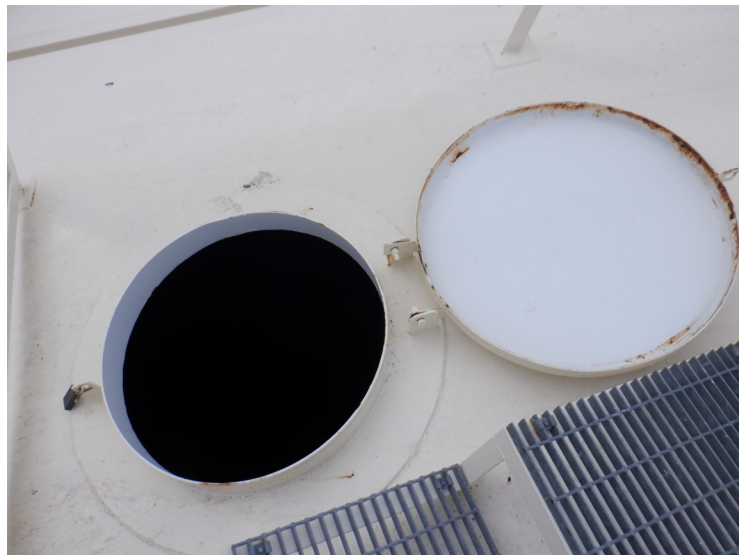
37) The roof hatch is secured with a padlock.

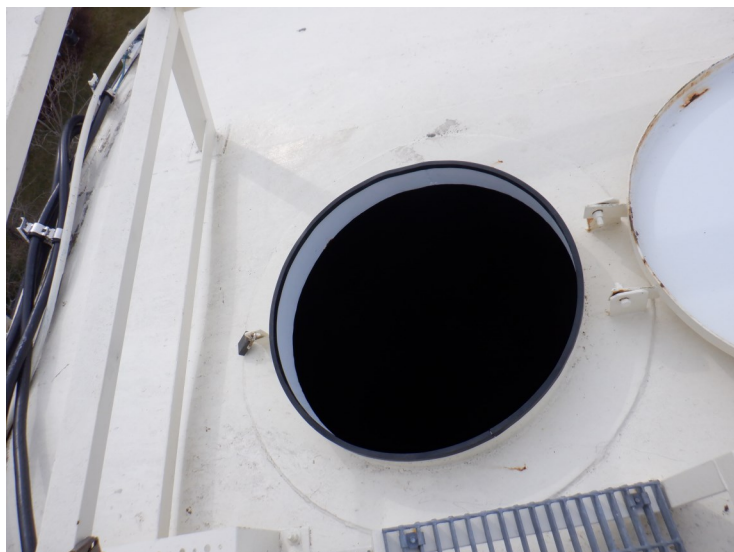
38) The roof hatch is in good condition.

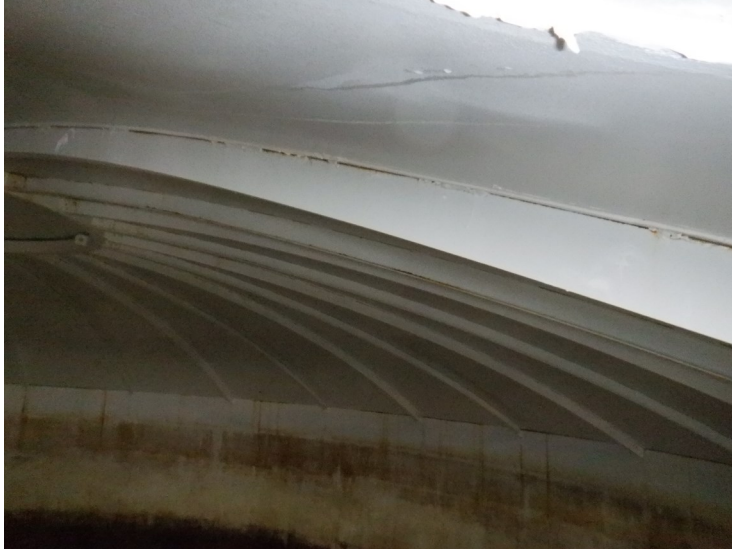
Topcoat condition: **Good**  
Primer coating condition: **Good**  
Describe coating: **Spot coating failures to substrate**  
Metal condition: **Good**  
Lap seams: **Caulked**  
Condition of lap seams: **Good**  
Roof comments: **There are only a few small spot coating failures mainly at the couplings**

40) The coating on the roof is in good condition overall.

41) Same.

42) Same.
