# Water System Master Plan

*April 2022*

**PREPARED FOR:**  
**Village of Pewaukee**  
235 Hickory Street  
Pewaukee, WI 53072

**PREPARED BY:**  
**Ruekert & Mielke, Inc.**  
W233 N2080 Ridgeview Parkway  
Suite 300  
Waukesha, WI 53188

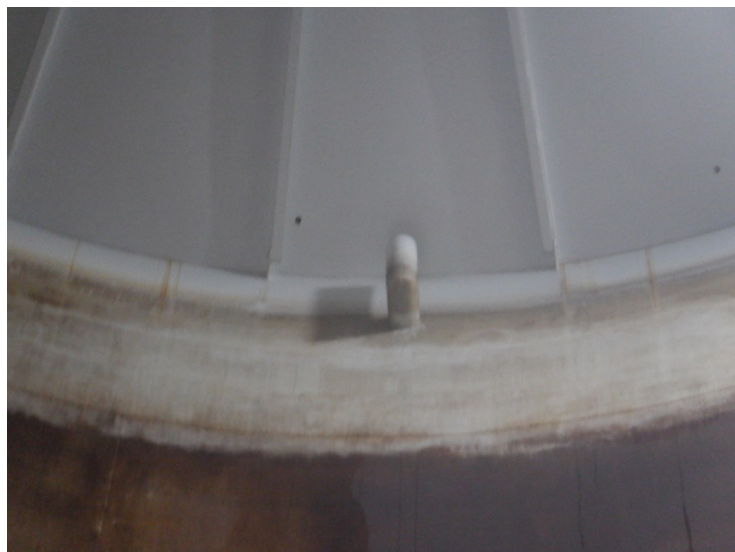
43) The roof stiffeners are in good condition.

44) Same.

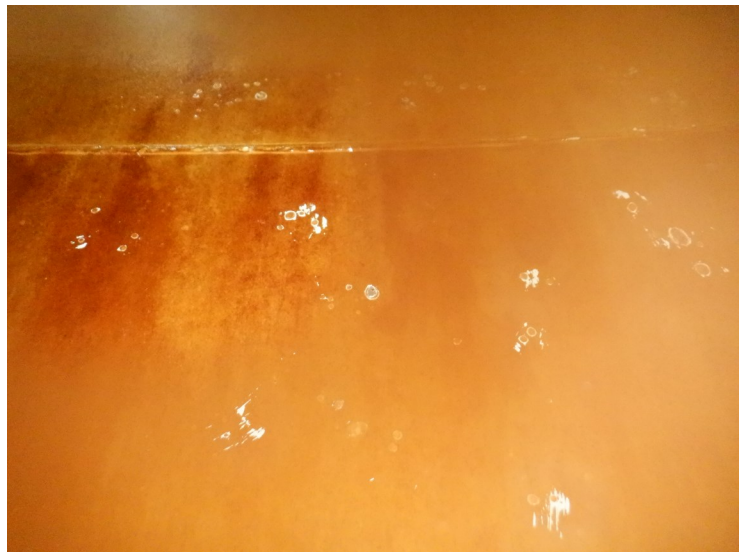
49) The scratches could be a sign of ice movement.

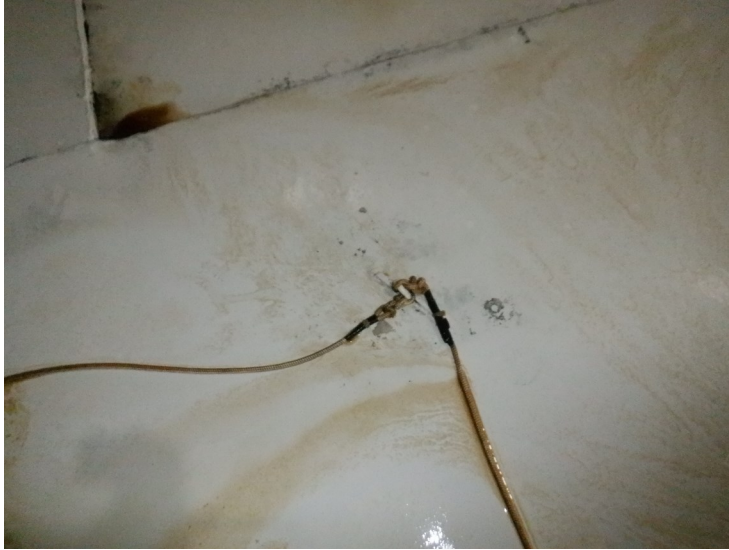
58) There are cathodic clips on the floor.

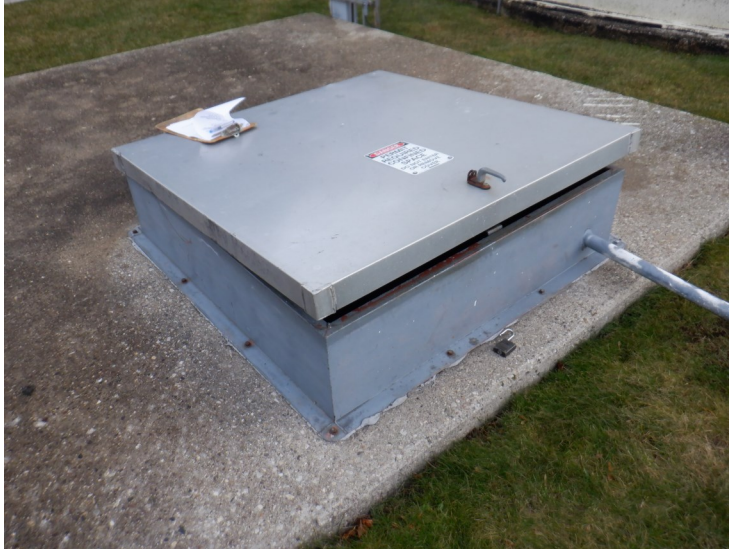
61) There is a pit adjacent to the tank. The pit has a metal hatch that is in good condition.

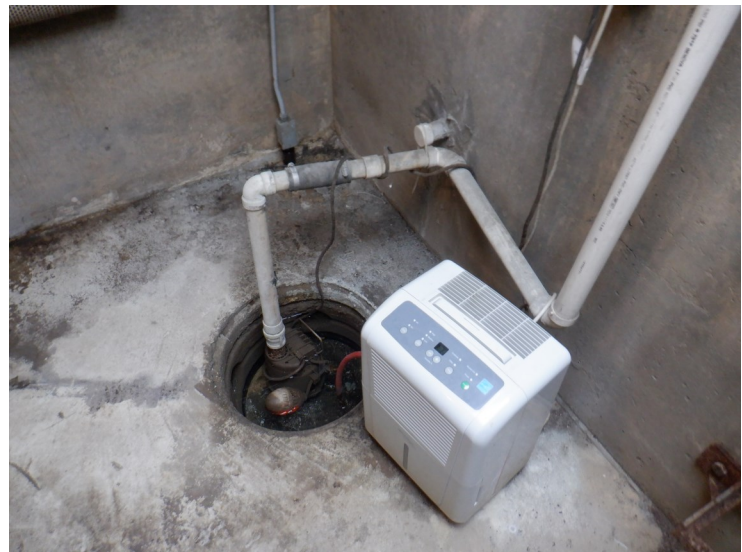
62) There is a sump pump in the pit.

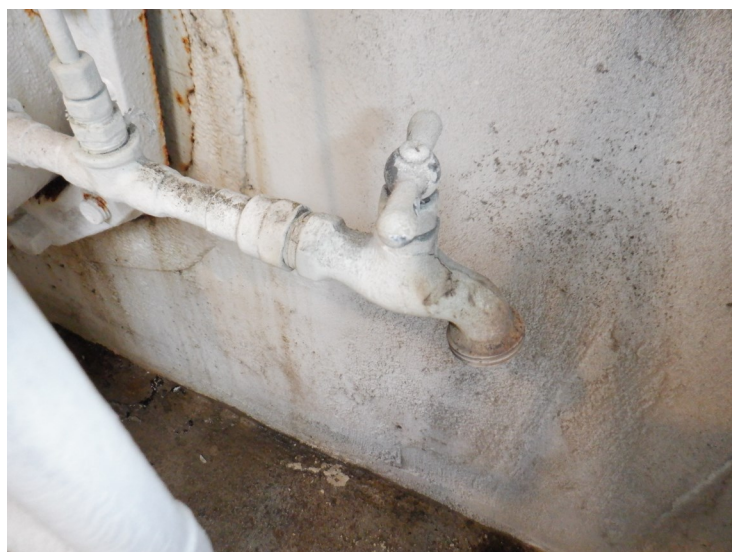
63) The sample tap is in good condition but has a threaded end.
