Water System Master Plan

April 2022

PREPARED FOR:
Village of Pewaukee
235 Hickory Street
Pewaukee, WI 53072

PREPARED BY:
Ruekert & Mielke, Inc.
W233 N2080 Ridgeview Parkway
Suite 300
Waukesha, WI 53188

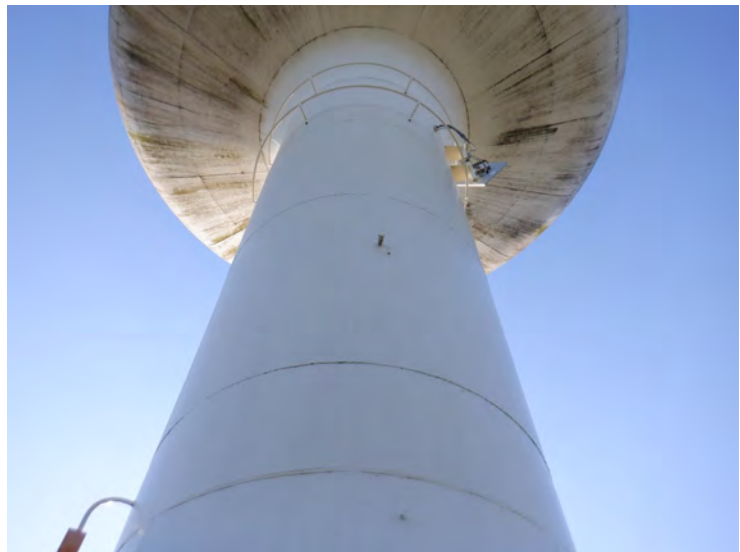
9) Same.

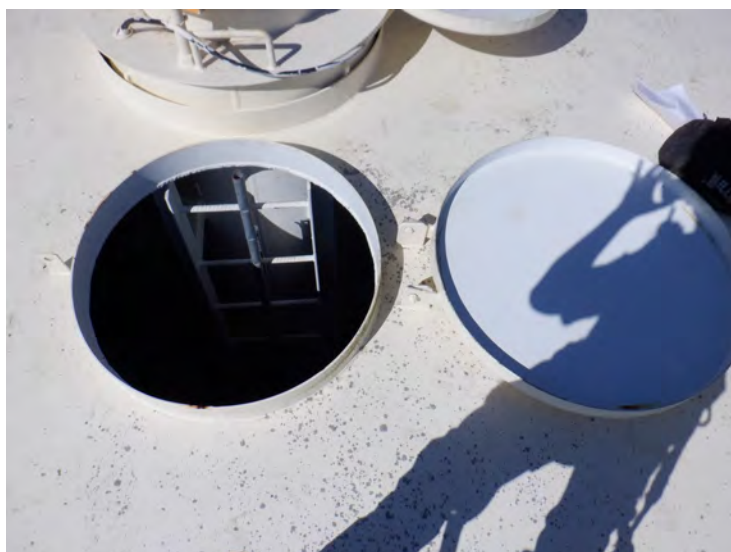
18) The wet interior roof hatch is in good condition. A gasket was installed on the hatch during the inspection.

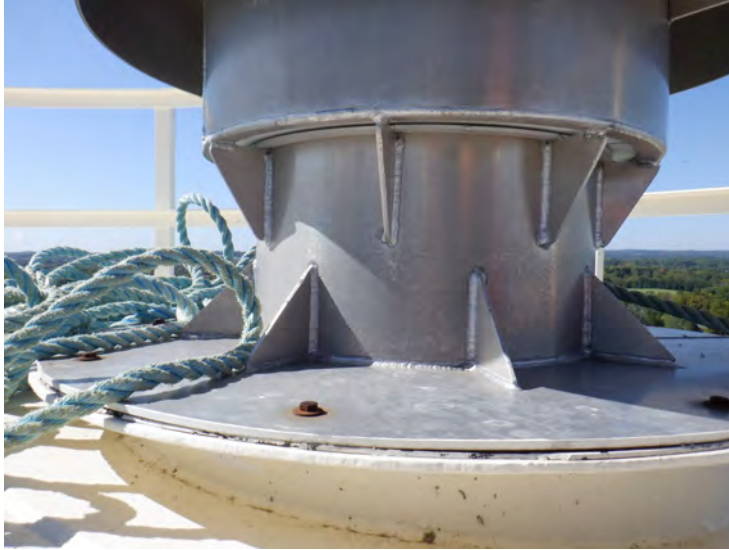
22) The roof vent pressure plate was properly aligned and free to move.

23) The vertical roof vent screen is in good condition.

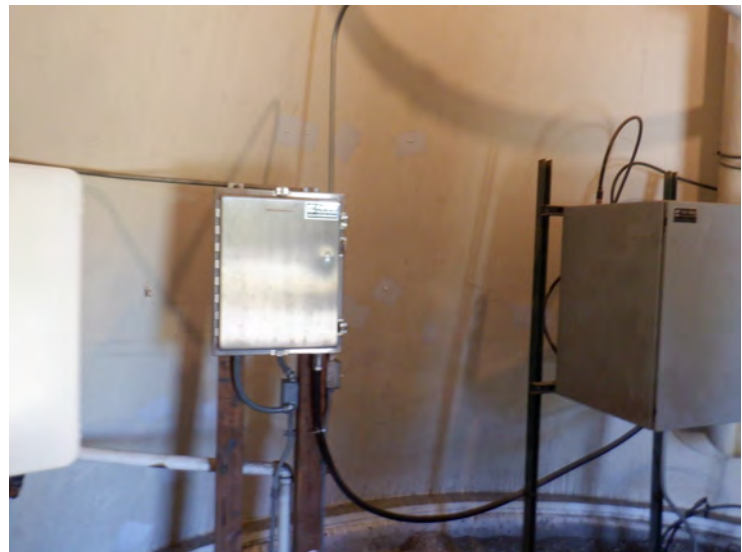
27) Same.

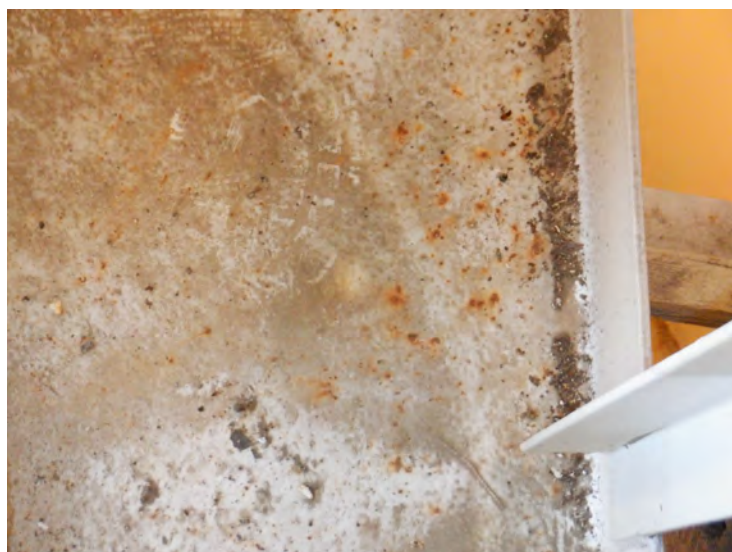
39) Minor coating failures on the top platform.

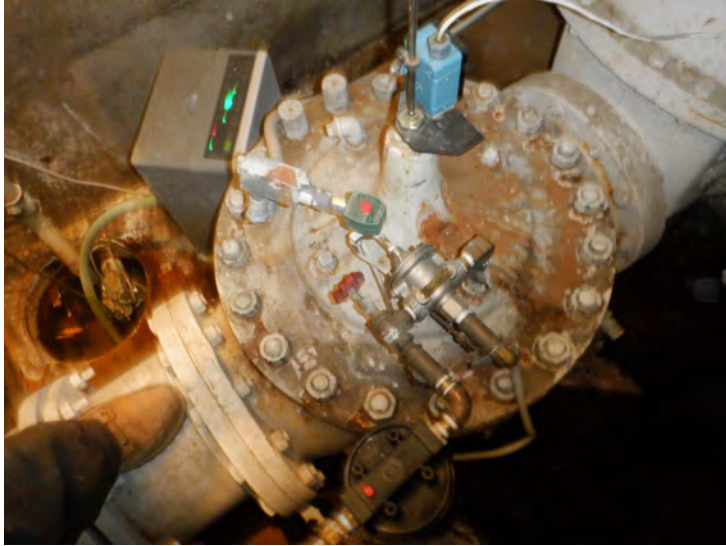
67) Minor coating failures on the pit piping.

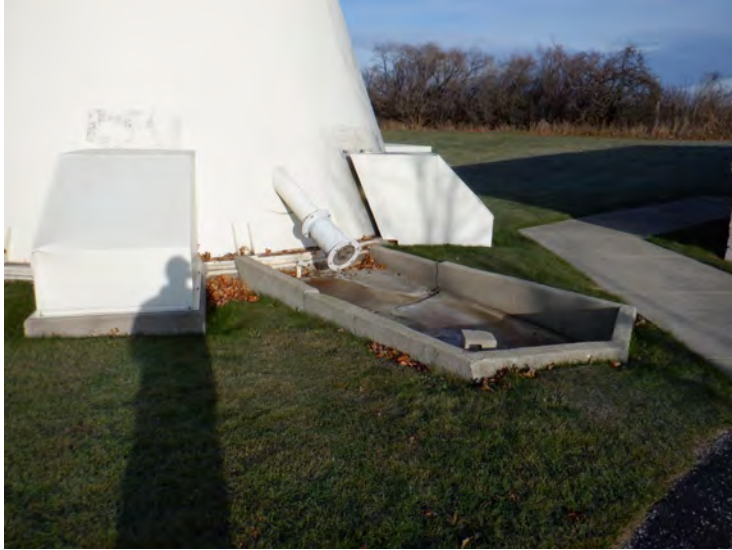
4) The overflow pipe discharges to a splash pad.

1. Modify the overflow pipe discharge so it points downward and so the air gap is 12 to 24 inches to bring it into compliance with current Wisconsin DNR requirements. The estimated cost is \$2,000.
2. Install a gasket on the wet interior roof hatch to meet current Wisconsin DNR requirements. The cost would be incidental to the next painting project or could be performed by in-house personnel.
3. Replace the roof vent with a pressure vacuum vent to meet current Wisconsin DNR requirements. The estimated cost is \$6,000.

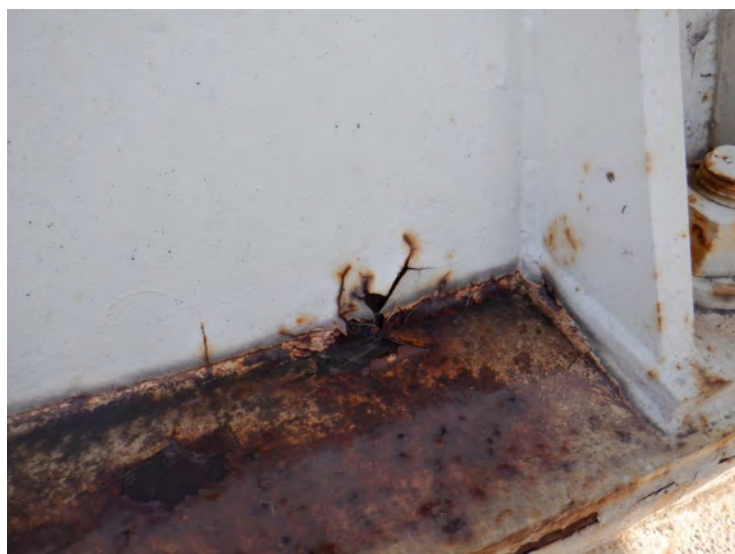
The basebell coating is in good condition with a few failures. Primary method of deterioration is spot failures to the substrate with rust undercutting. Most of the failures are on the baseplate.

6) Coating failures on the baseplate.

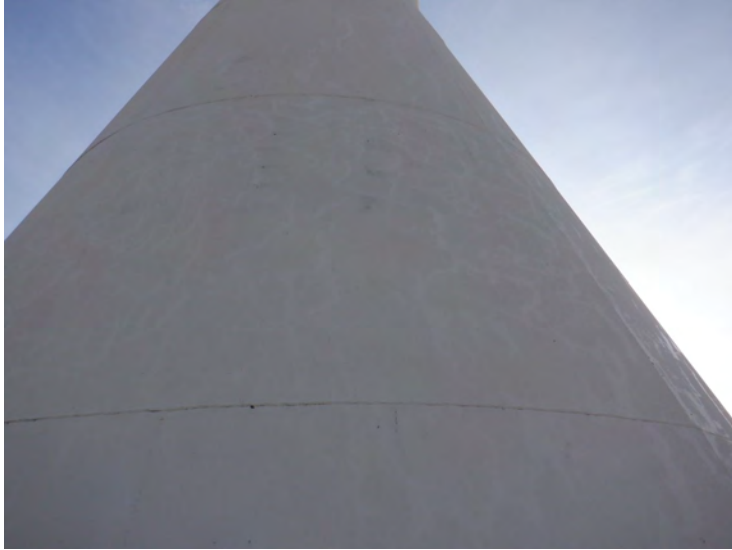
10) The basebell coating is in fair condition overall.

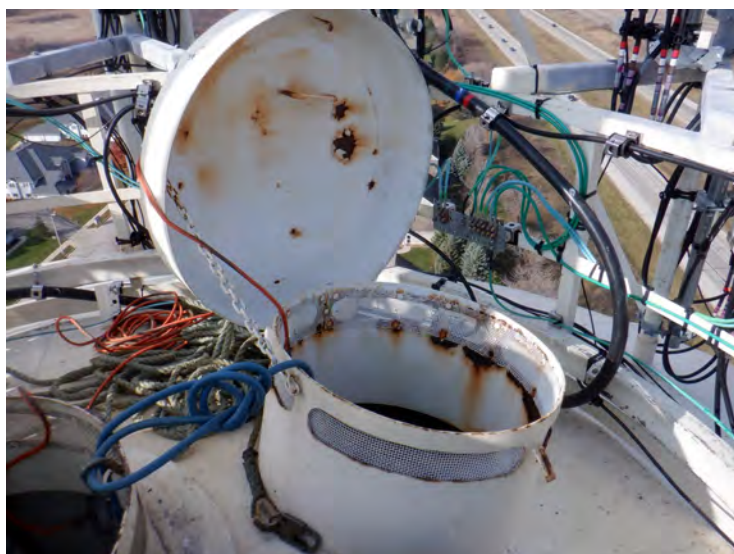
24) There is not a gasket on the wet interior roof hatch.

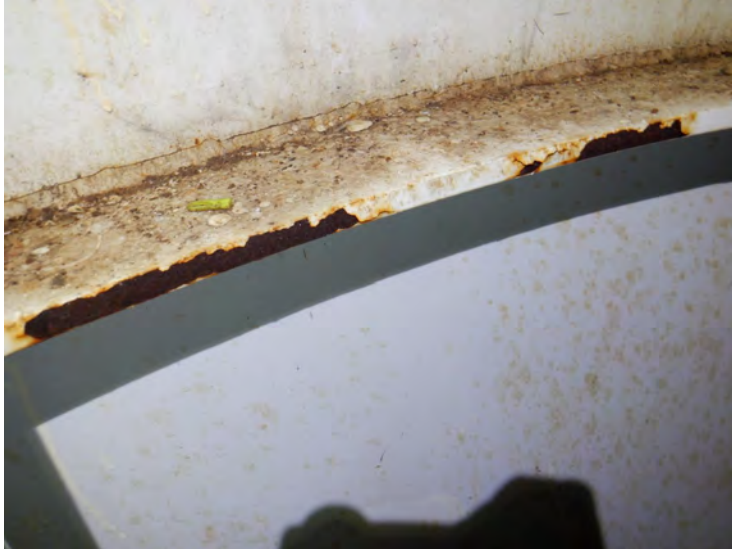
37) Coating failure on a stiffener in the dry riser.

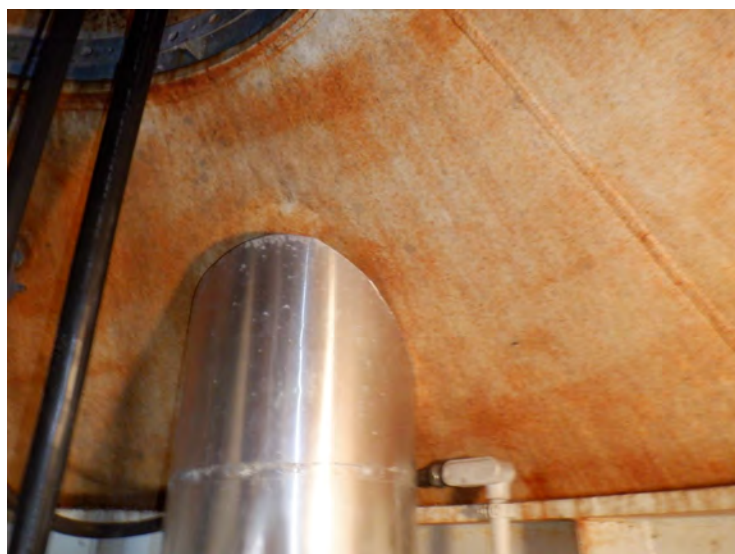
45) Rust bleedthrough on the transition cone.

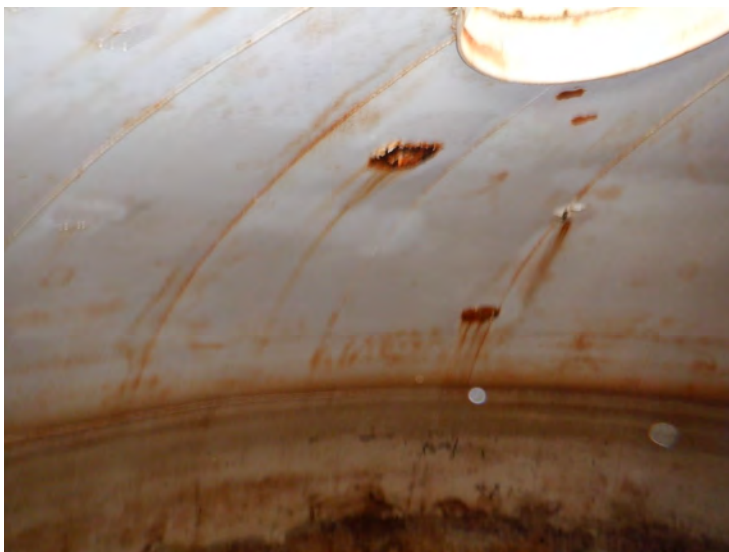
51) Coating failures on the wet interior roof.

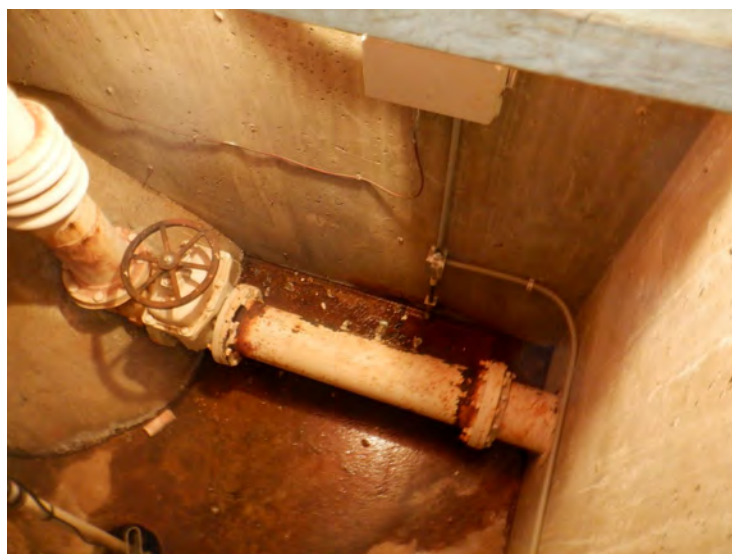
66) Coating failures on the pit piping.

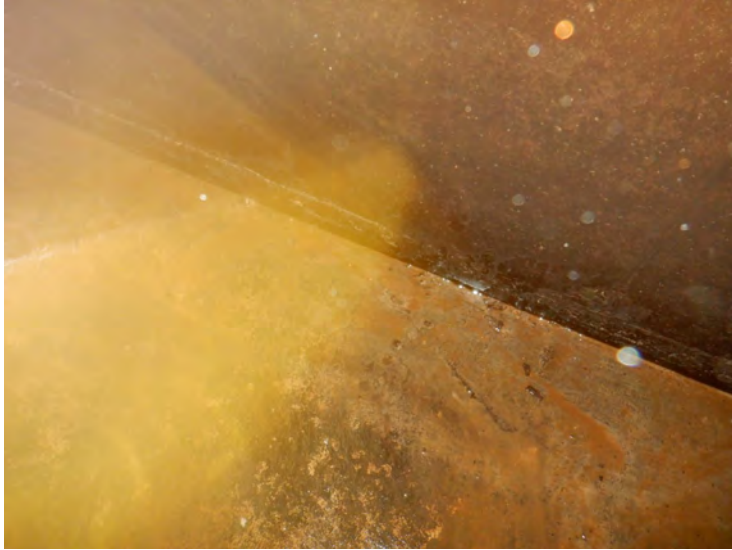
15) The metal wet interior appurtenances are not coated.

Abrasive blast clean the wet interior piping and repaint with an epoxy system. The piping could be allowed to deteriorate and then be replaced once it no longer operates properly, replacement could be performed by in-house personnel. The estimated to repaint the piping is \$10,000.

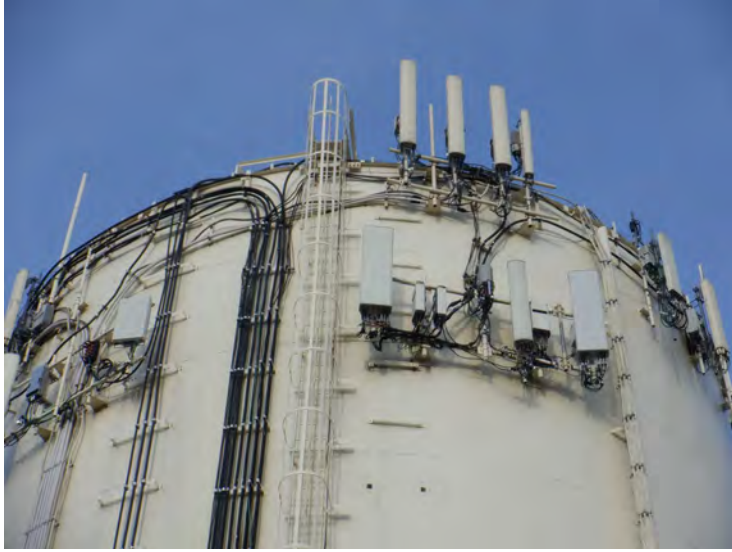
18) Same.

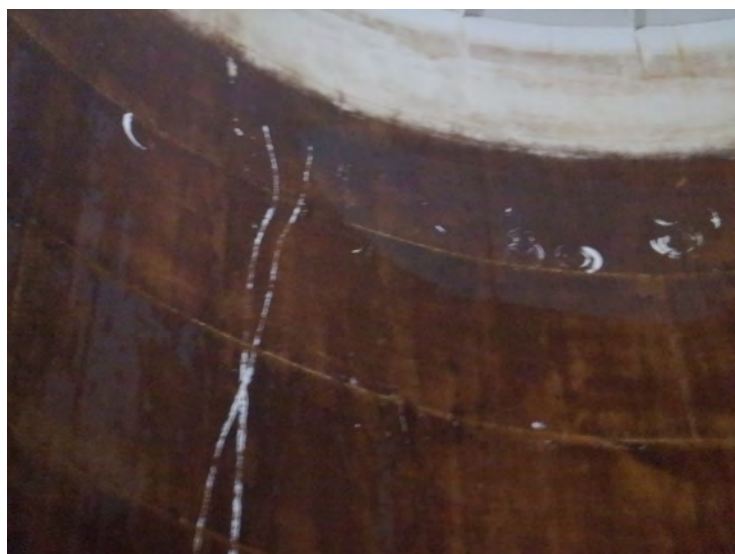
47) There is heavy mineral staining on the sidewall.

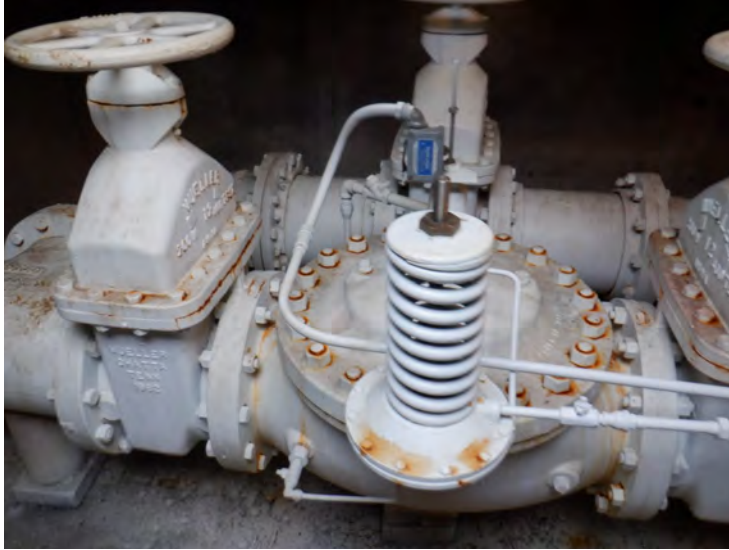
64) The coating on the piping is in good condition overall.
