Regular Village Board Meeting Agenda

July 19, 2022 – 7:00 pm
Village Hall, 235 Hickory Street, Pewaukee, WI 53072

250,000 gallon spheroid (Lake Street) elevated water storage tank owned by the Village of Pewaukee, Wisconsin.

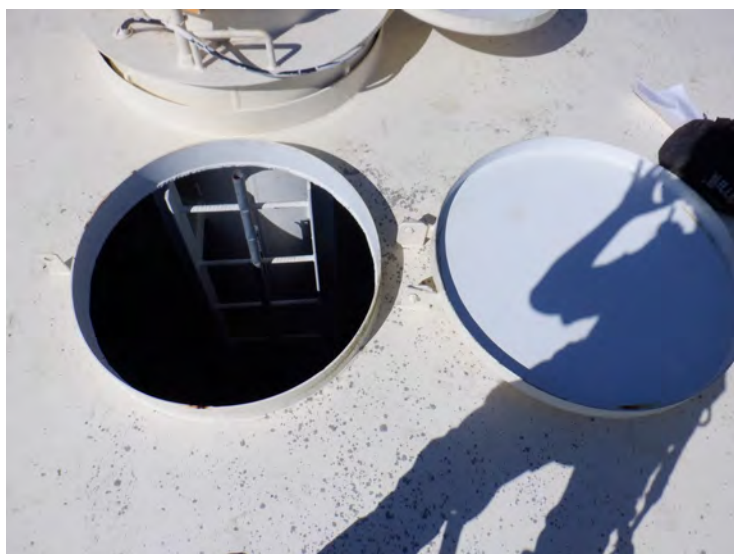
18) The wet interior roof hatch is in good condition. A gasket was installed on the hatch during the inspection.

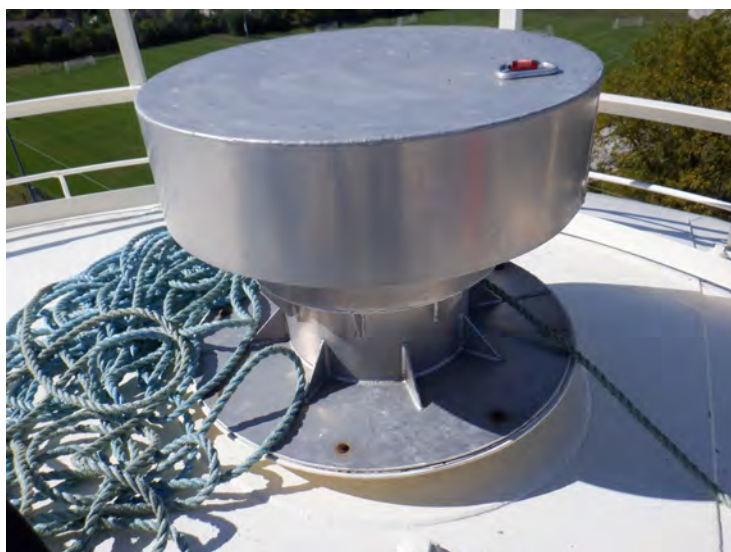
21) The roof vent is in good condition.

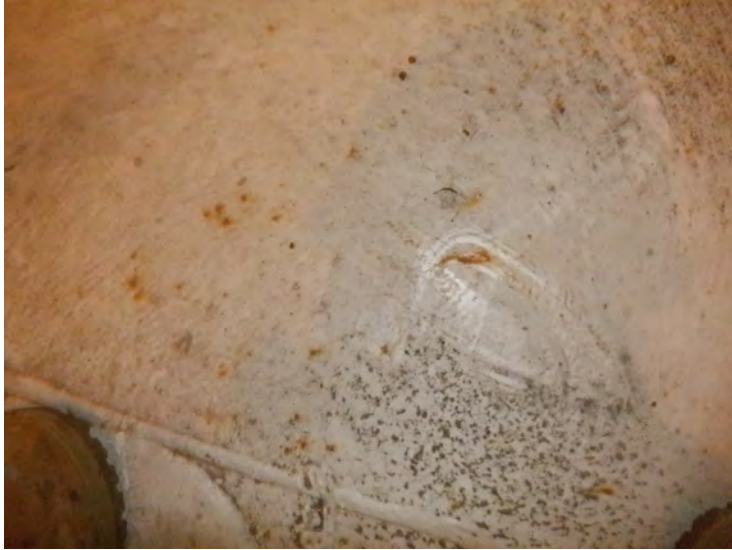
31) Minor coating failures on the condensate platform.

2. Spot abrasive blast clean the topside of the platforms, the entire access tube, transition cone, and other spot coating failures in the dry interior. Spot repaint all prepared surfaces with an epoxy coating system. The estimated cost is \$30,000.

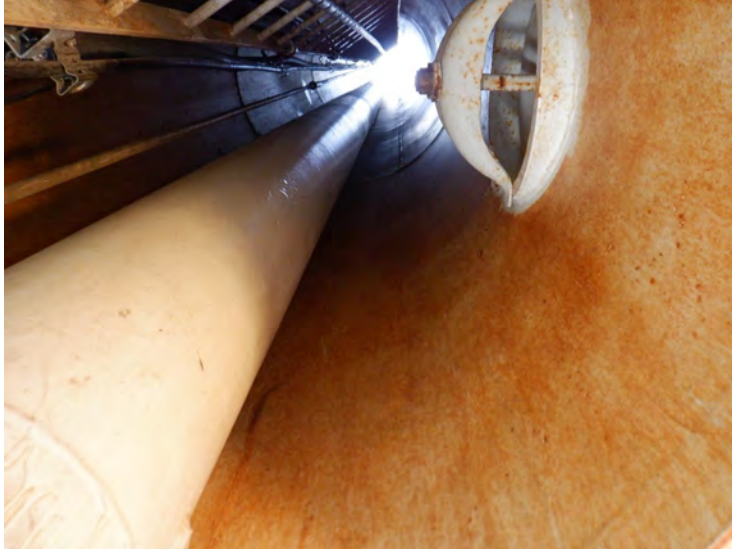
46) Extensive rust bleedthrough in the access tube.

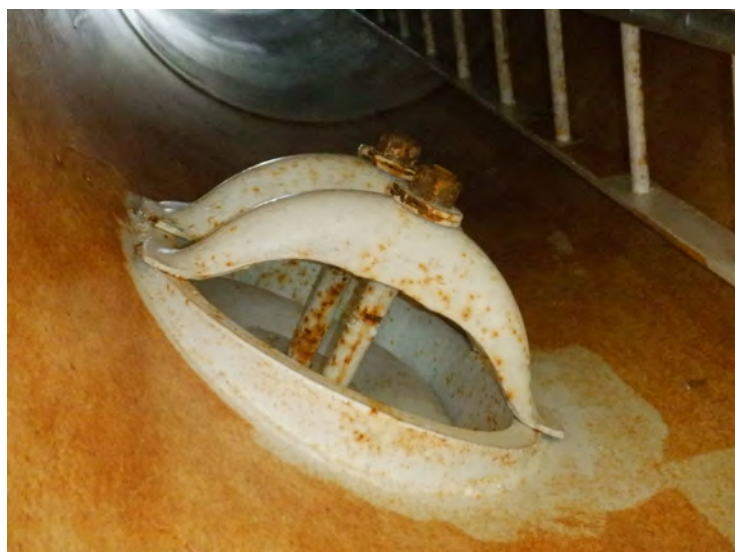
48) Coating failures on the wet interior manway.

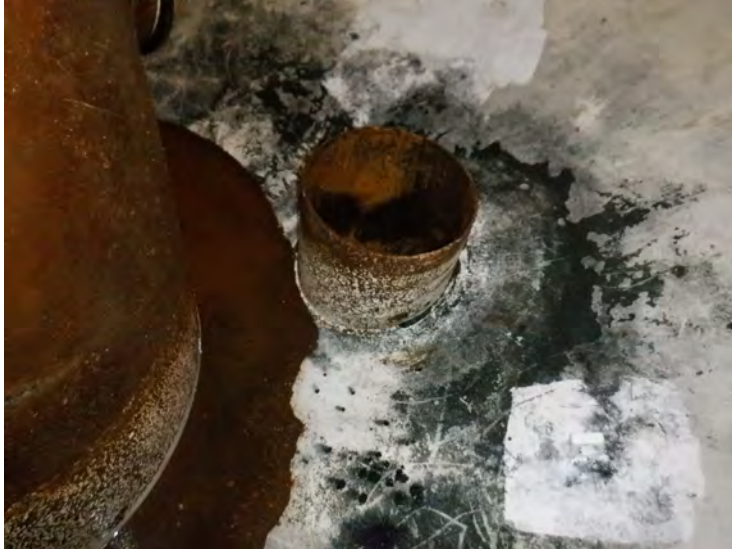
64) There are no deflector bars over the fill/draw pipe in the wet interior.

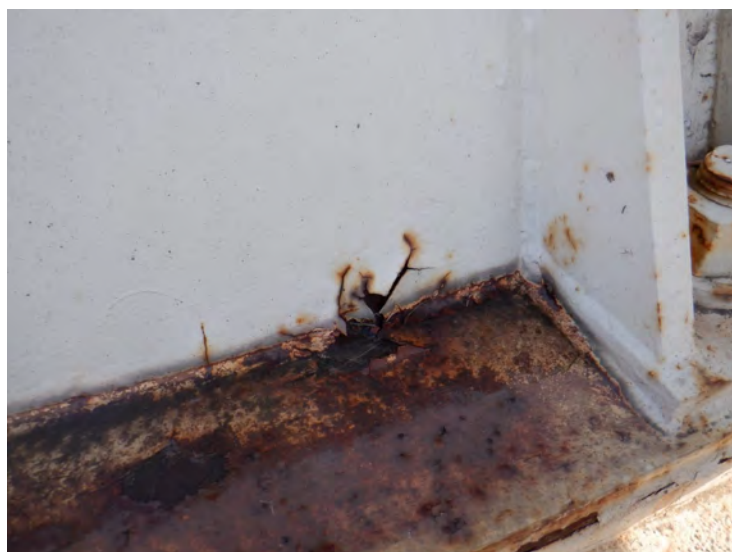
6) Coating failures on the baseplate.

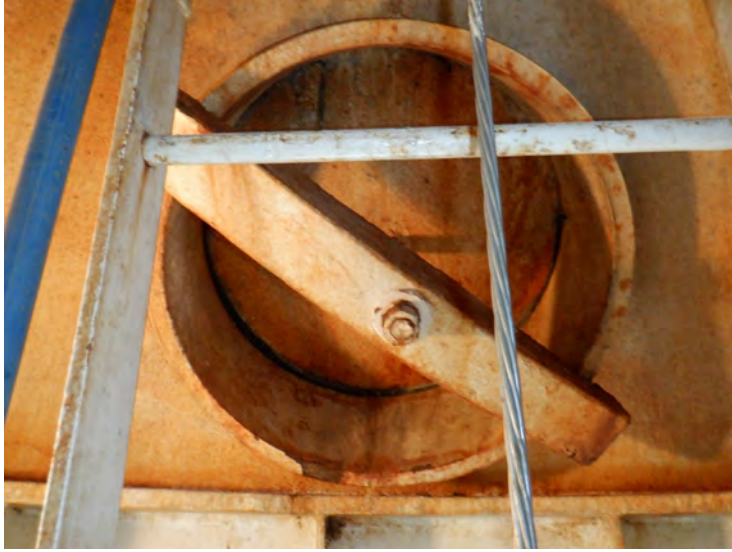
46) Coating failures on the wet interior manway. The manway is in the transition cone.

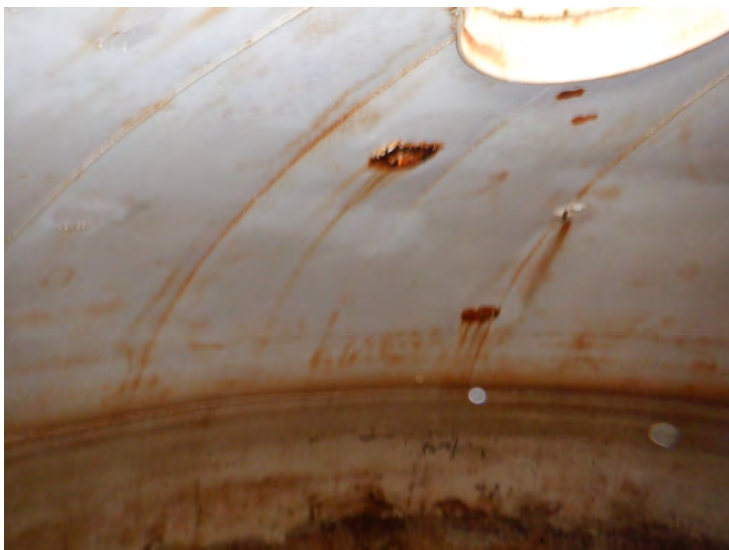
51) Coating failures on the wet interior roof.

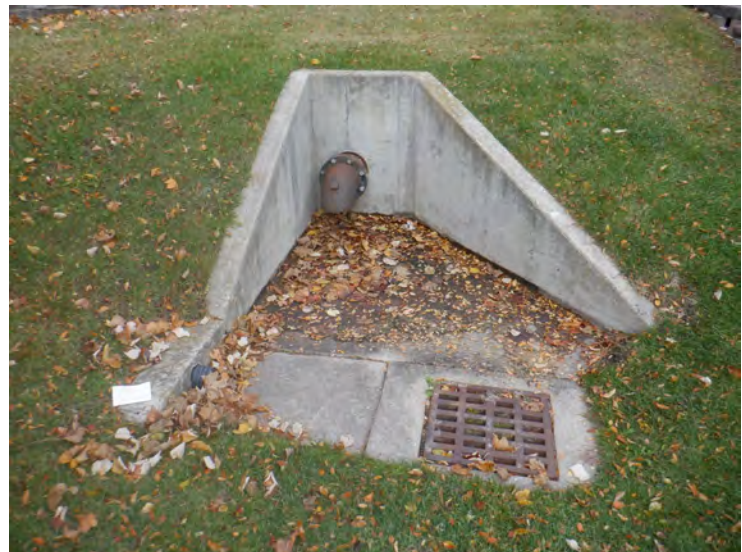
2) The overflow pipe discharges to a catch basin.

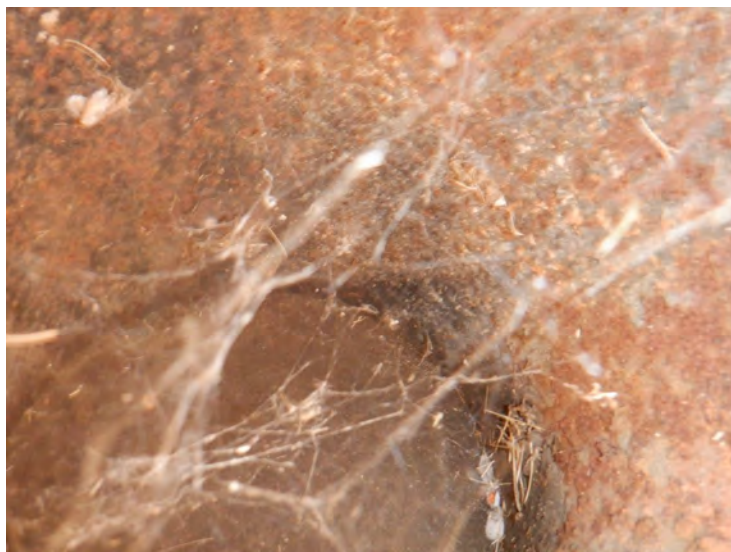
3) The screen at the overflow discharge is intact with no gaps or holes.

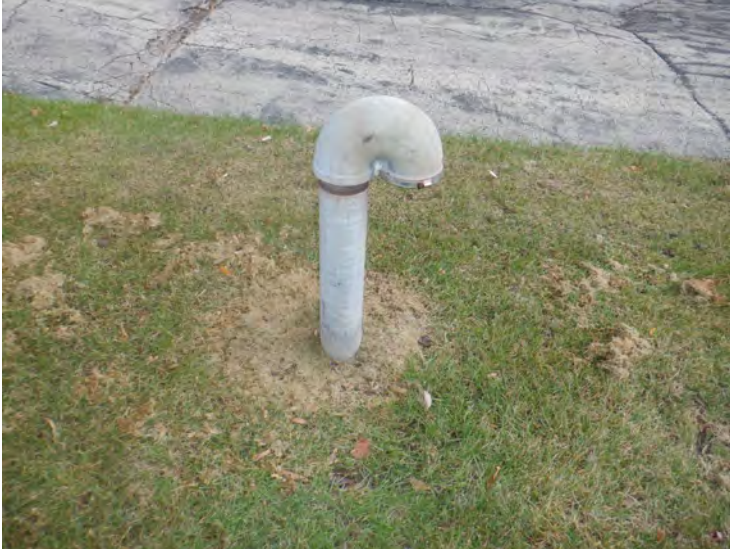
4) The goose neck roof vent is in good condition.

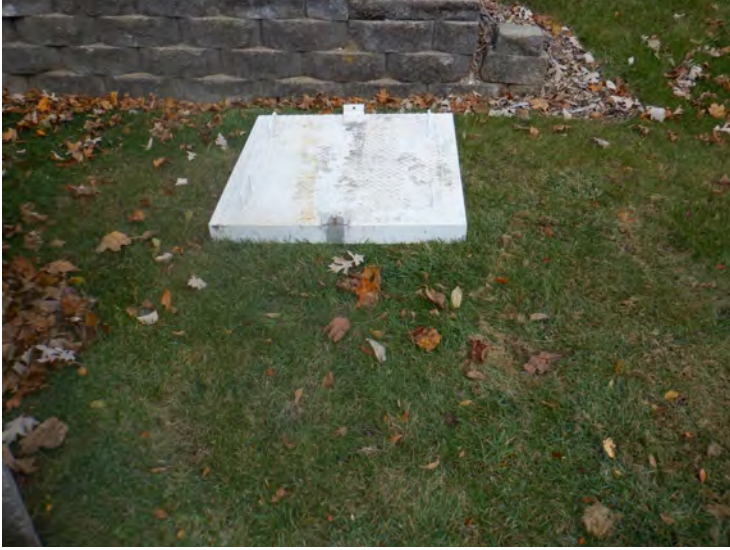
7) The roof hatch covers are in good condition with some coating erosion.

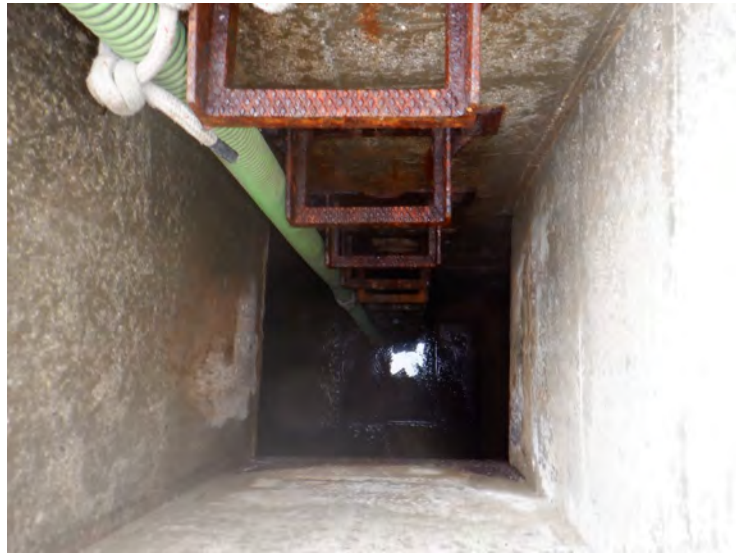
8) The ladder cleats from the roof to the floor are in good condition.

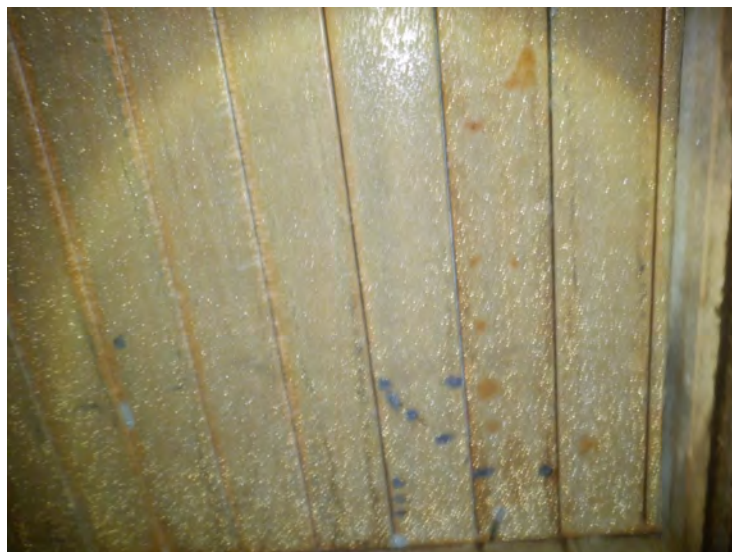
The roof is in good condition overall with no significant deterioration. There is some rusting at the surface from rebar chair bases and rebar.

9) Rusting at the surface of the wet interior roof.

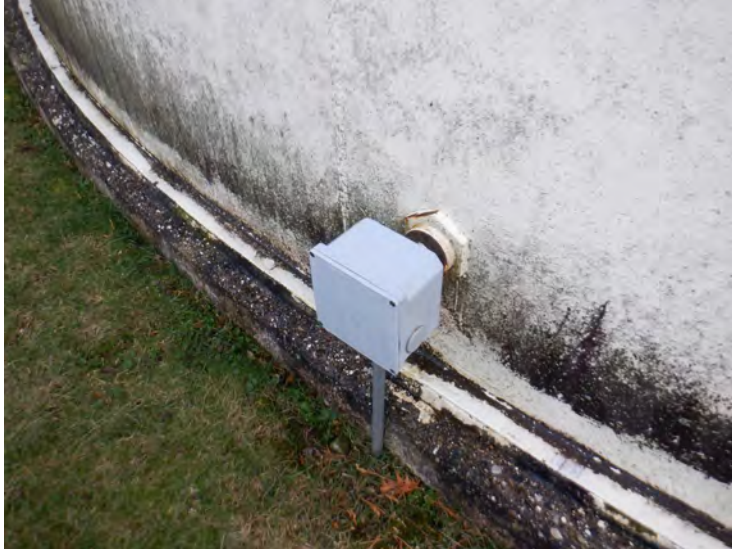
4) The cathodic protection pressure fitting is in good condition.

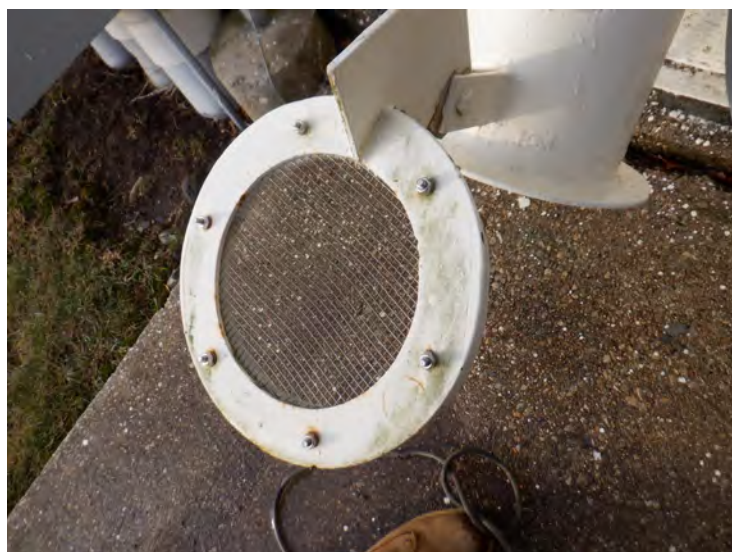
6) The screened flap gate is in good condition.

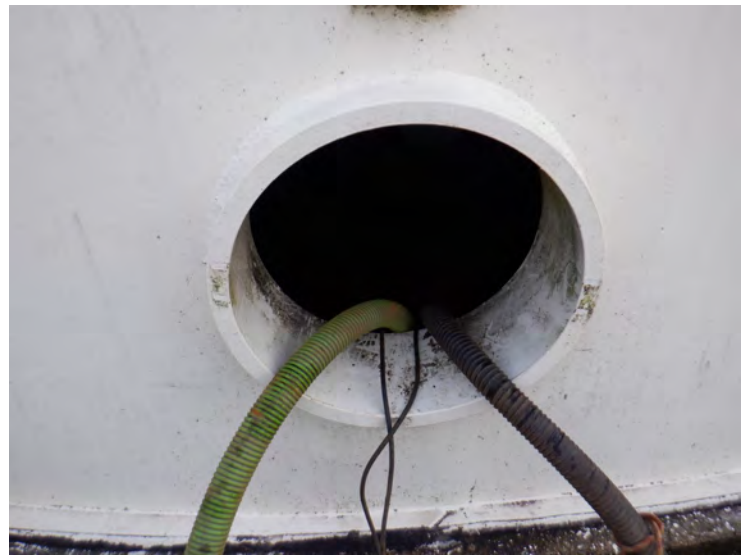
8) The two sidewall manways are in good condition.

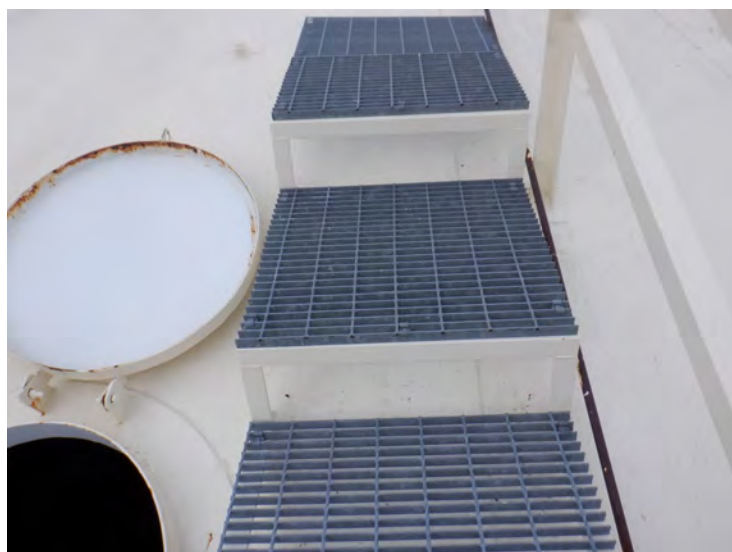
23) The step-off platform is in good condition.

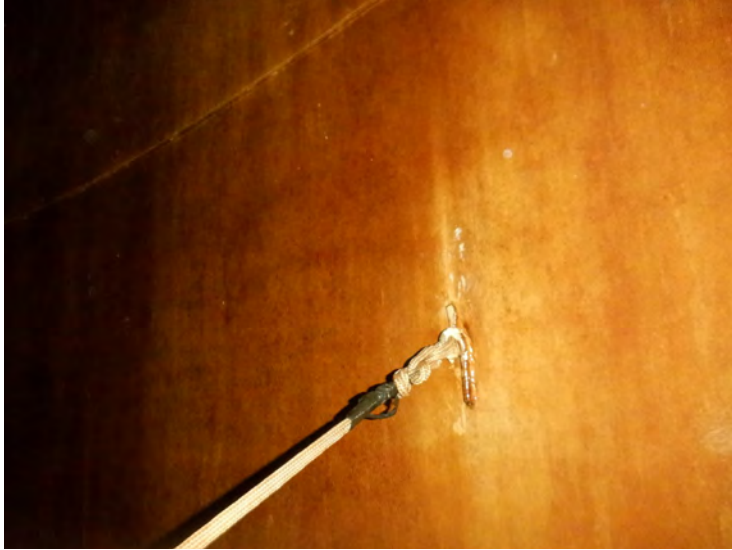
52) There are cathodic protection clips on the sidewall.

53) The manway covers are held by a davit arm that is in good condition.

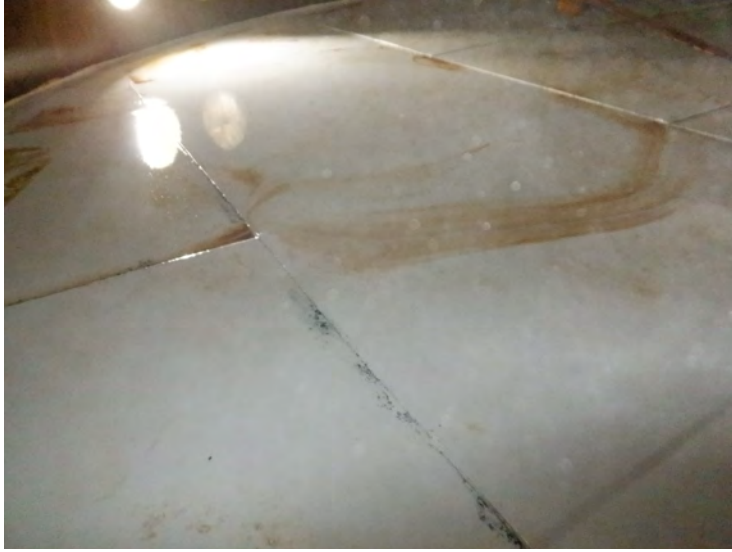
55) The coating on the floor is in good condition.

56) Same.

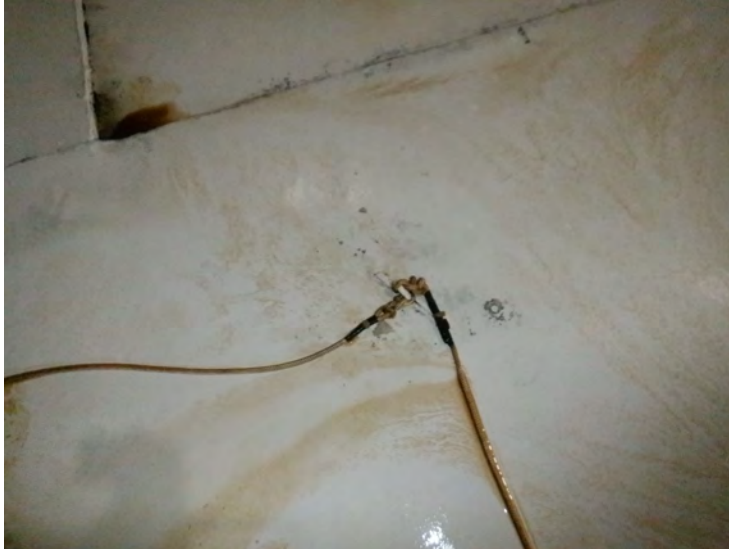
58) There are cathodic clips on the floor.

59) The cathodic protection system appears to be in good condition.
