Water System Master Plan

June 7, 2022

PREPARED FOR:
Village of Pewaukee
235 Hickory Street
Pewaukee, WI 53072

PREPARED BY:
Ruekert & Mielke, Inc.
W233 N2080 Ridgeview Parkway
Suite 300
Waukesha, WI 53188

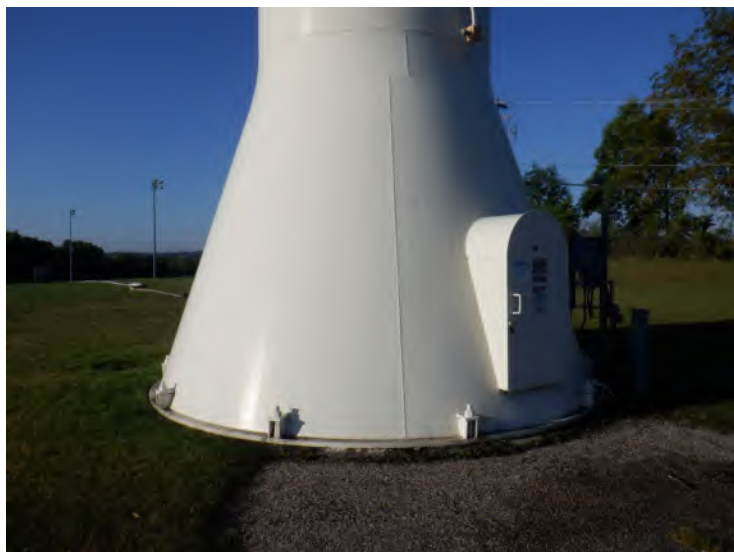
6) There are no coating failures on the basebell.

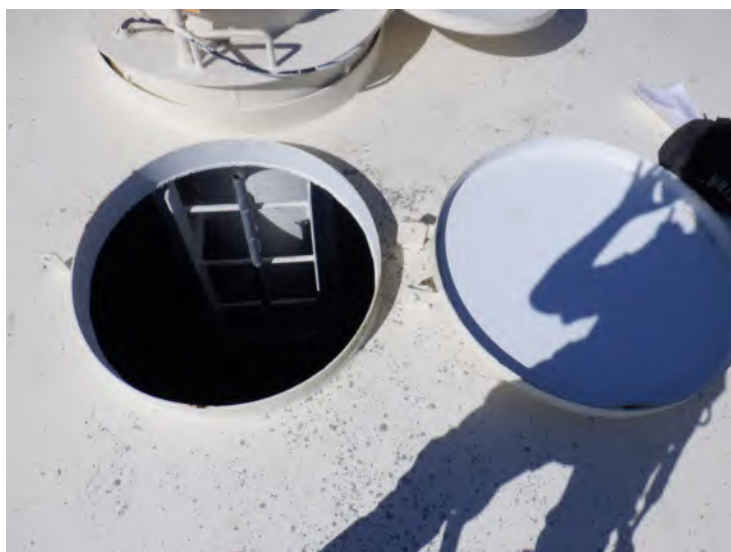
18) The wet interior roof hatch is in good condition. A gasket was installed on the hatch during the inspection.

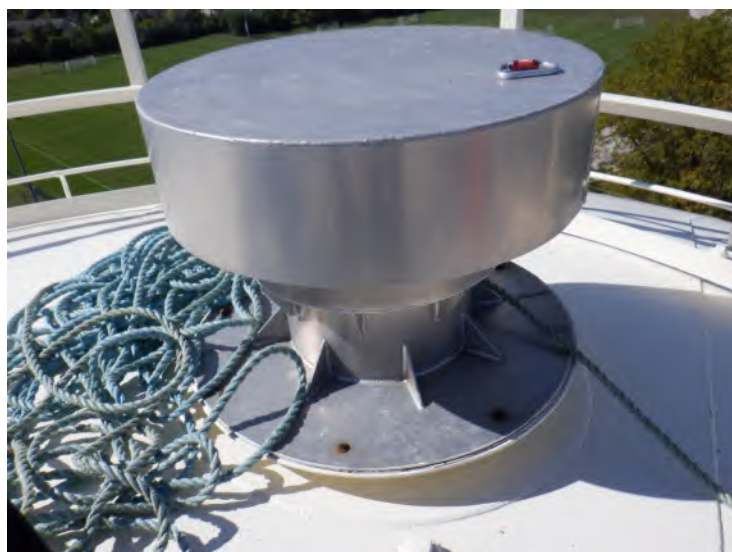
21) The roof vent is in good condition.

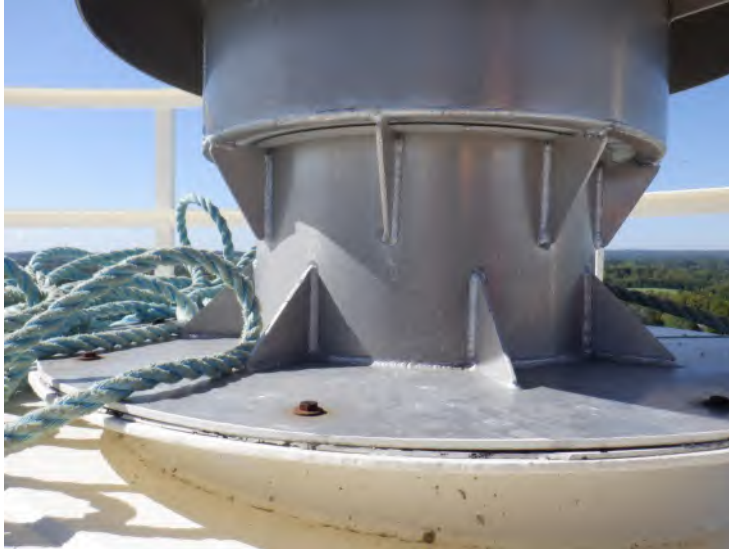
22) The roof vent pressure plate was properly aligned and free to move.

23) The vertical roof vent screen is in good condition.

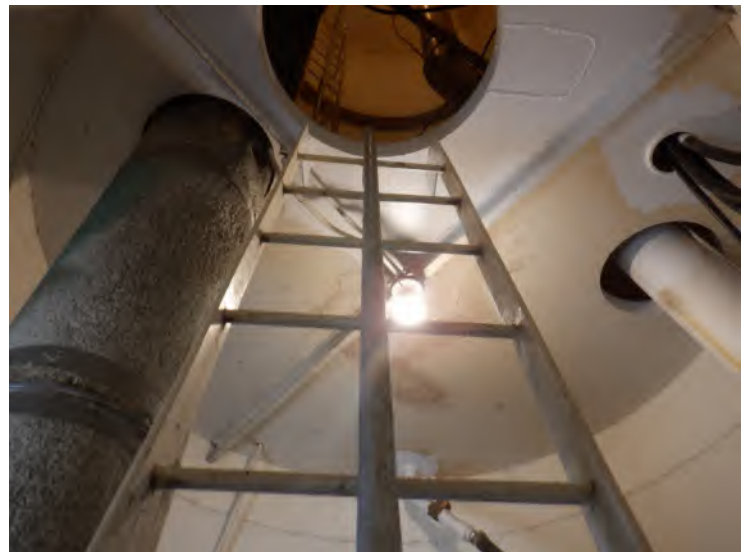
29) The baseball ladder is in good condition. The ladder is equipped with a fall prevention device.

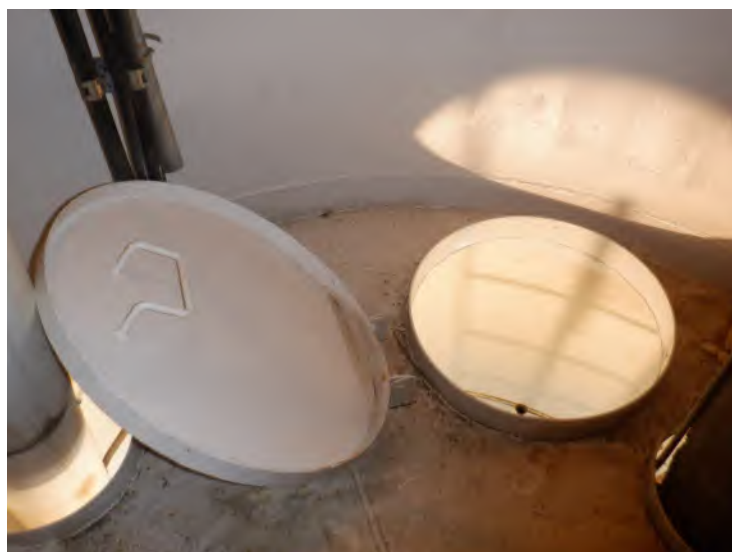
30) The ladder opening at the condensate platform is equipped with a hinged cover.

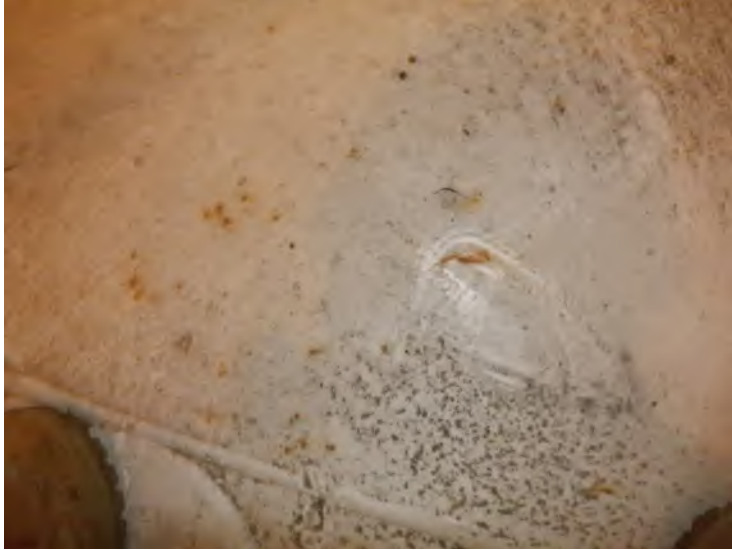
31) Minor coating failures on the condensate platform.

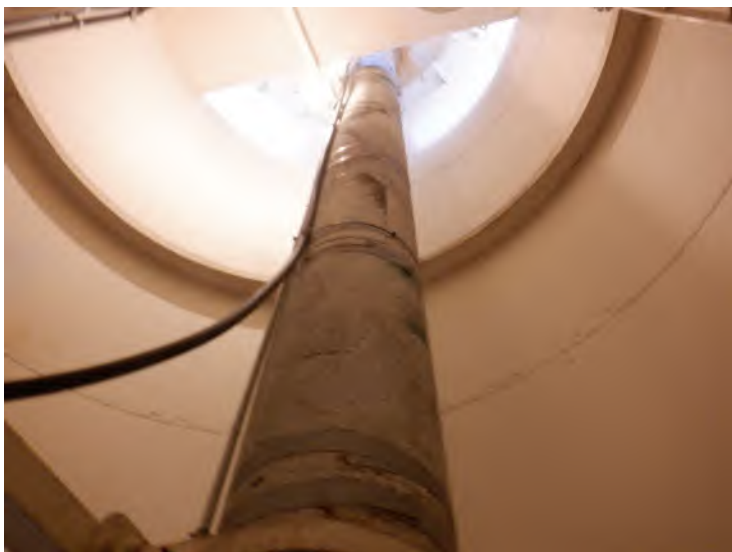
36) There is no cover over the fill/draw pipe insulation.

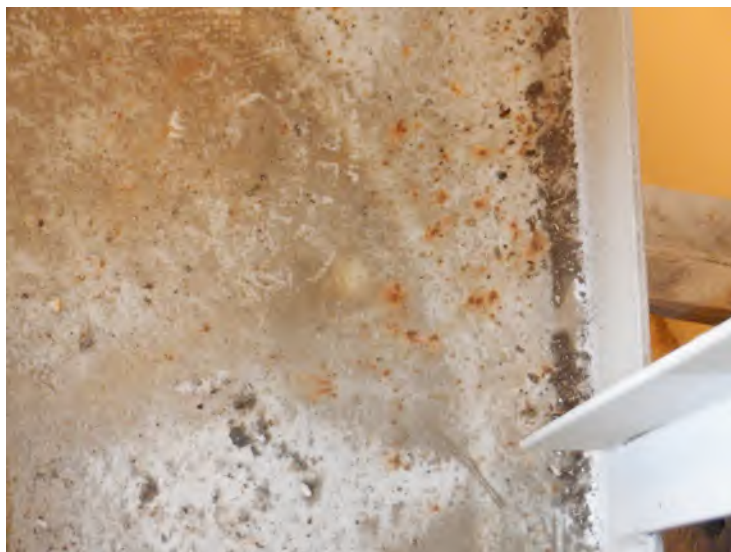
39) Minor coating failures on the top platform.

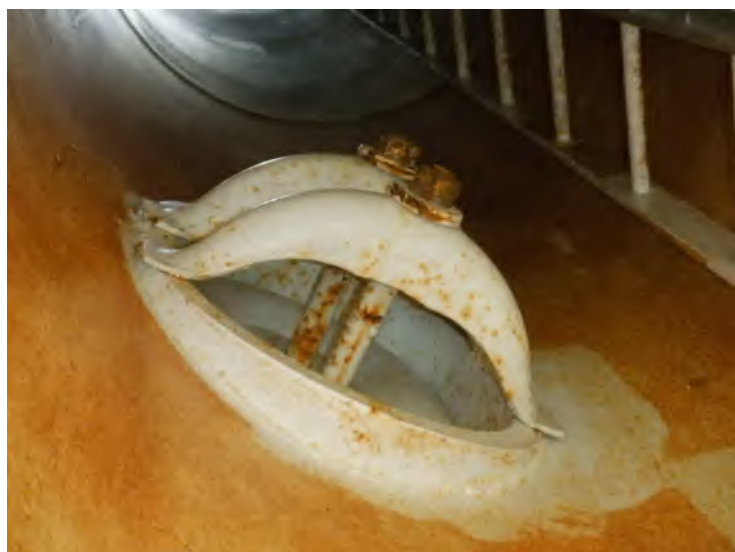
48) Coating failures on the wet interior manway.

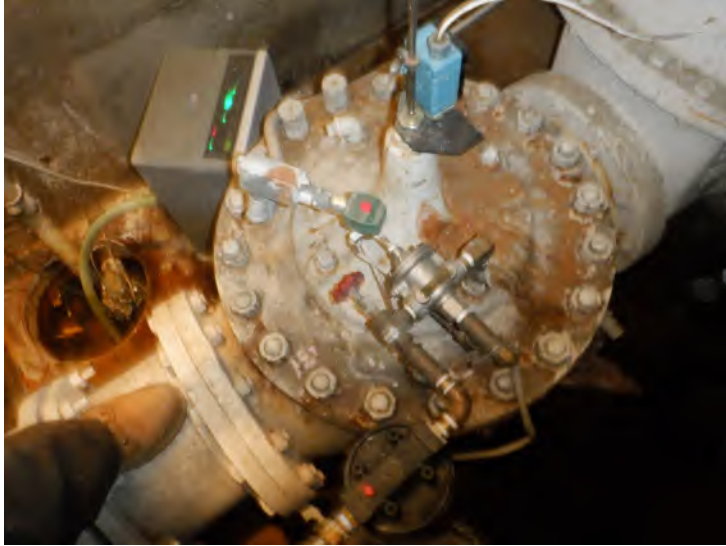
67) Minor coating failures on the pit piping.

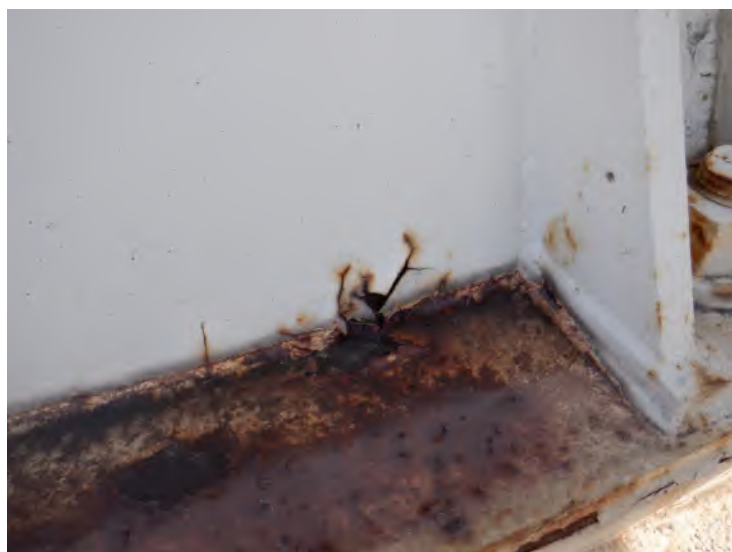
6) Coating failures on the baseplate.

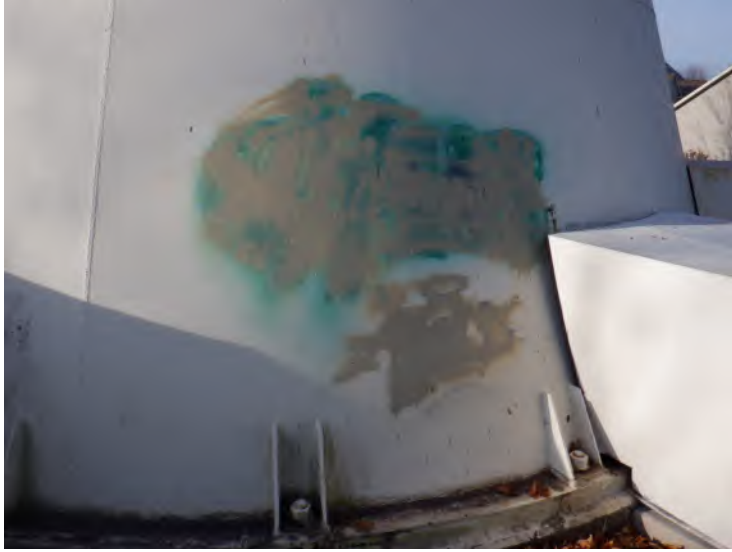
7) Coating failures on the basebell.

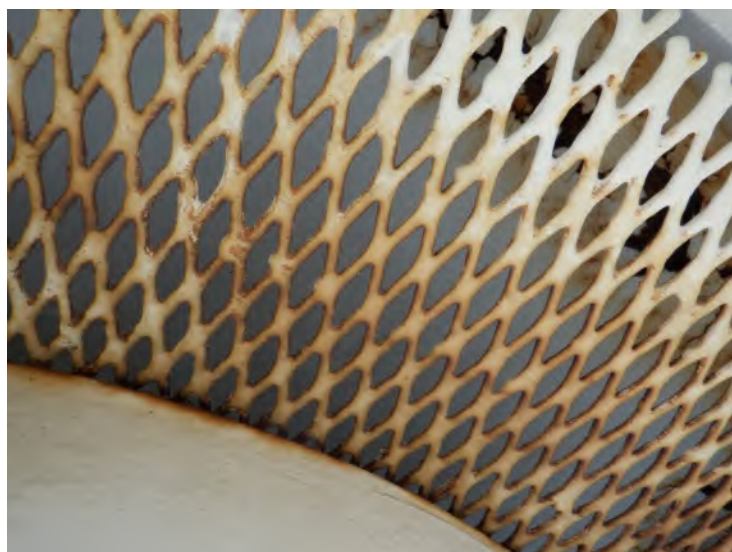
27) The roof vent screen is intact with no gaps.

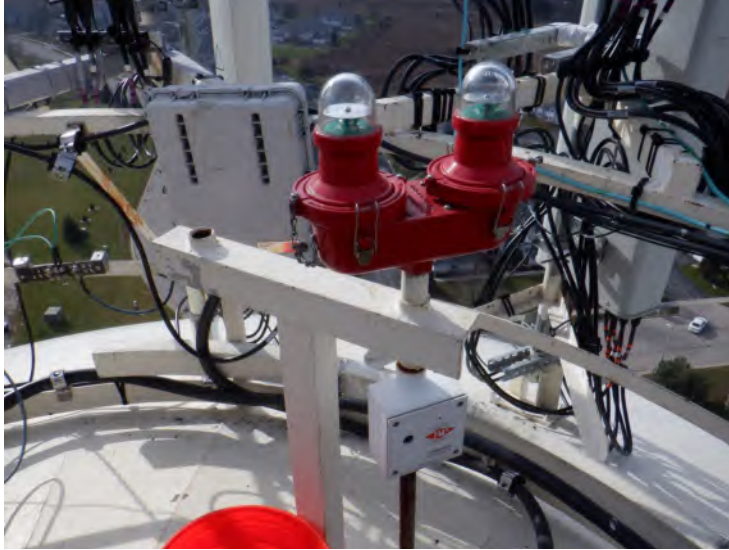
28) The aviation light was operating properly during the inspection.

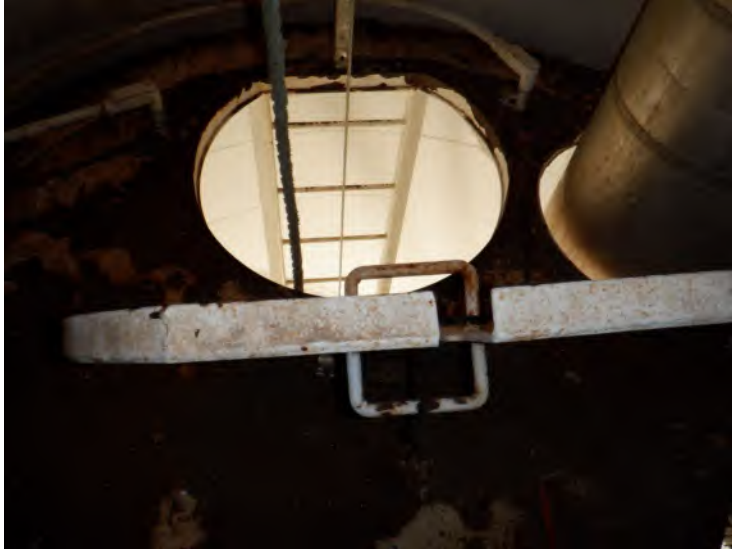
34) The ladder opening in the condensate platform is equipped with a hinged cover.

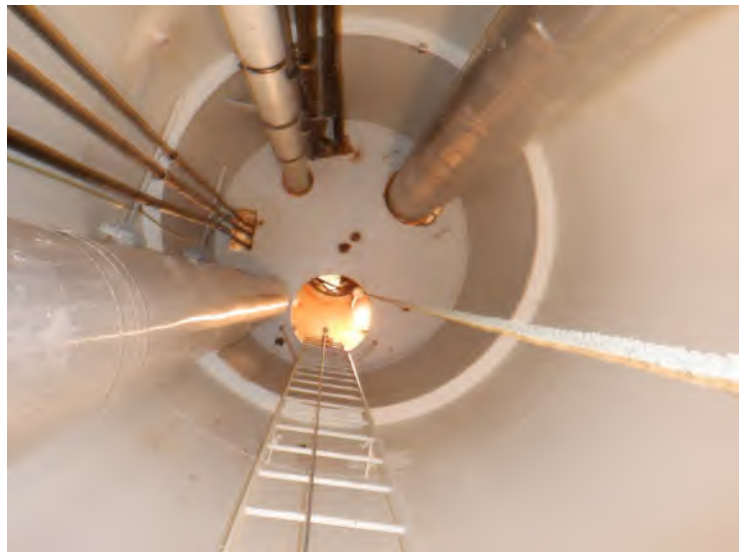
41) The riser ladder is in good condition. The ladder is equipped with a fall prevention device.

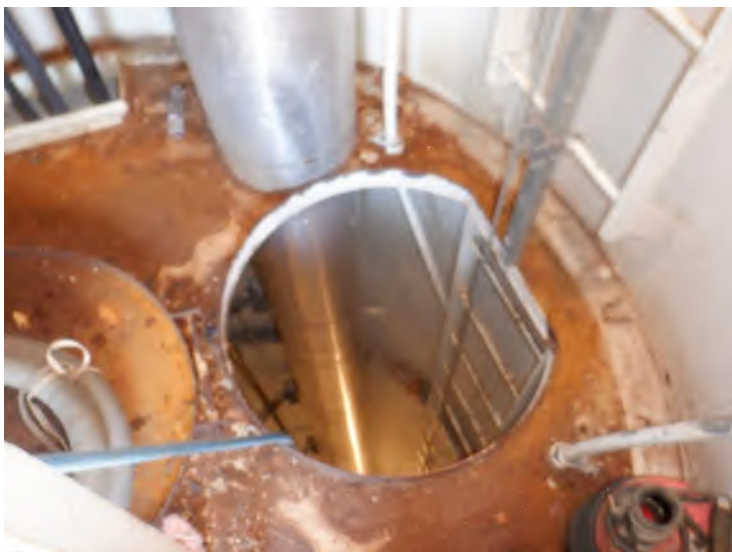
42) The ladder opening at the top platform is equipped with a hinged cover.

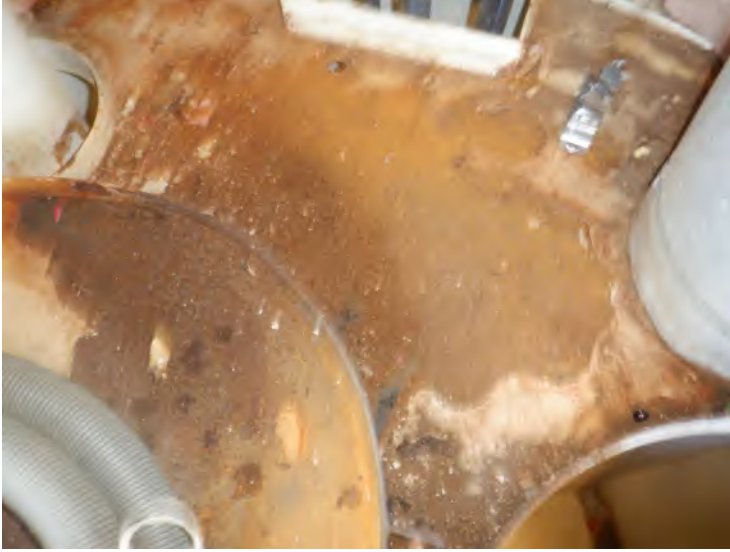
43) Coating failure on the top platform.

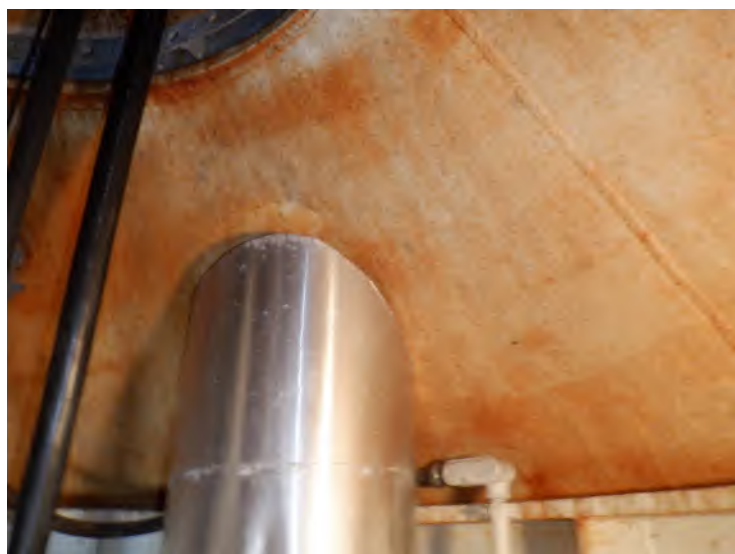
45) Rust bleedthrough on the transition cone.

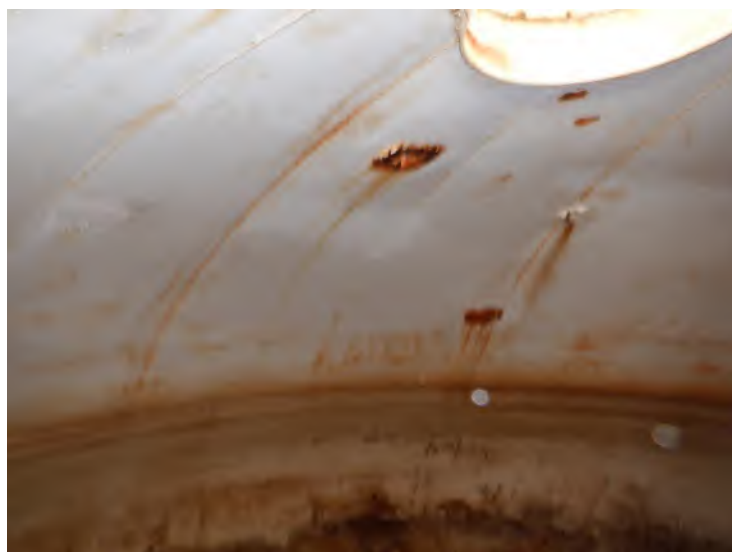
51) Coating failures on the wet interior roof.

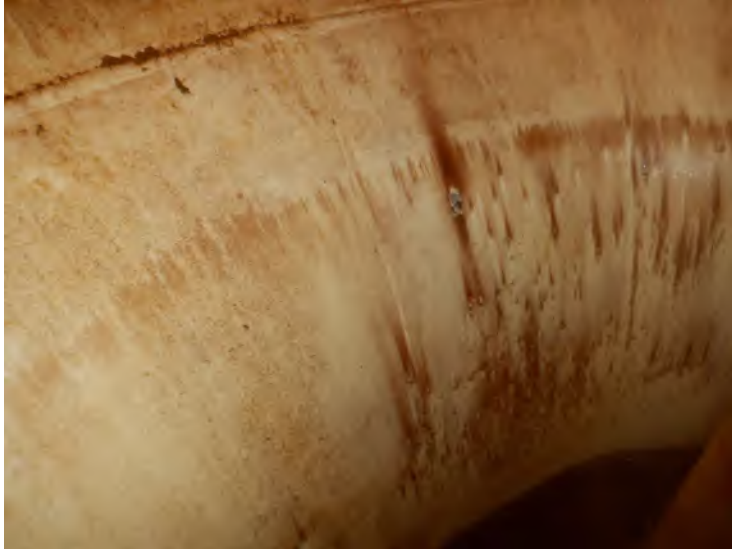
61) Coating failures in the transition cone.

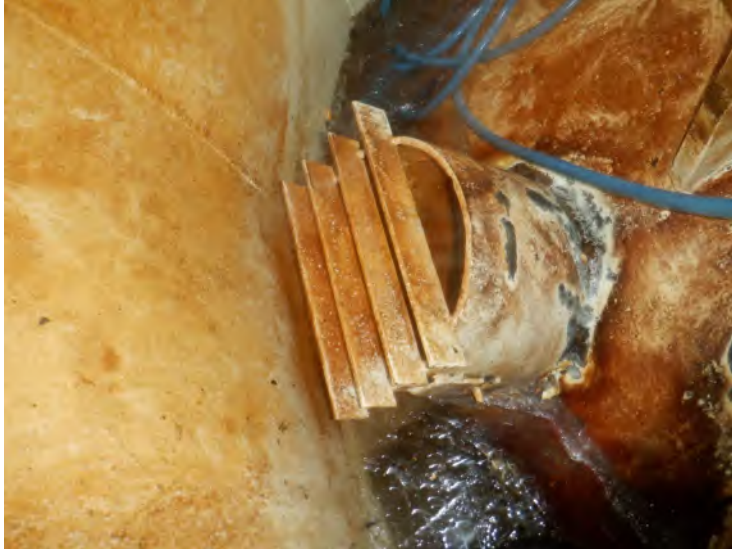
64) There are deflector bars over the fill/draw pipe in the wet interior.

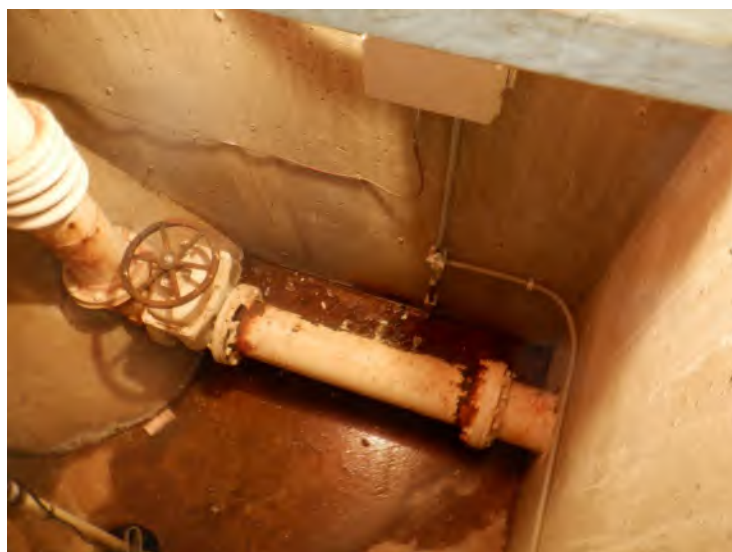
66) Coating failures on the pit piping.

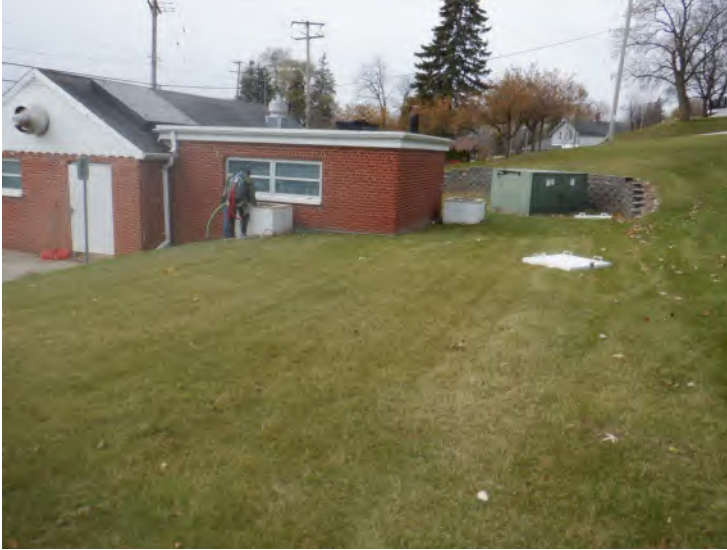
1) 125,000 gallon underground concrete water storage reservoir (Well 2) owned by the Village of Pewaukee, Wisconsin.

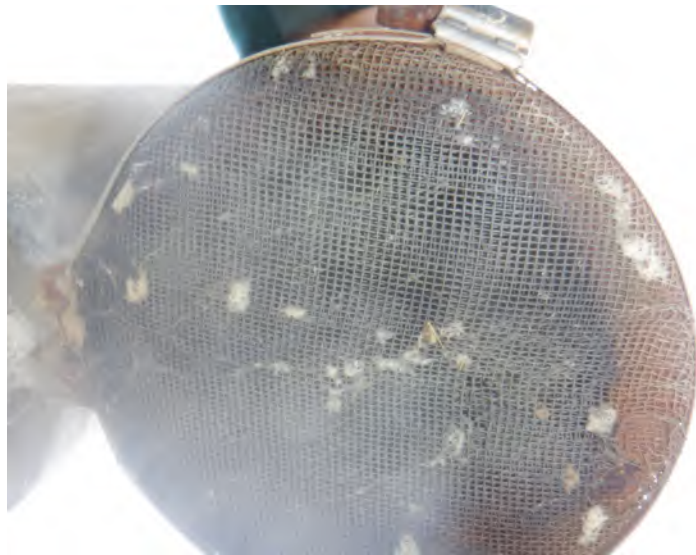
5) The roof vent screen is intact.

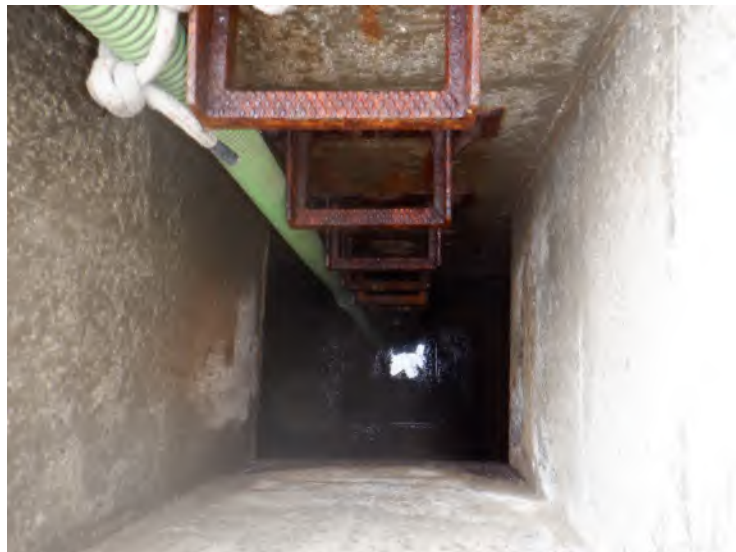
8) The ladder cleats from the roof to the floor are in good condition.

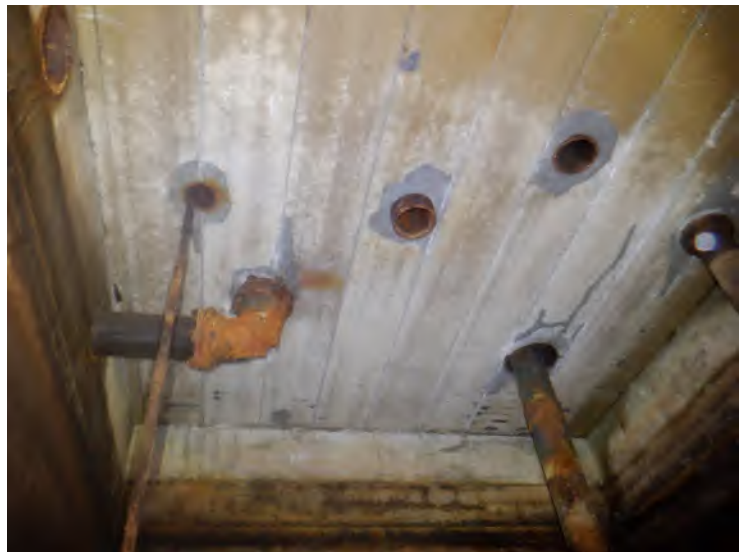
11) The fill pipe stubs at the wet interior roof.

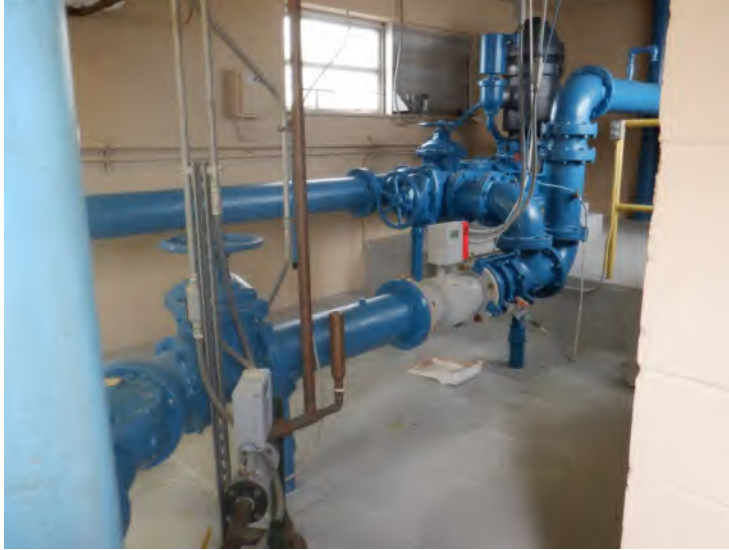
19) Coating on the piping in the pumphouse is in good condition overall.

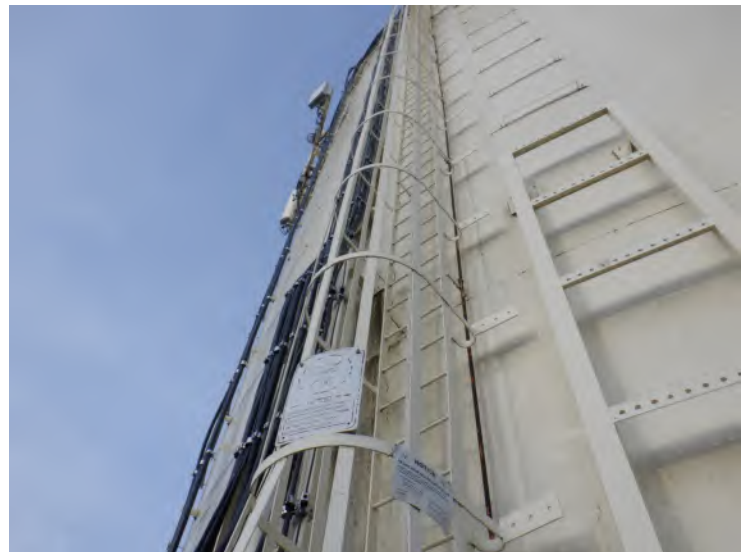
10) The sidewall ladder vandal guard is in good condition.

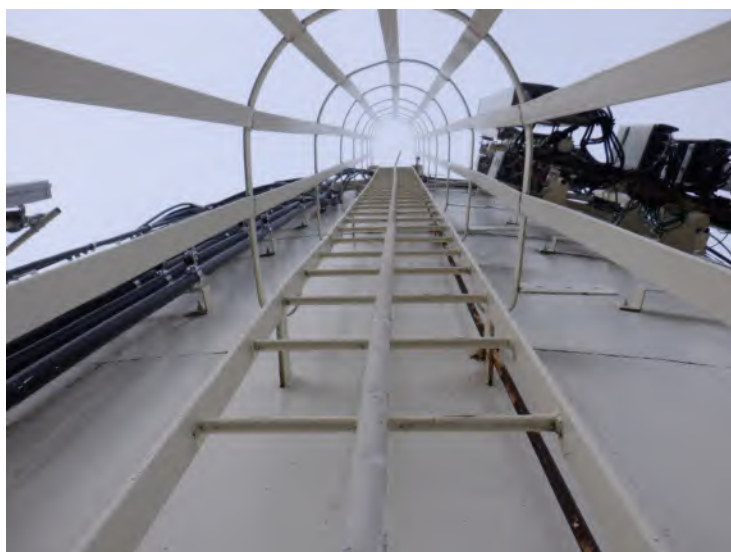
11) The sidewall ladder and cage are in good condition.

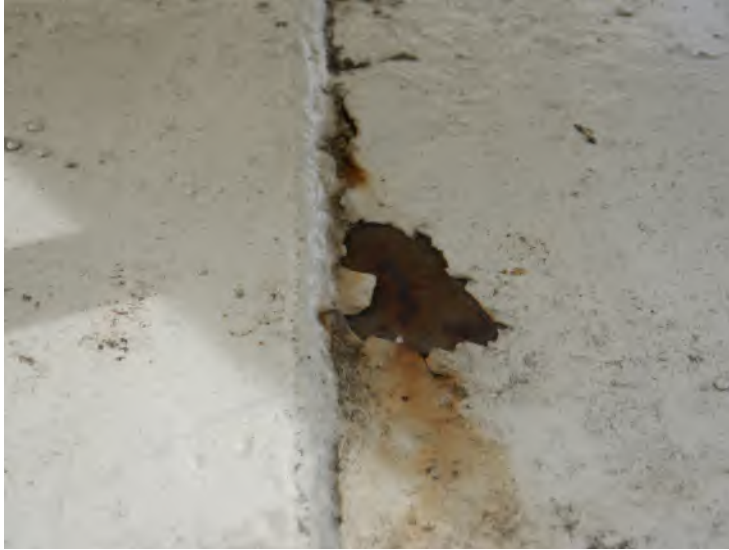
21) Same.

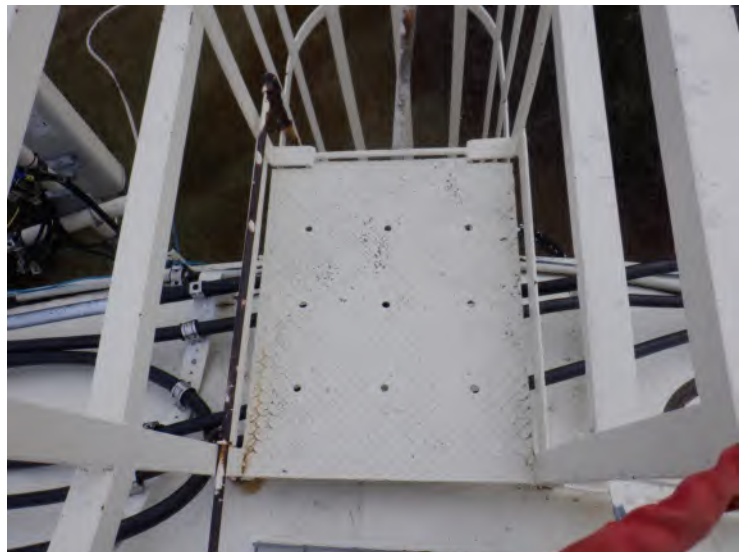
Roof comments: **There is delamination on the center handrail, several scratches in the topcoat at roof edge, antenna spot coating failures that are 1-2 inch diameter under the step off platform**

22) Spot coating failures on the roof.

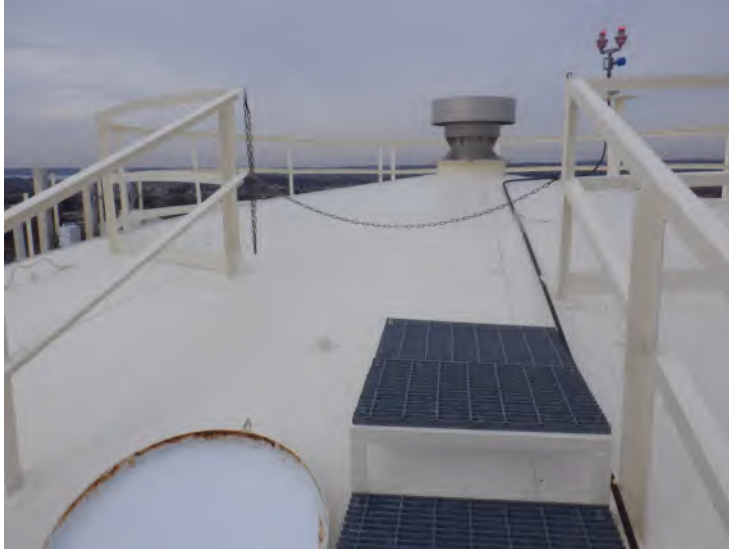
24) The steps to the center of the roof are in good condition.

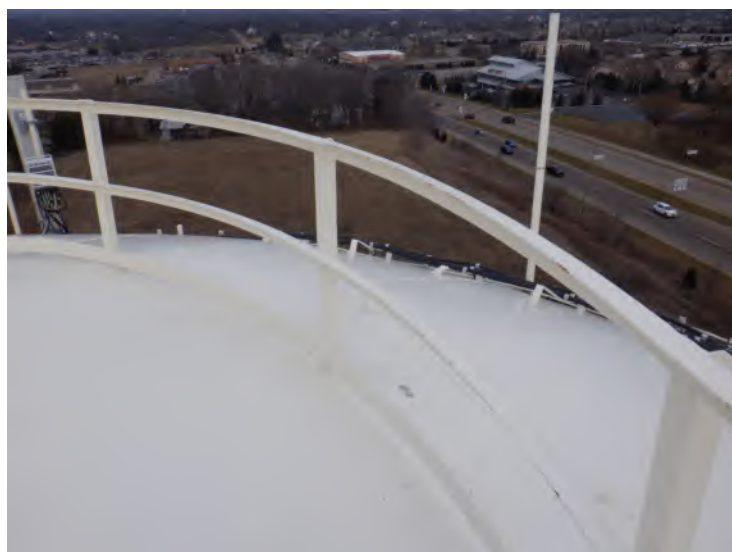
26) The step-off platform and roof hatch are surrounded by a handrail that is in good condition.

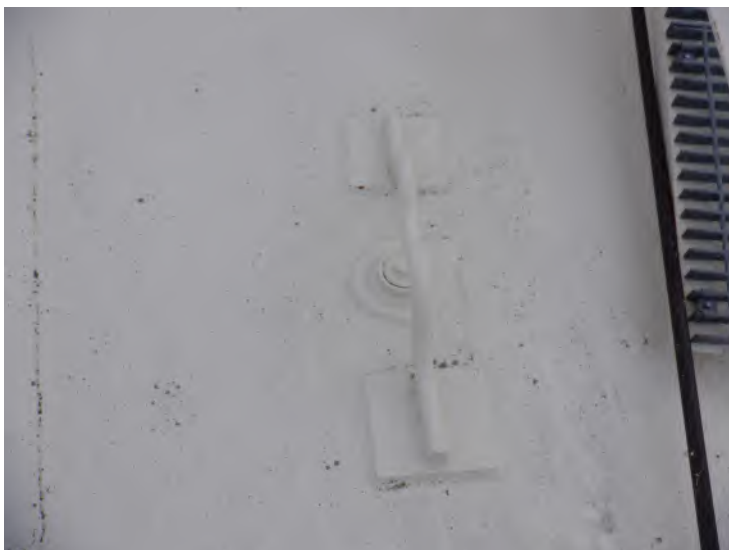
29) The roof rigging couplings are in good condition.

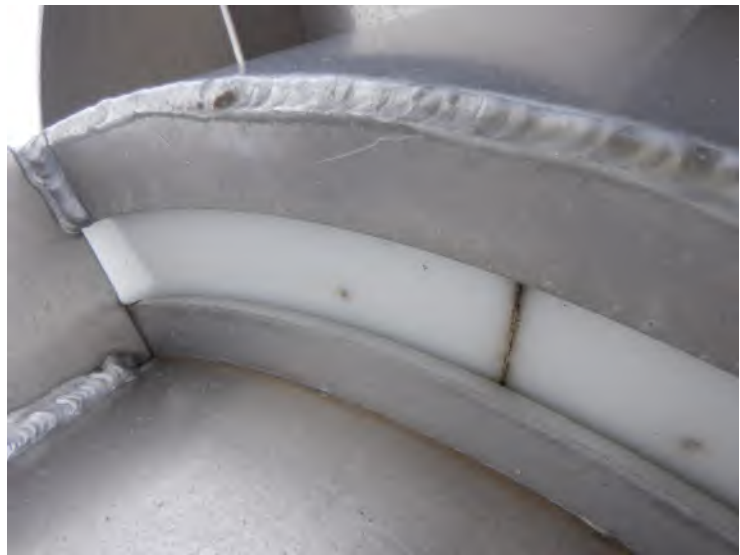
34) The vertical expanded metal screen is in good condition.

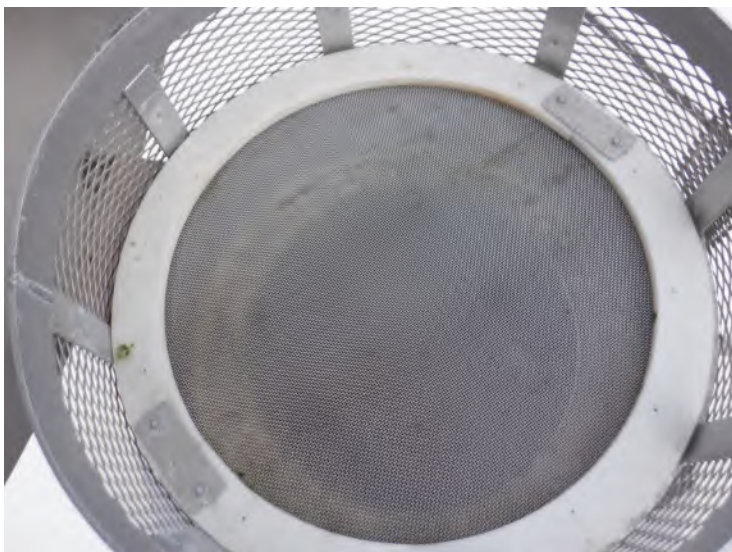
35) The pressure plate is in good condition.

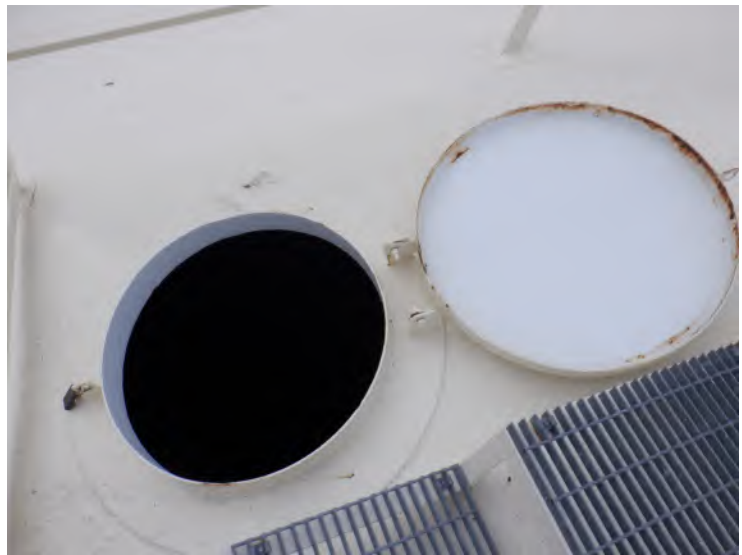
37) The roof hatch is secured with a padlock.

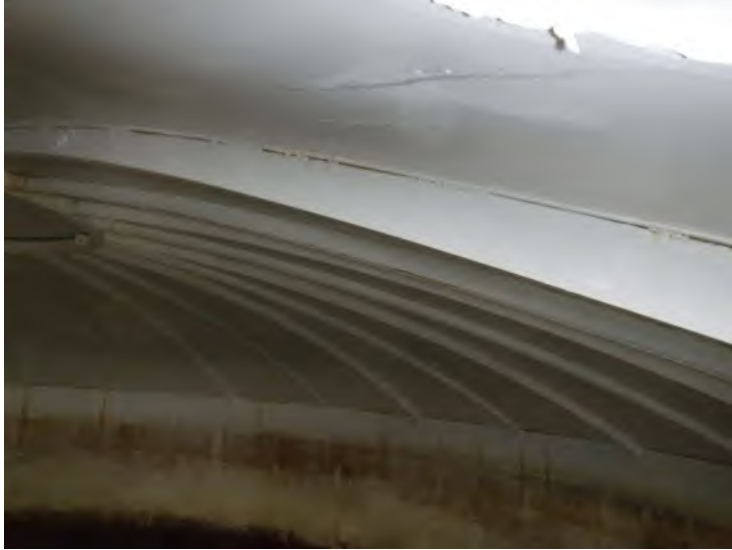
42) Same.

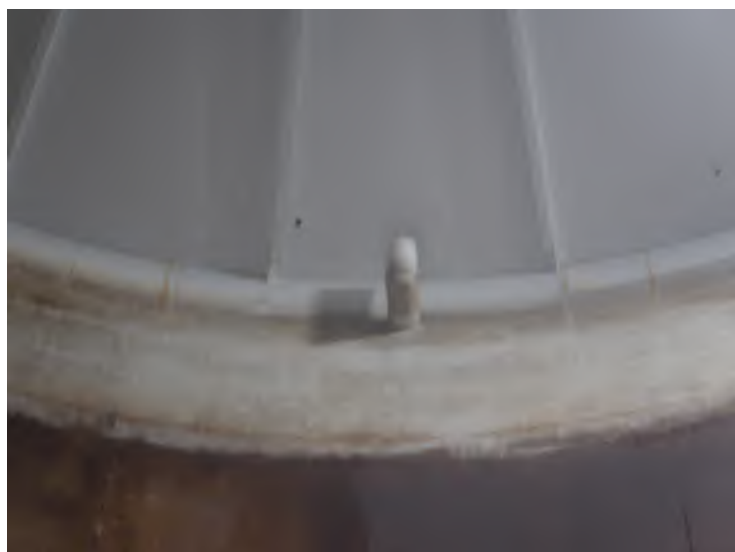
43) The roof stiffeners are in good condition.

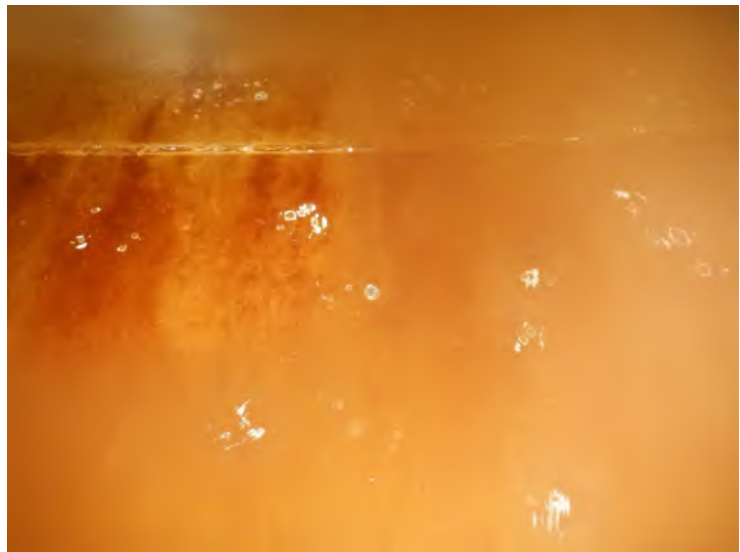
50) There are blisters in the sidewall coating on the lower sidewall panels.

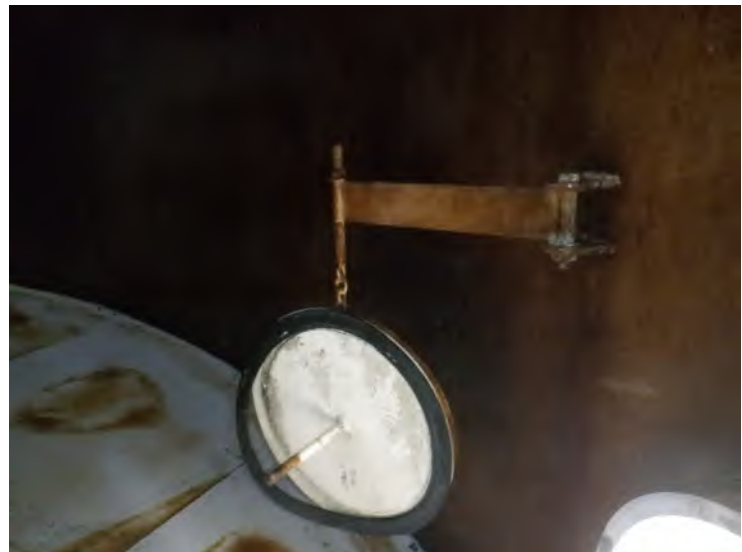
53) The manway covers are held by a davit arm that is in good condition.

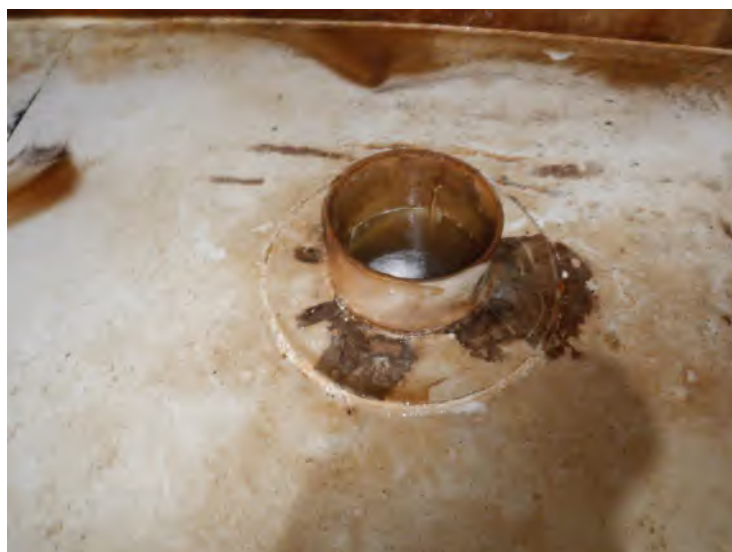
60) The fill/draw pipe is in good condition. There is not a deflector plate or bar over the top of the pipe.
