# Water System Master Plan

*April 2022*

**PREPARED FOR:**  
**Village of Pewaukee**  
235 Hickory Street  
Pewaukee, WI 53072

**PREPARED BY:**  
**Ruekert & Mielke, Inc.**  
W233 N2080 Ridgeview Parkway  
Suite 300  
Waukesha, WI 53188

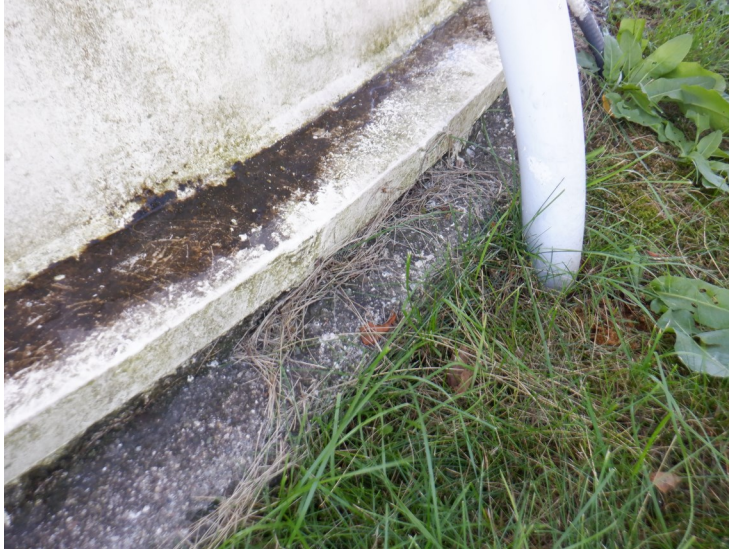
1) The concrete foundation is in good condition with no significant deterioration.

2) The anchor bolts are in good condition. There is no missing grout between the baseplate and foundation.

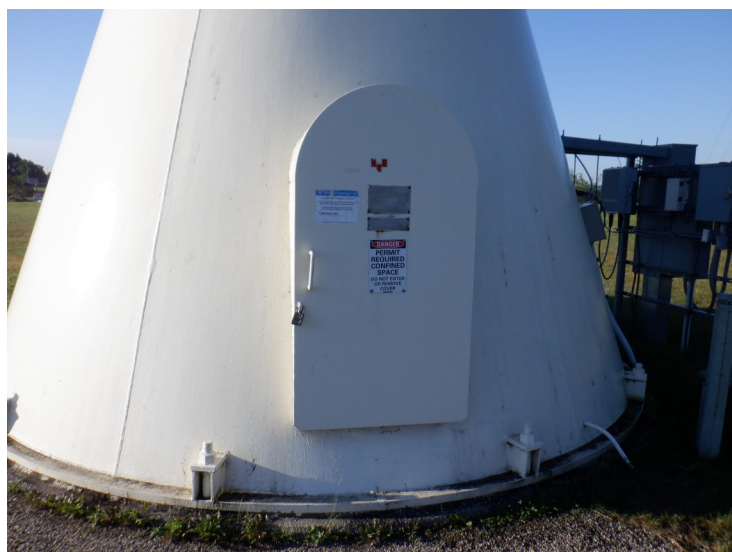
3) The service door operated properly during the inspection.

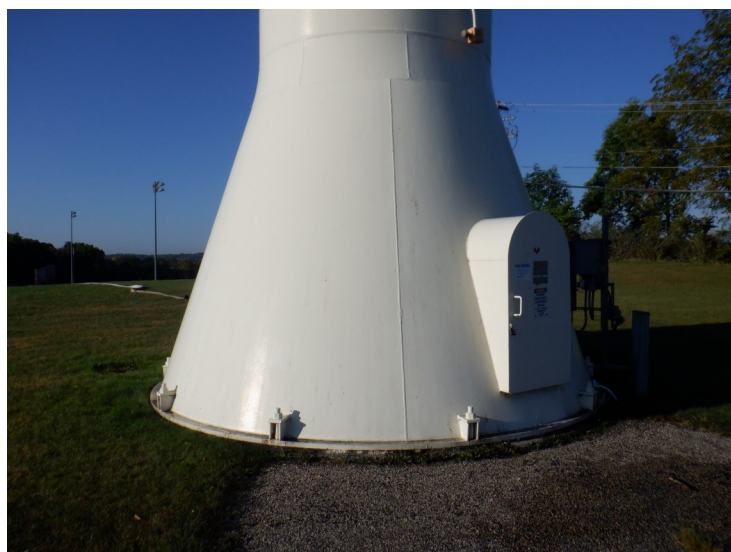
6) There are no coating failures on the basebell.

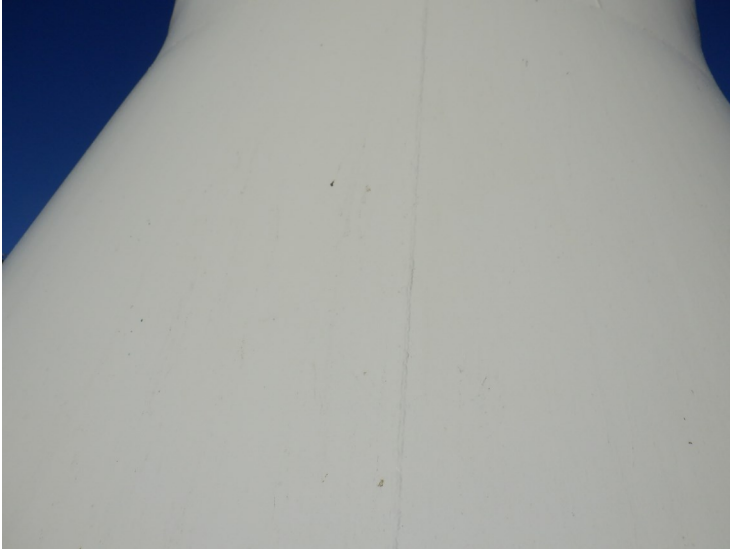
7) Same.

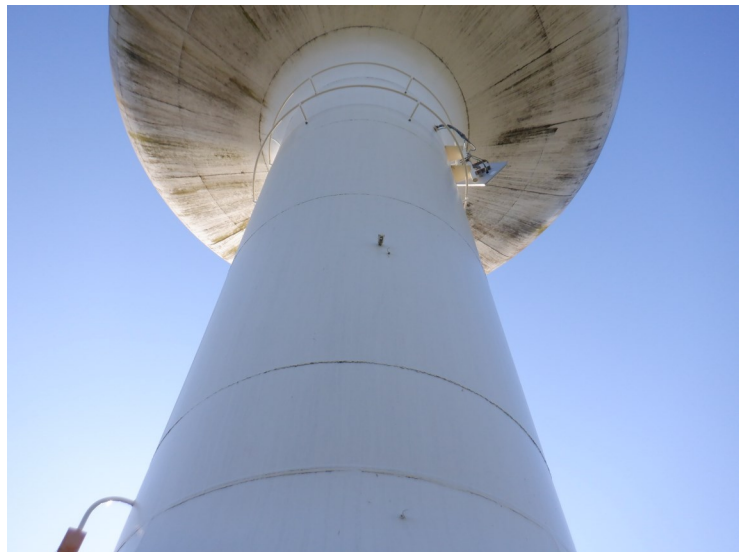
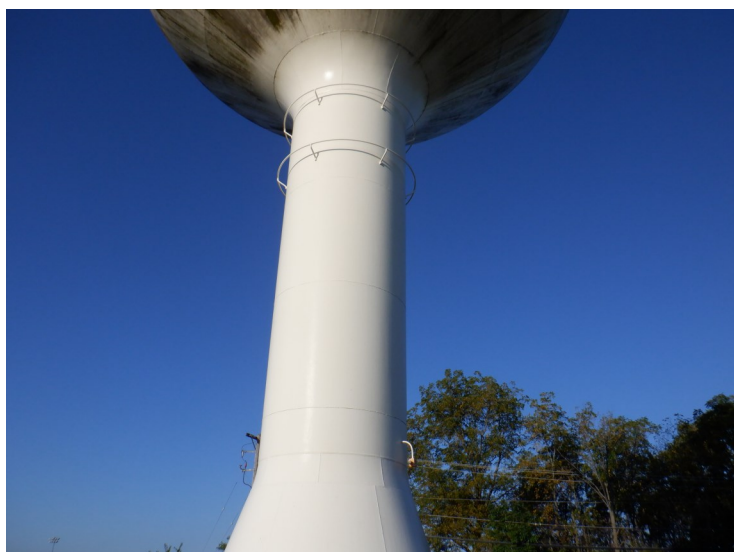
8) The riser coating is in good condition with no deterioration.

9) Same.

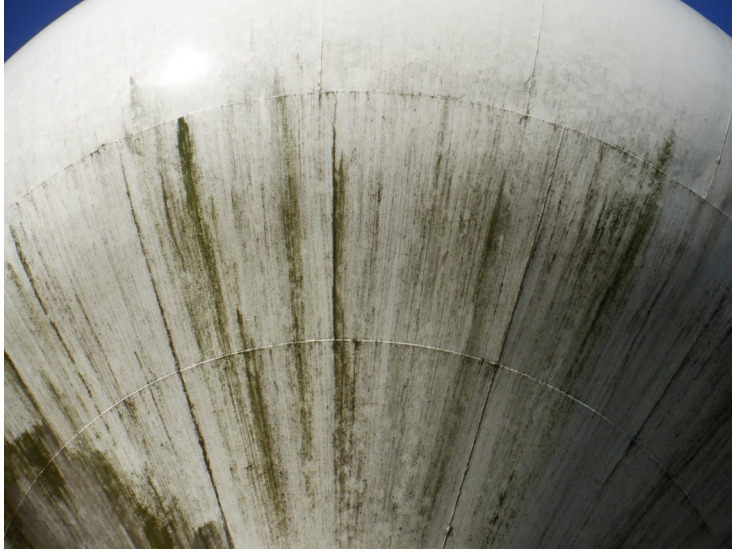
10) The bowl is covered with mildew growth but there are no visible coating failures.

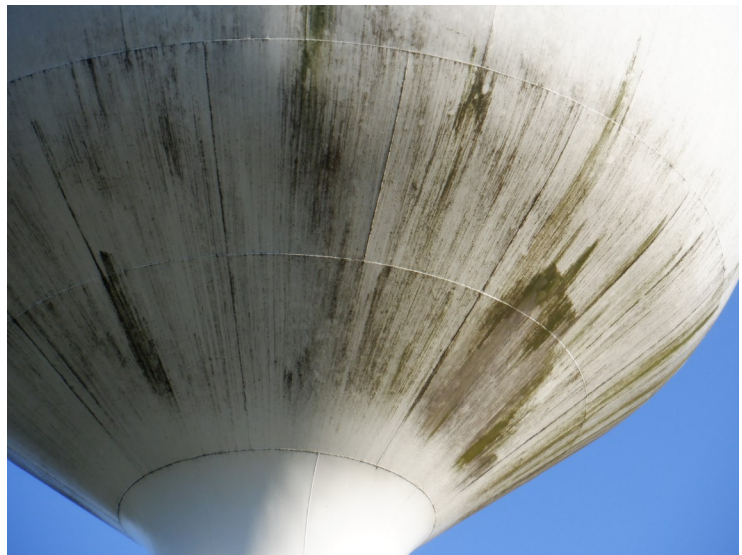
11) Same.

12) The sidewall coating is in good condition overall.

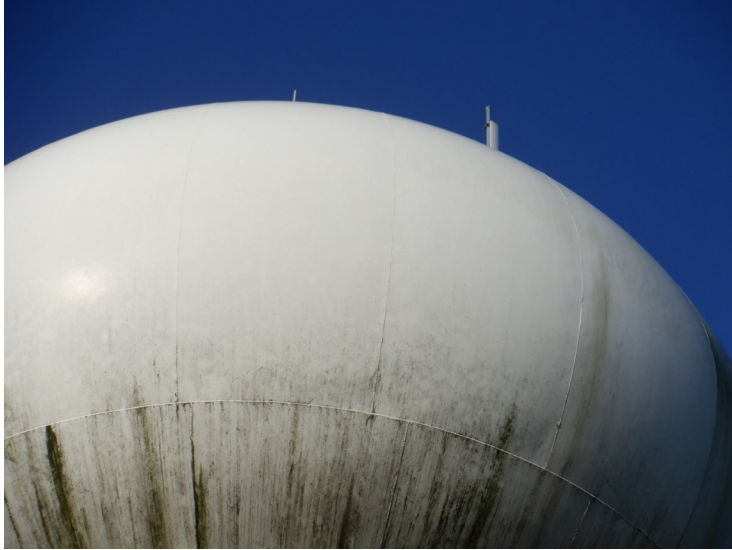
13) Same.

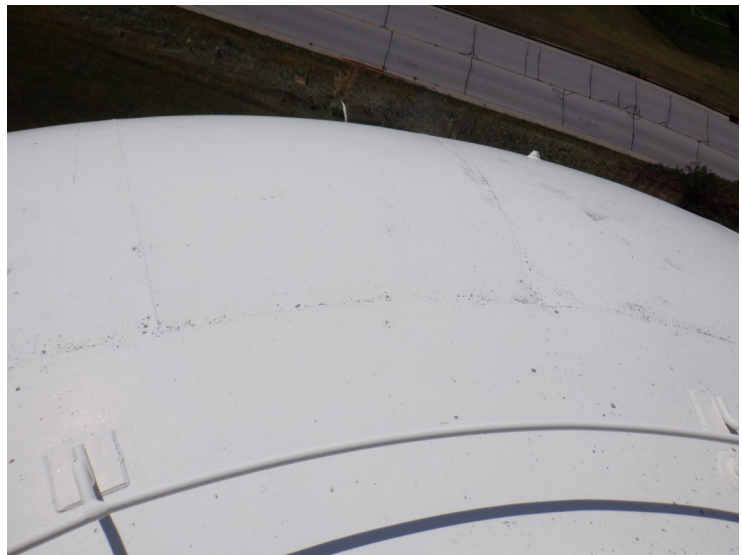
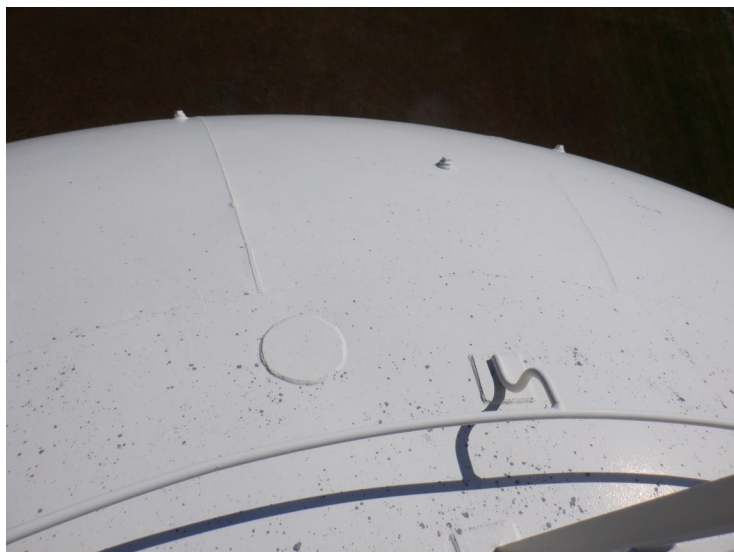
14) The roof coating has faded but there is no significant deterioration.

15) Same.

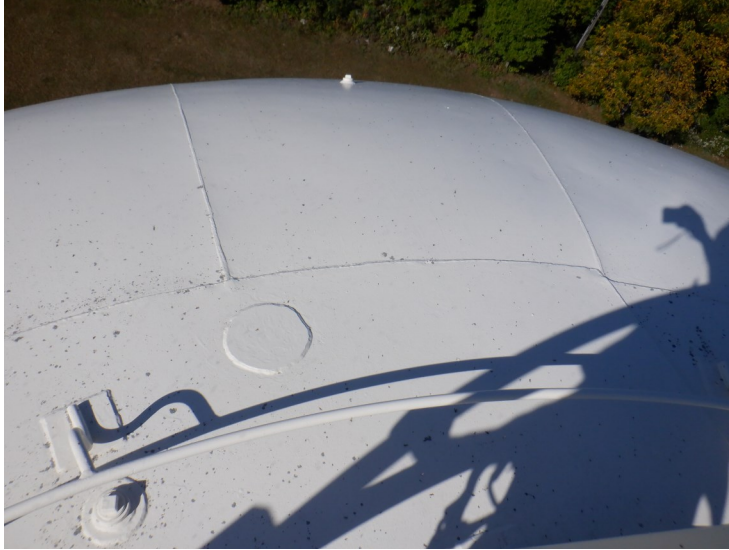
16) Same.

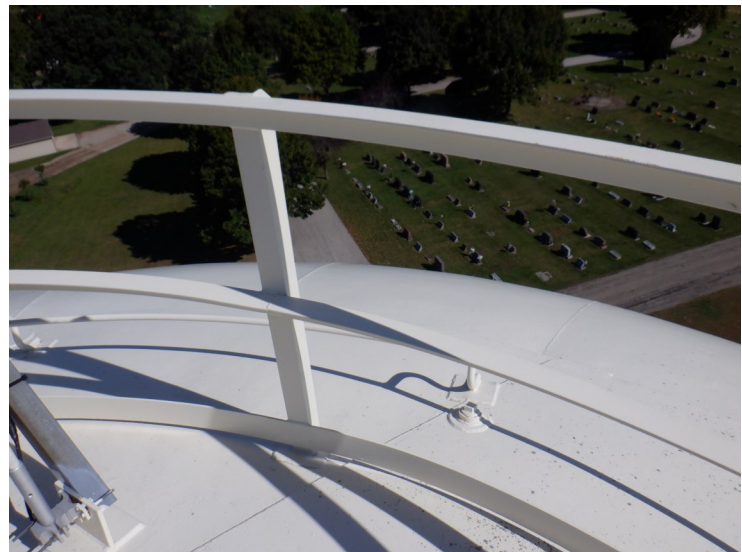
17) The roof handrail and painter's railing are in good condition.

18) The wet interior roof hatch is in good condition. A gasket was installed on the hatch during the inspection.

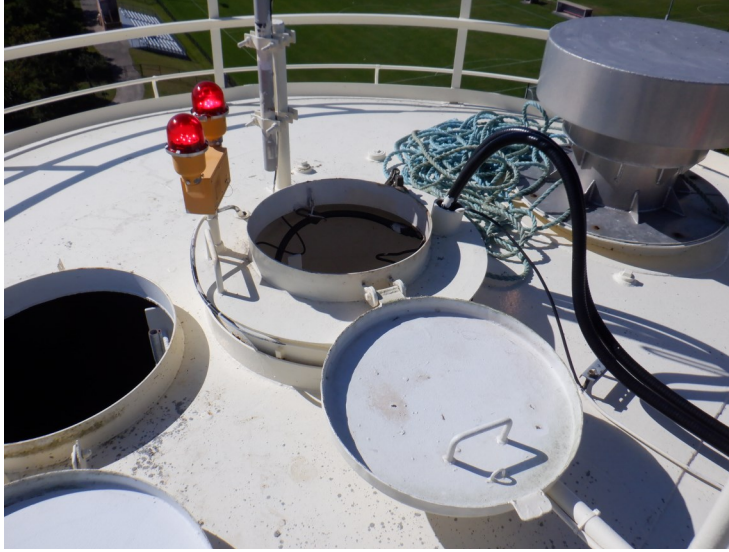
19) The dry interior roof hatch is in good condition.

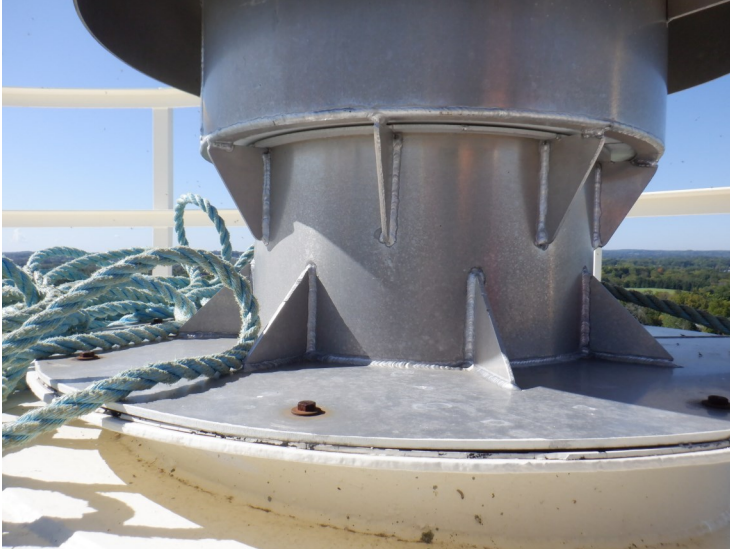
22) The roof vent pressure plate was properly aligned and free to move.

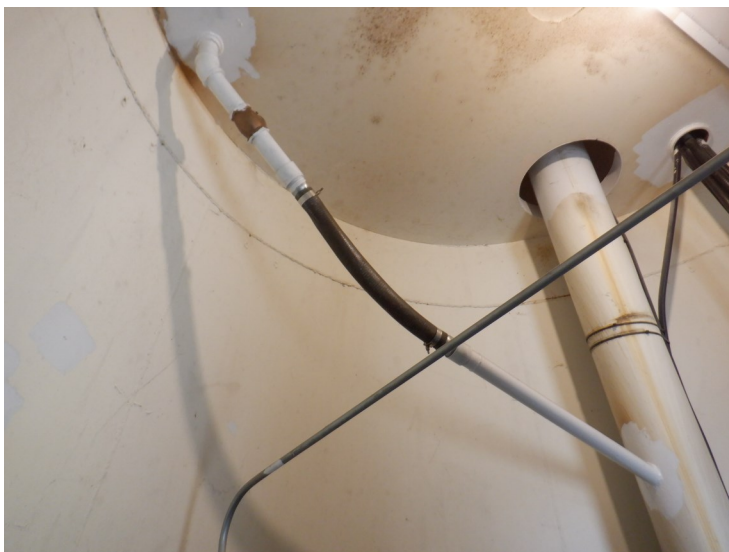
26) The dry interior basebell coating is in good condition overall with no significant deterioration.

27) Same.

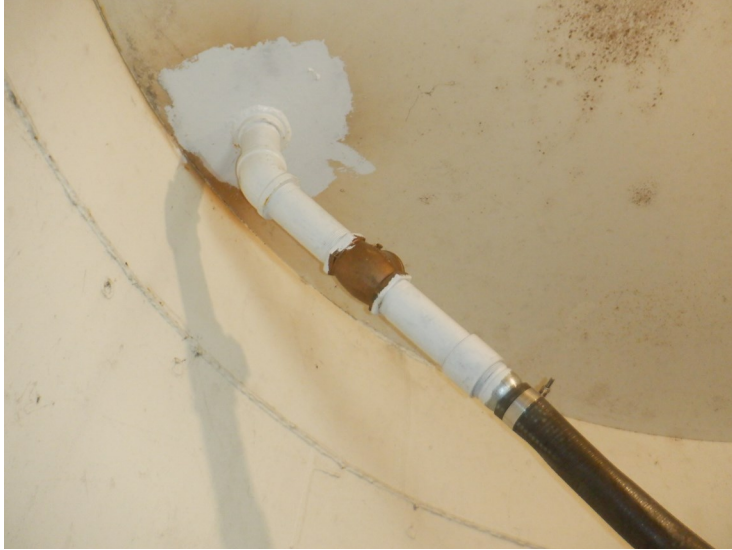
28) There is a check valve on the condensate platform drain.

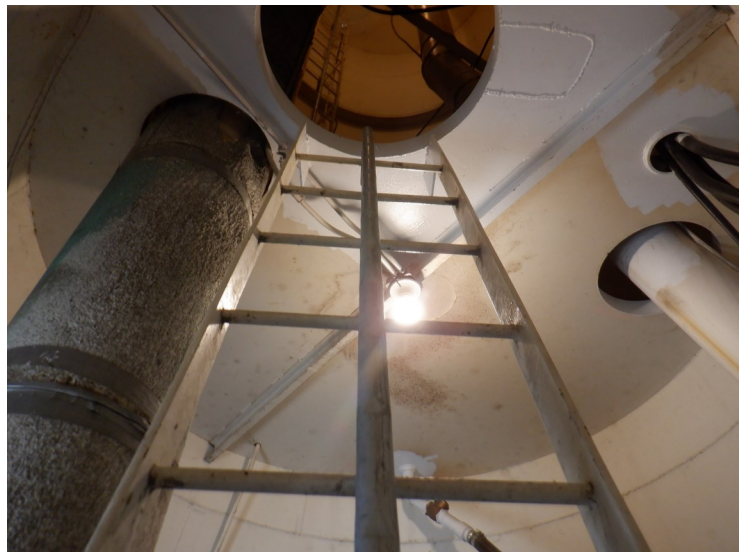
29) The baseball ladder is in good condition. The ladder is equipped with a fall prevention device.

30) The ladder opening at the condensate platform is equipped with a hinged cover.

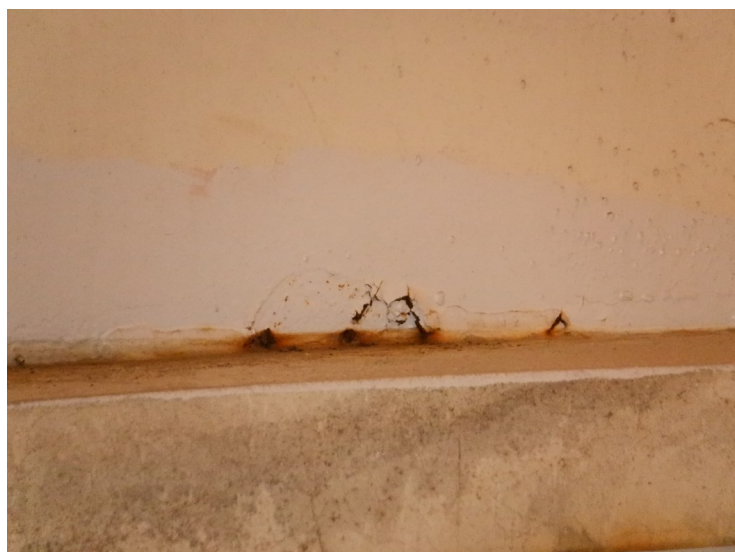
32) Same.

33) Coating failures along a stiffener in the dry riser.

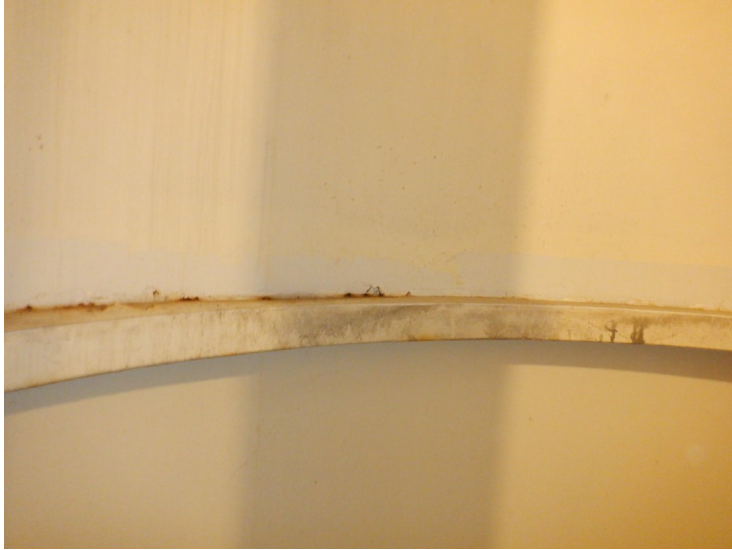
34) Same.

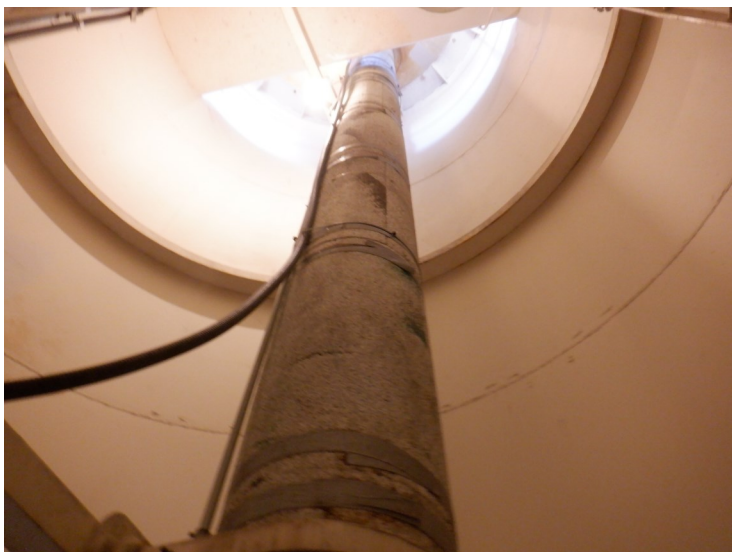
35) The dry riser coating is in good condition overall.

36) There is no cover over the fill/draw pipe insulation.

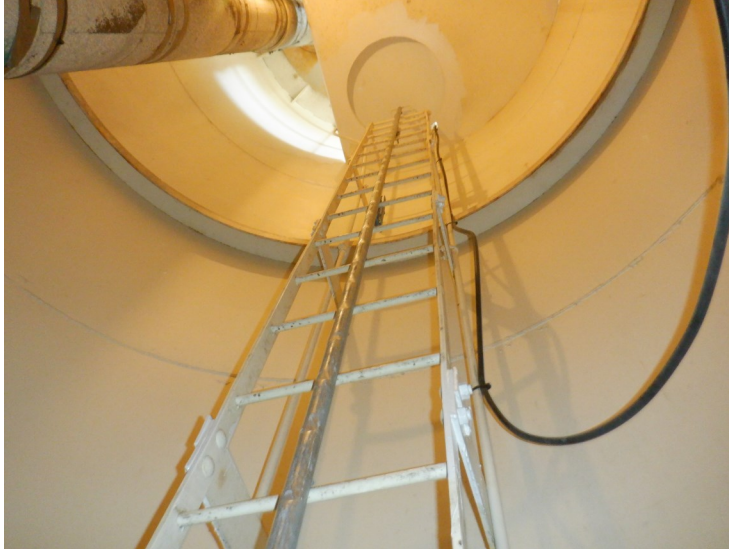
37) The riser ladder is in good condition. The ladder is equipped with a fall prevention device.

38) The ladder opening at the top platform is equipped with a hinged cover.

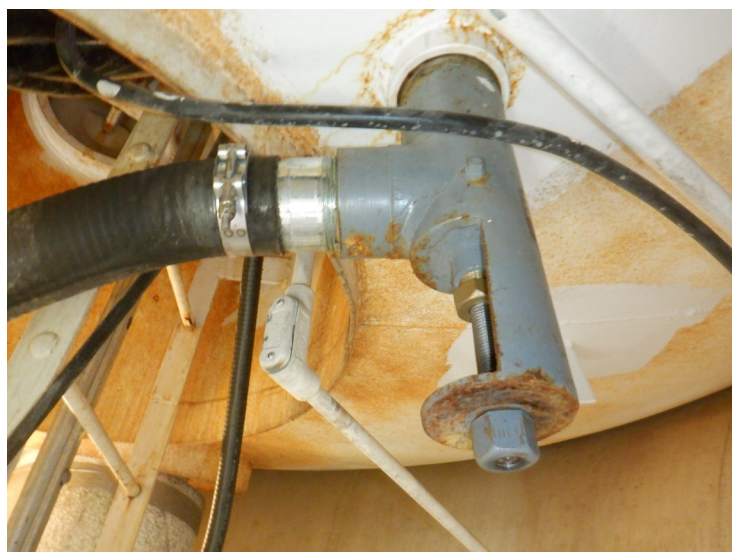
41) There is a handhold above the painter's hatch at the top of the riser.

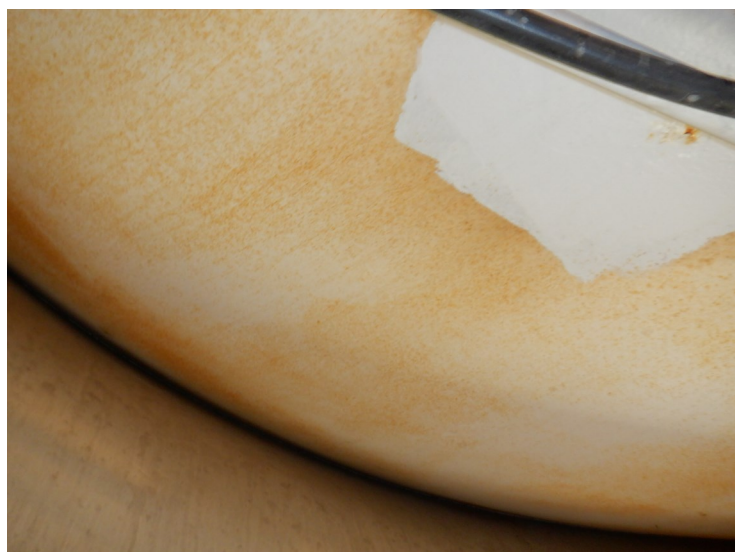
44) Extensive rust bleedthrough on the bowl.

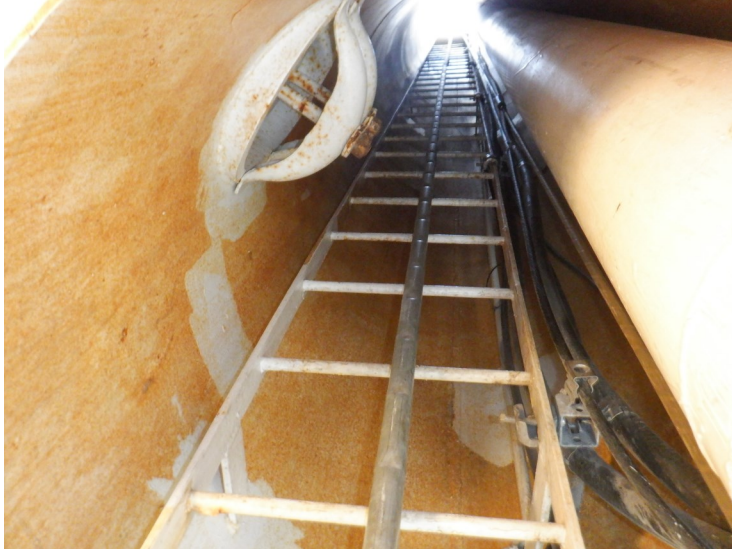
48) Coating failures on the wet interior manway.

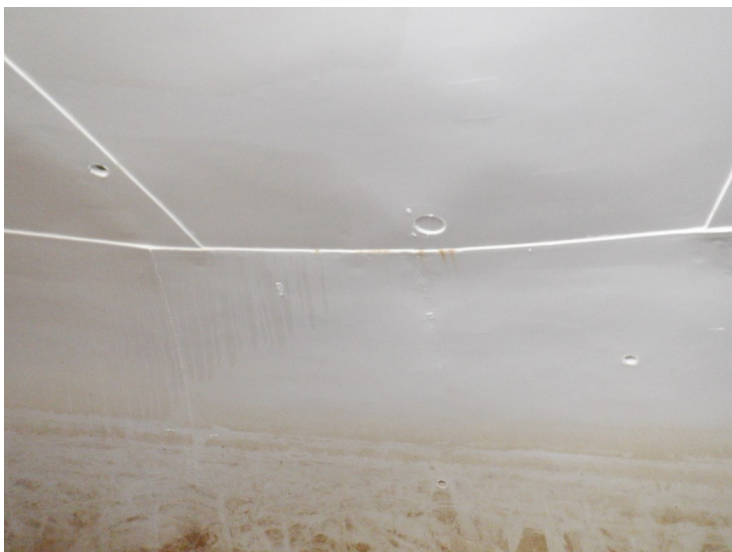
50) Coating on the wet interior roof is in good condition with no significant deterioration.

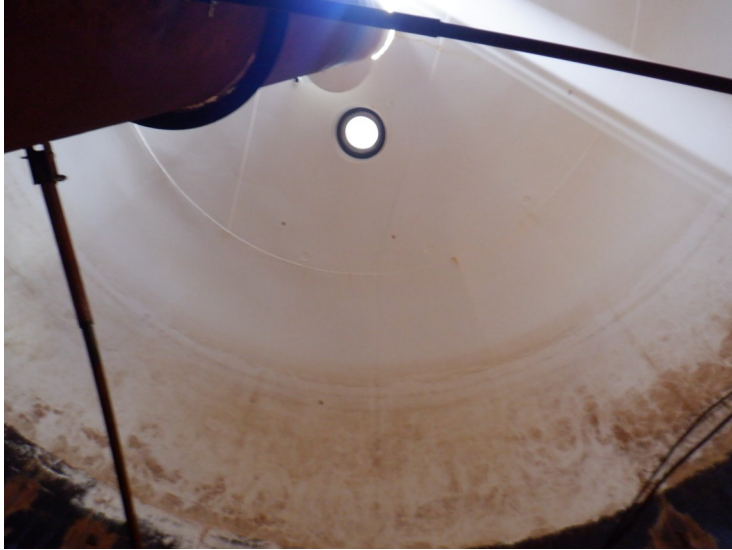
51) Same.

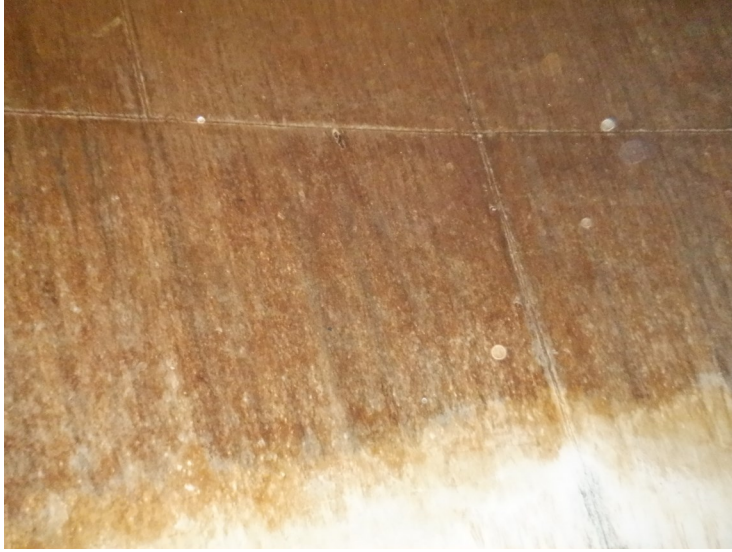
54) Same.

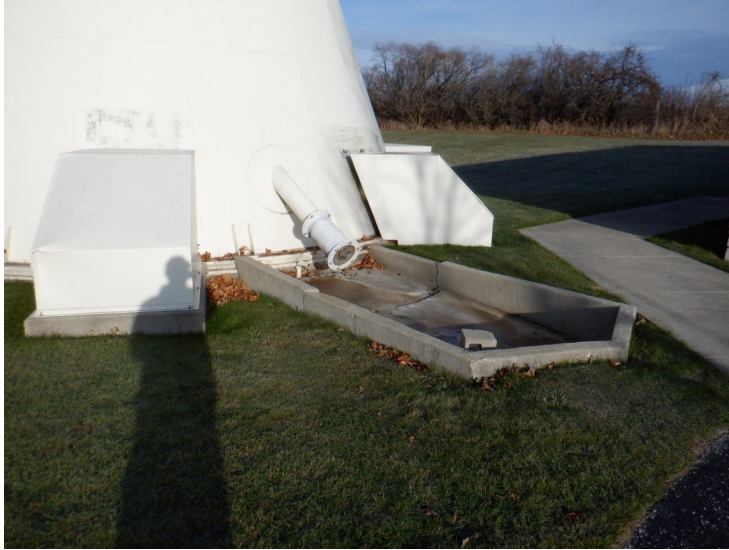
3) The service door operated properly during the inspection.

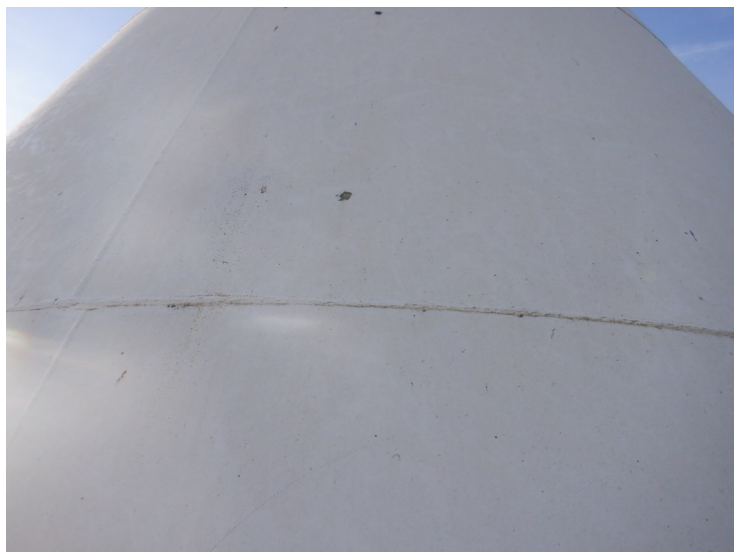
8) Same.

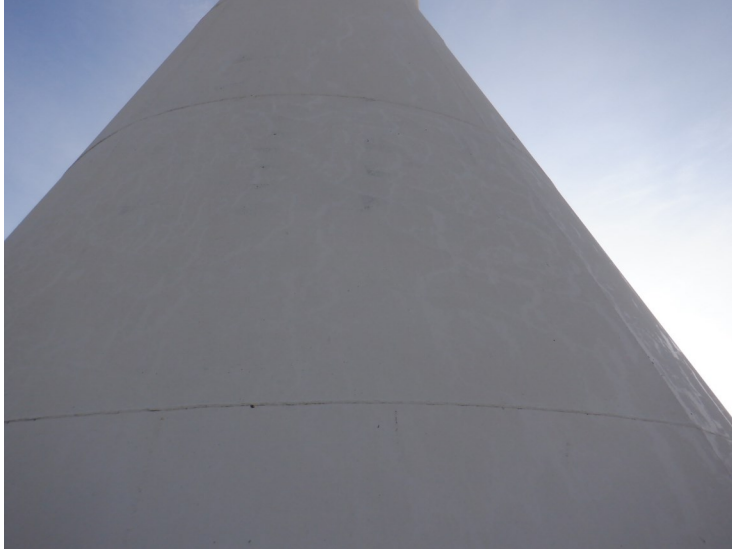
9) Same.

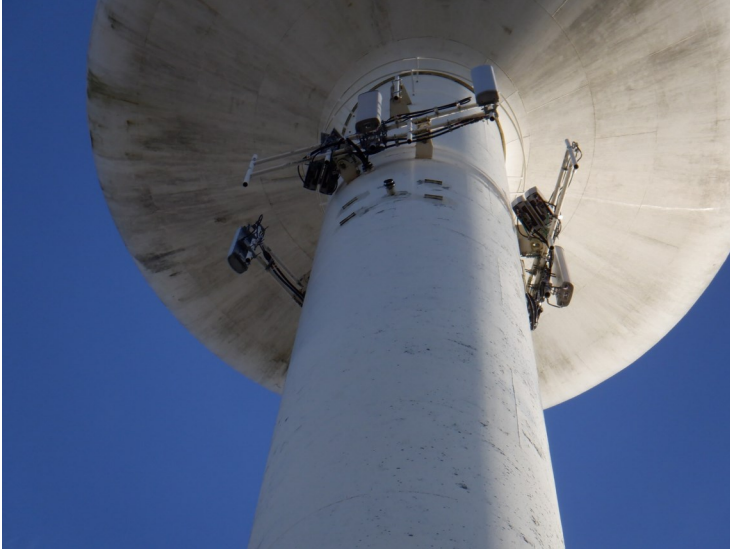
12) The riser coating is in good condition overall.

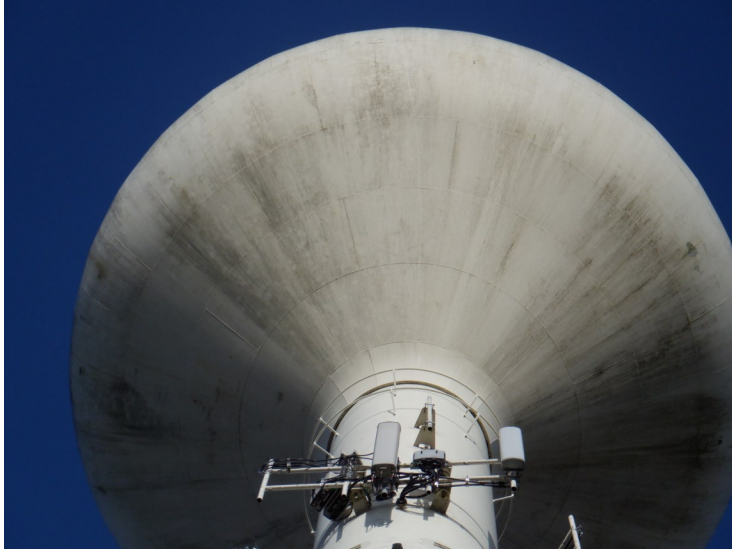
16) The bowl is covered with moderate mildew growth.

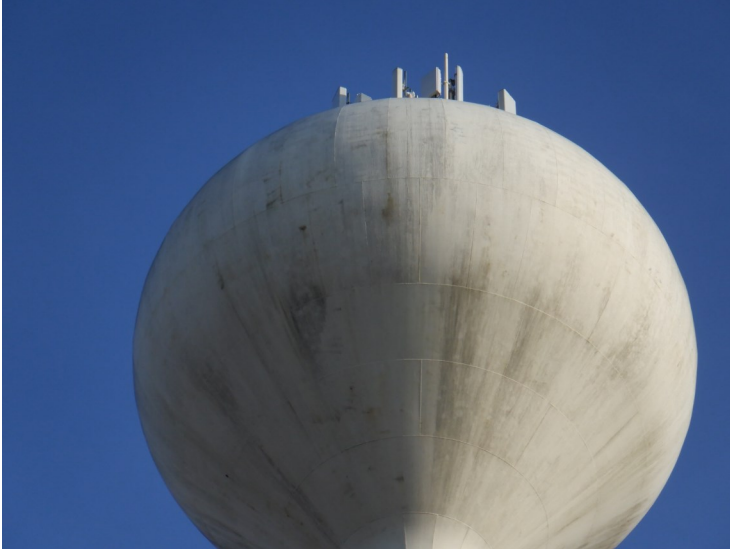
19) Same.

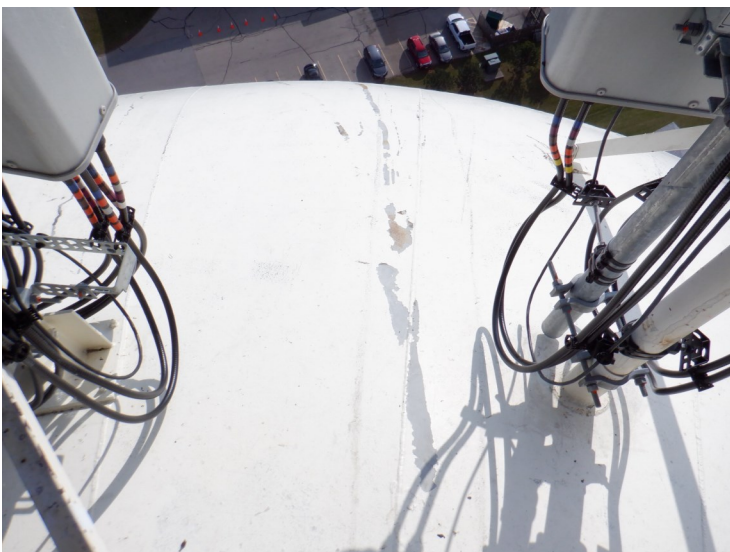
21) Same.

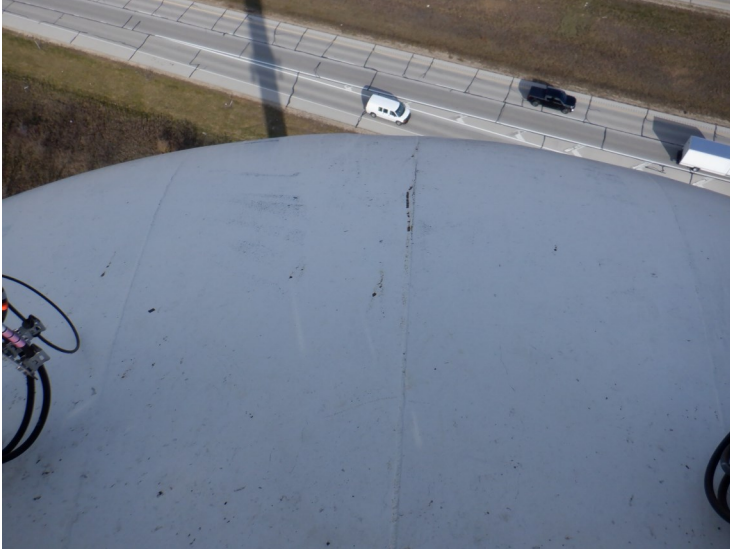
22) Same.

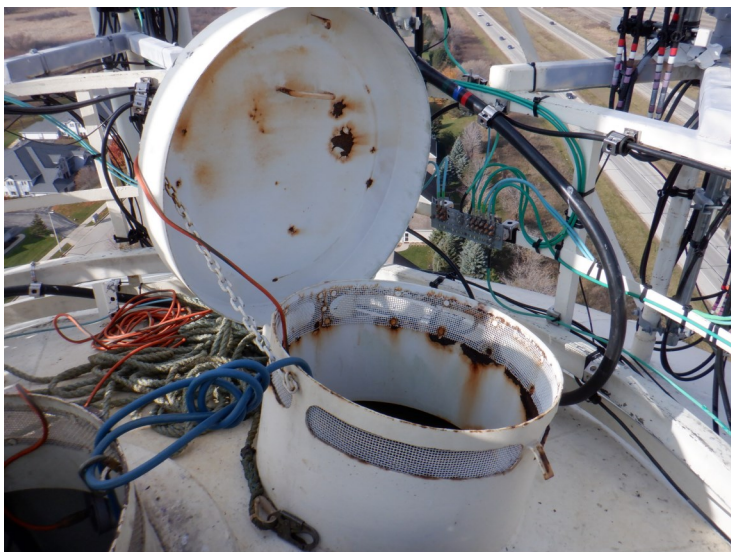
24) There is not a gasket on the wet interior roof hatch.

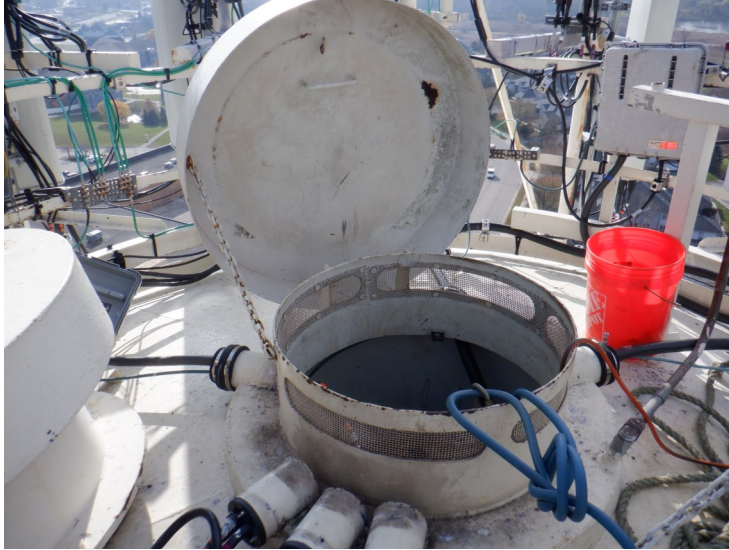
25) The dry interior roof hatch is in good condition.

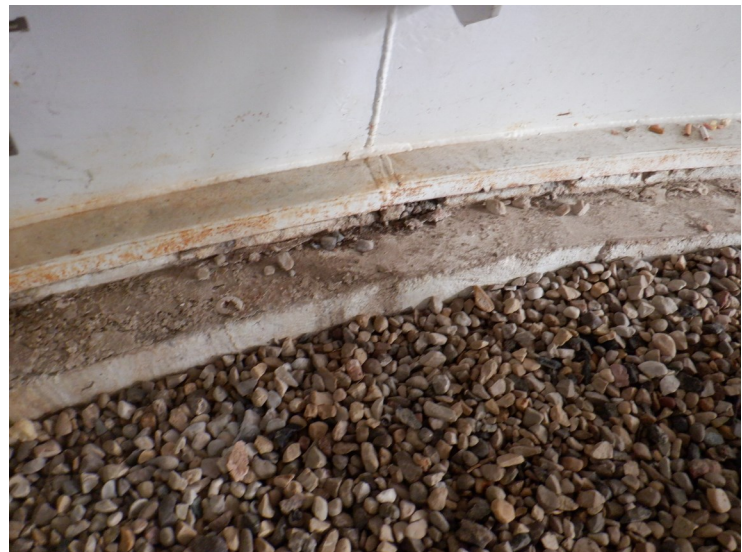
30) The dry interior basebell coating is in good condition overall.

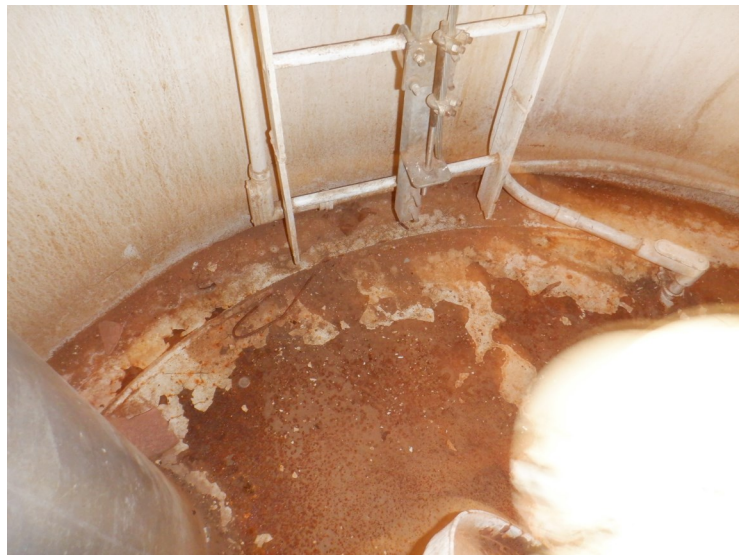
36) Same.

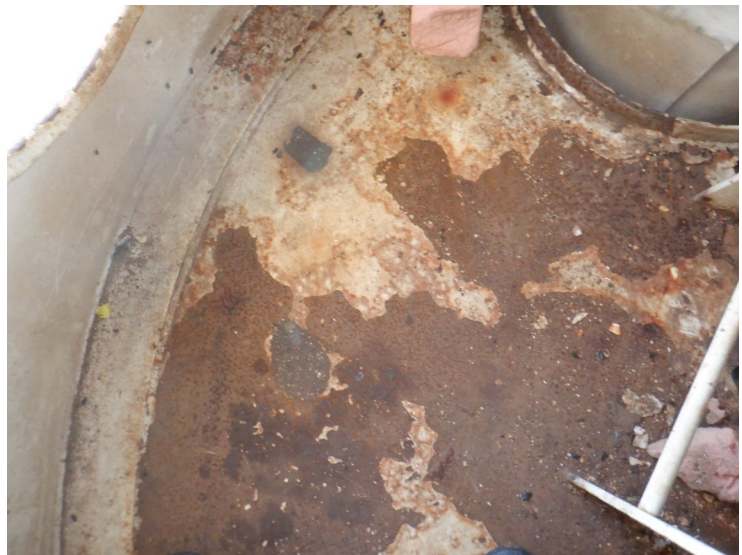
45) Rust bleedthrough on the transition cone.

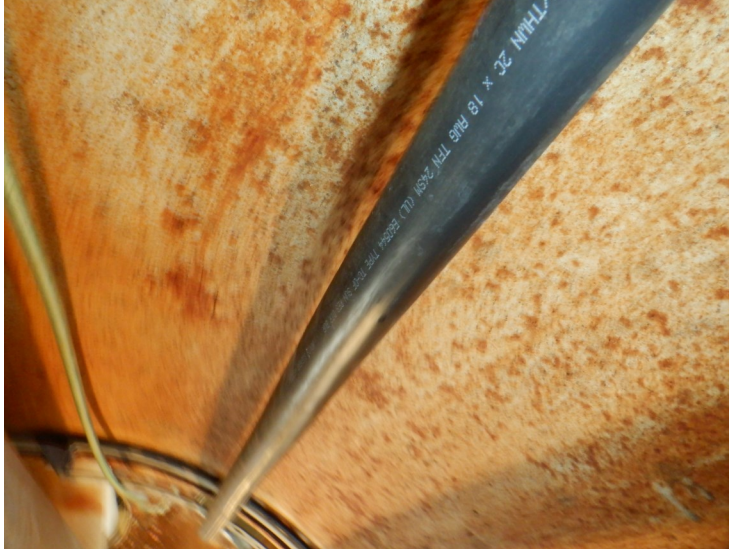
49) Same.

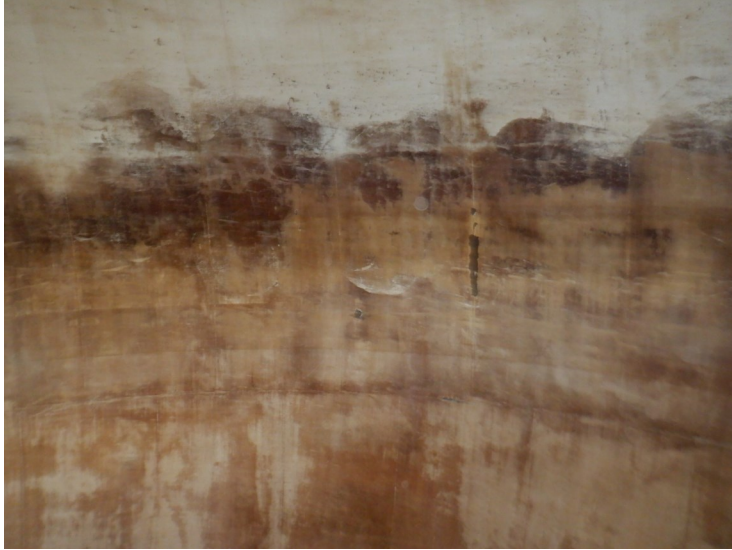
55) Same.

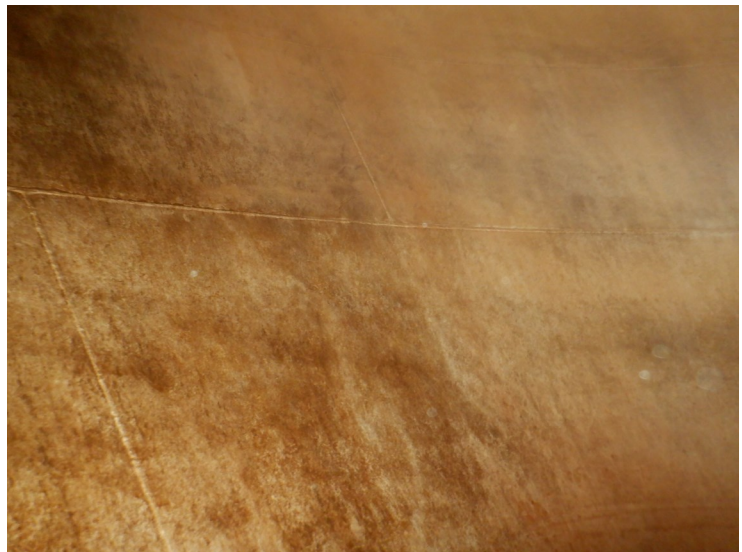
62) Same.

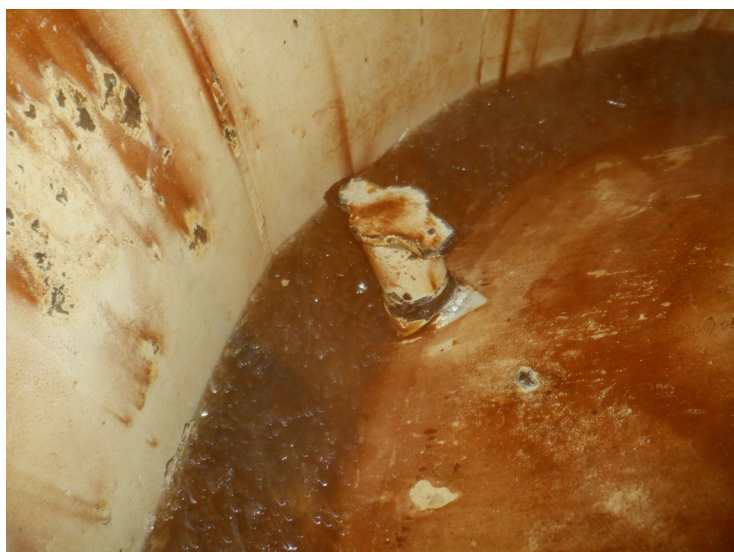
63) There is a threaded drain plug in the bowl.me.

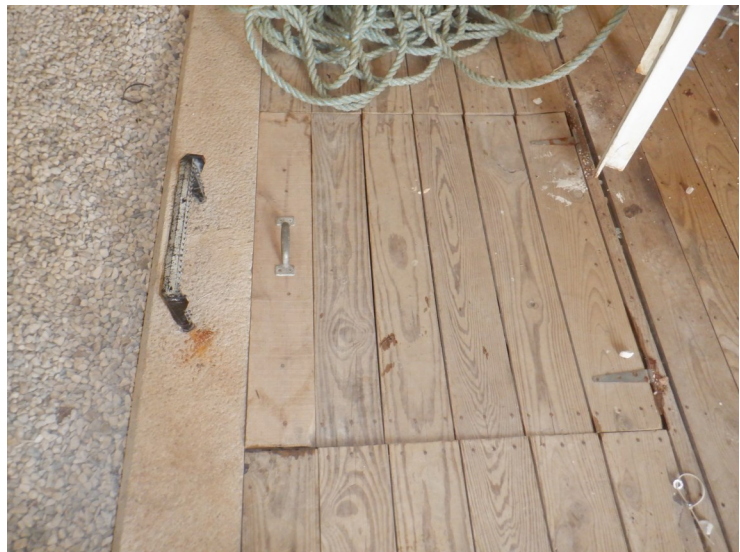
65) The wooden cover on the pit is in good condition.

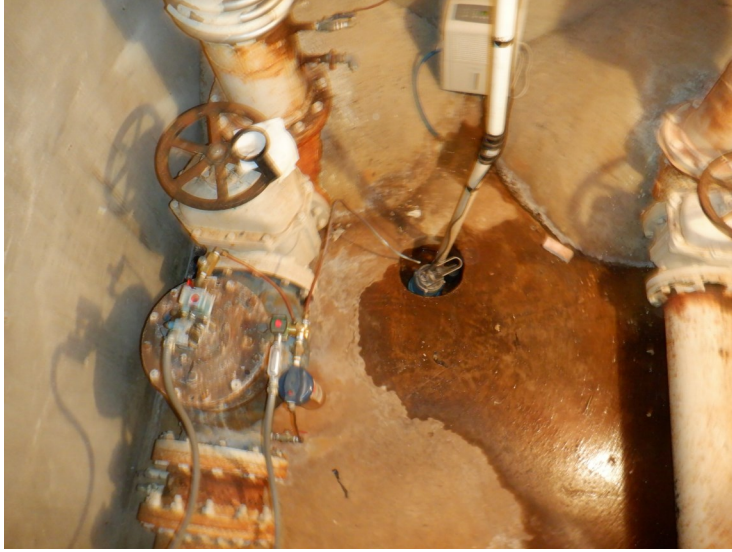
67) Same.

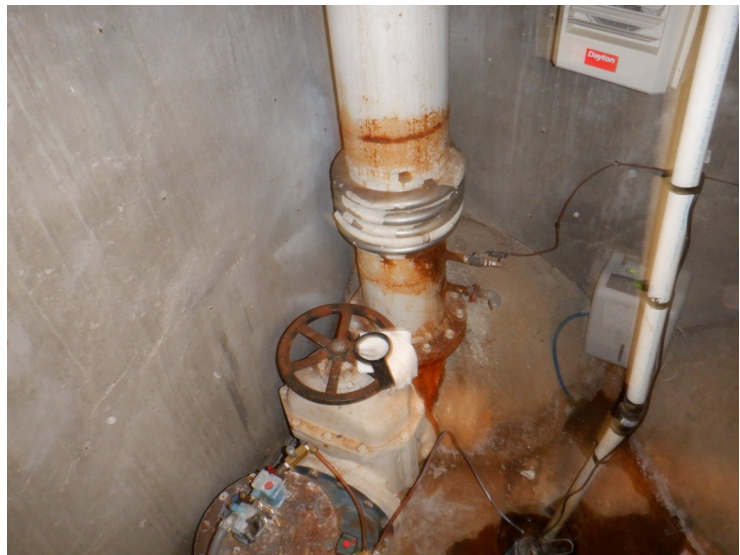
68) The bellow type expansion joint is in good condition.

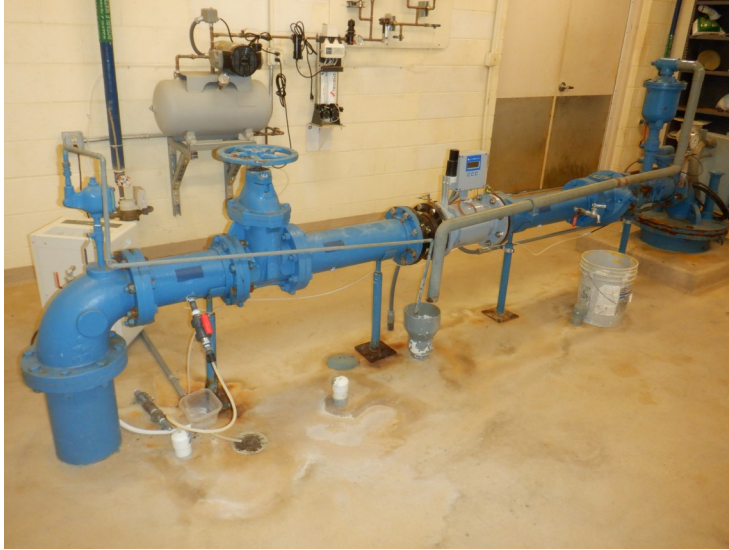
70) Same.

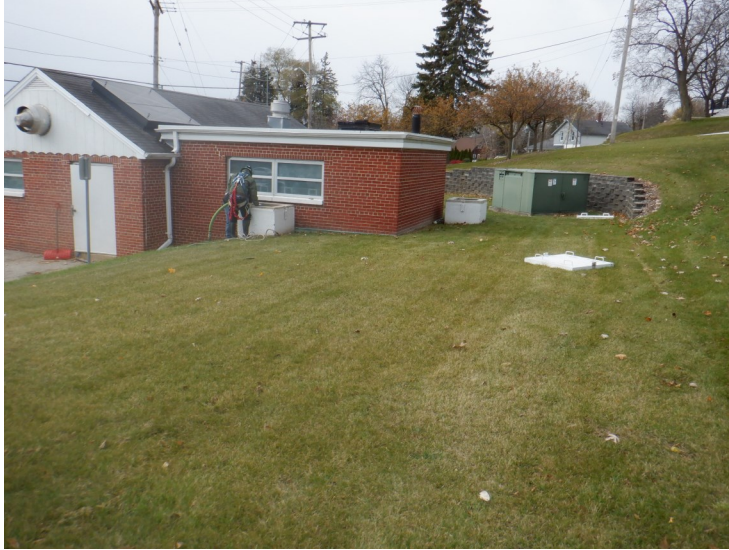
1) 125,000 gallon underground concrete water storage reservoir (Well 2) owned by the Village of Pewaukee, Wisconsin.

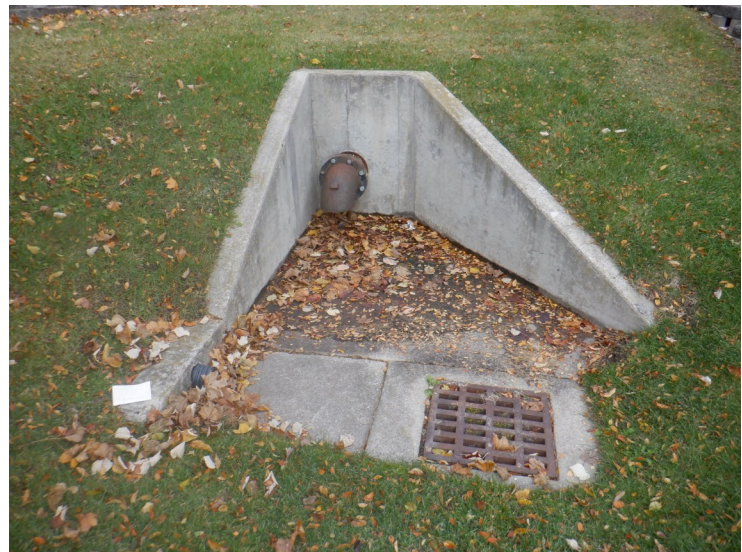
The exterior metal appurtenances include the roof hatches, overflow pipe, and roof vent. The roof hatches are coated. The coating is in fair condition. The coating on the overflow pipe is in poor condition. The roof vent is not coated.

2) The overflow pipe discharges to a catch basin.

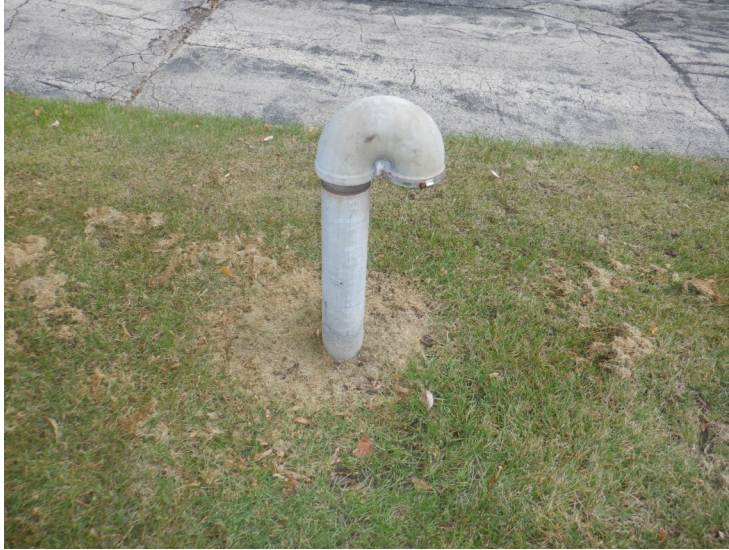
4) The goose neck roof vent is in good condition.

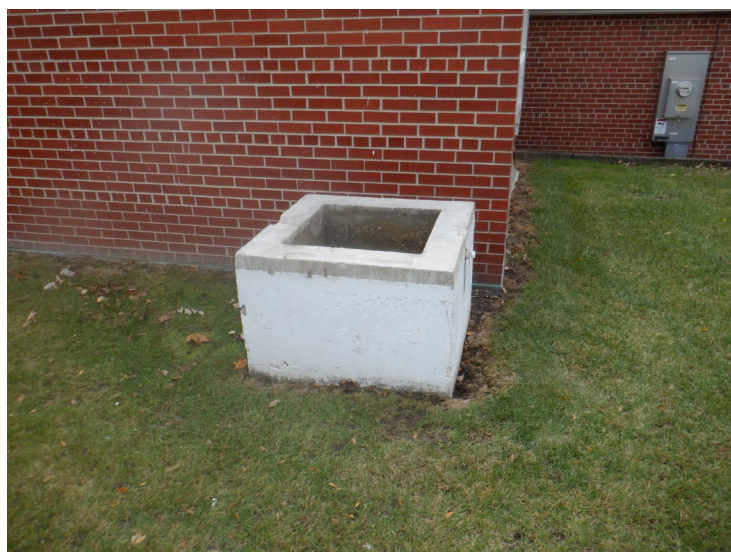
6) The roof hatch curb is more than 24 inches above grade.

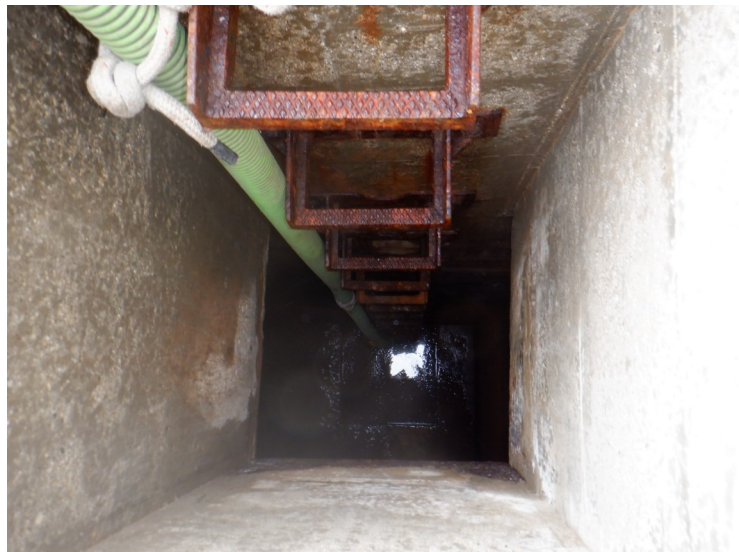
8) The ladder cleats from the roof to the floor are in good condition.
