# Water System Master Plan

*April 2022*

**PREPARED FOR:**  
**Village of Pewaukee**  
235 Hickory Street  
Pewaukee, WI 53072

**PREPARED BY:**  
**Ruekert & Mielke, Inc.**  
W233 N2080 Ridgeview Parkway  
Suite 300  
Waukesha, WI 53188

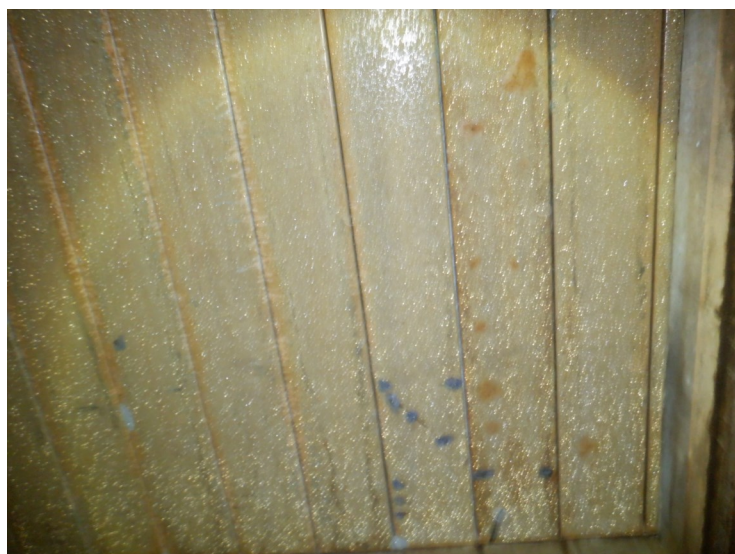
The roof is in good condition overall with no significant deterioration. There is some rusting at the surface from rebar chair bases and rebar.

9) Rusting at the surface of the wet interior roof.

Abrasive blast clean the exposed rebar in the wet interior and coat with an epoxy system. The repair is intended to extend the life of the structure by protecting the exposed rebar. The exposed rebar is due to lack of concrete cover during construction. The rebar near the surface has expanded and created a spall exposing the steel. There may be more exposed areas that will appear in the future. The estimated cost is \$5,000.

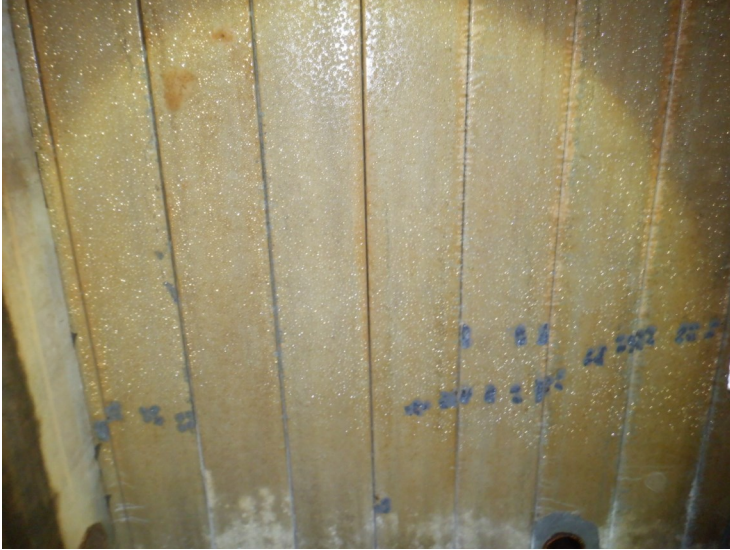
10) Same.

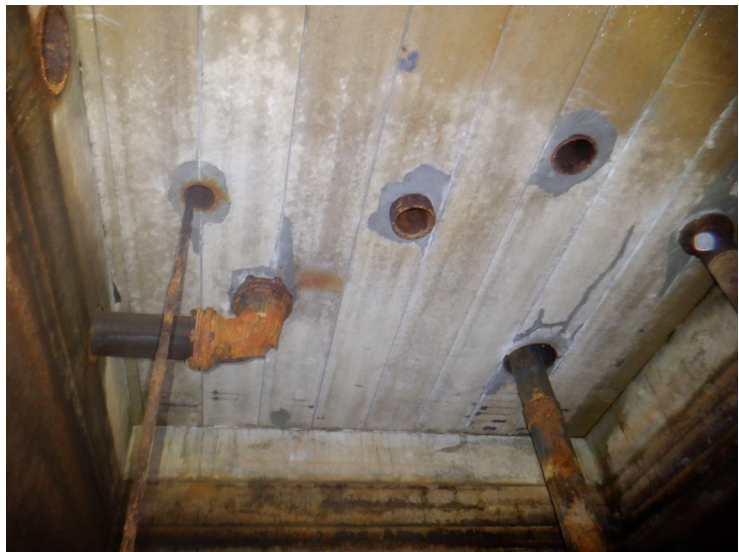
11) The fill pipe stubs at the wet interior roof.

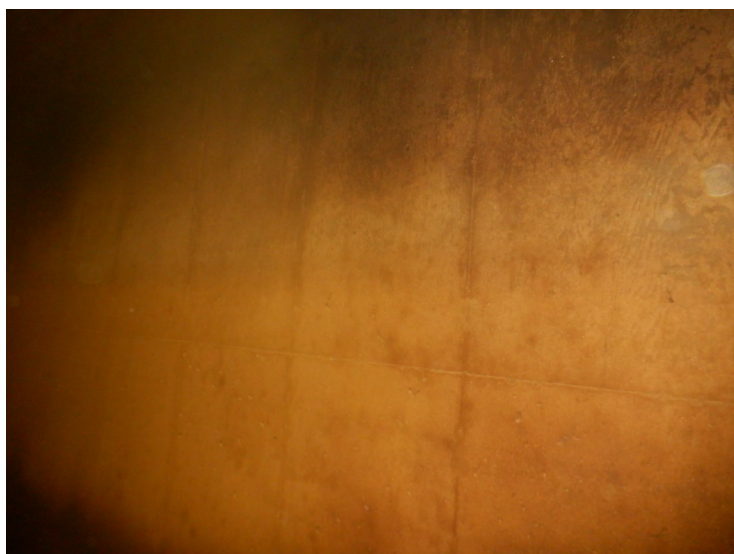
12) The concrete sidewalls are in good condition with no significant deterioration.

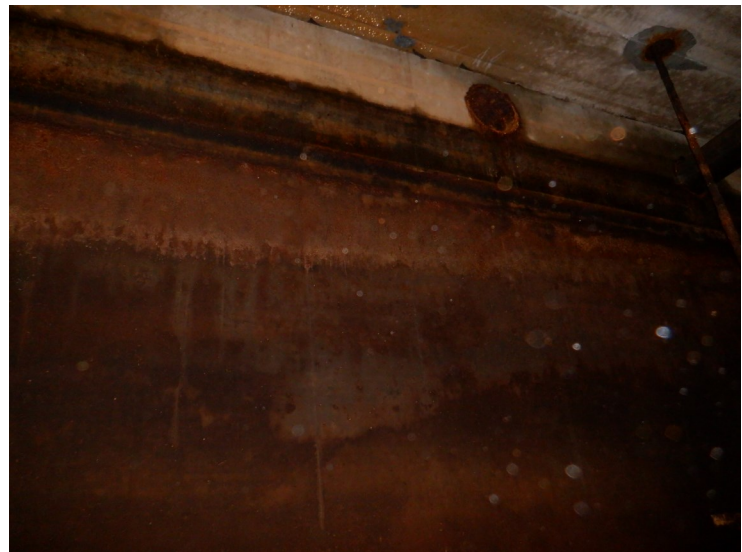
14) Same.

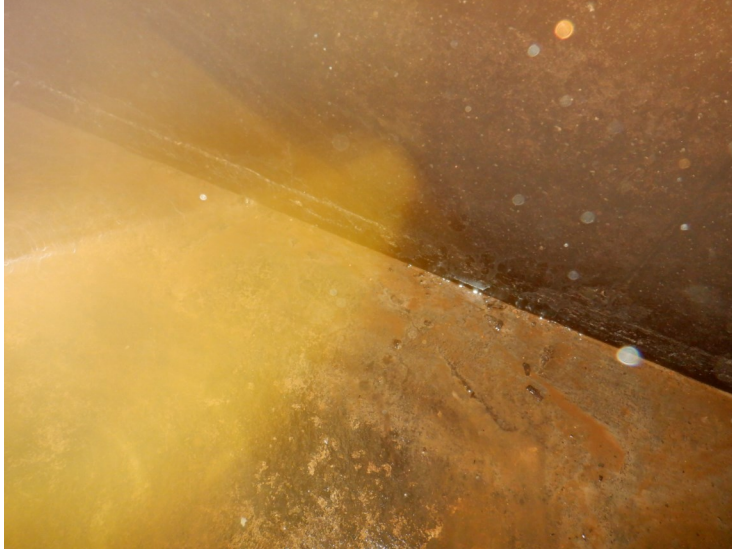
16) The wall to floor joint is in good condition.

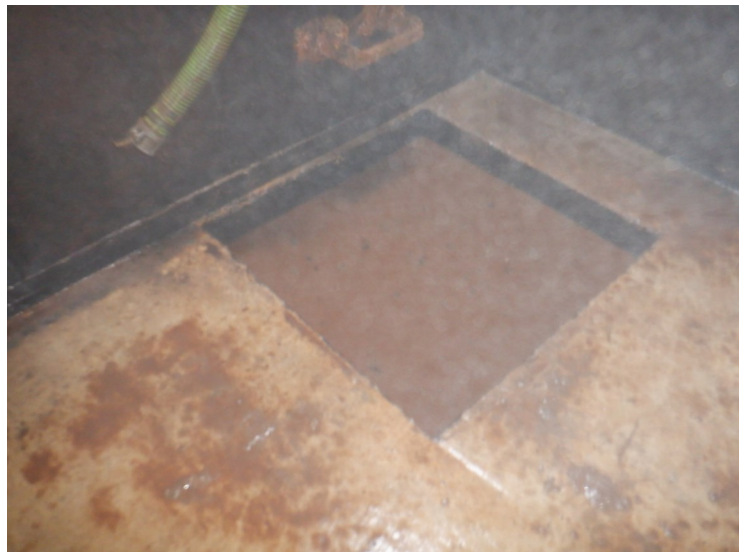
17) There is no deterioration of the concrete floor.

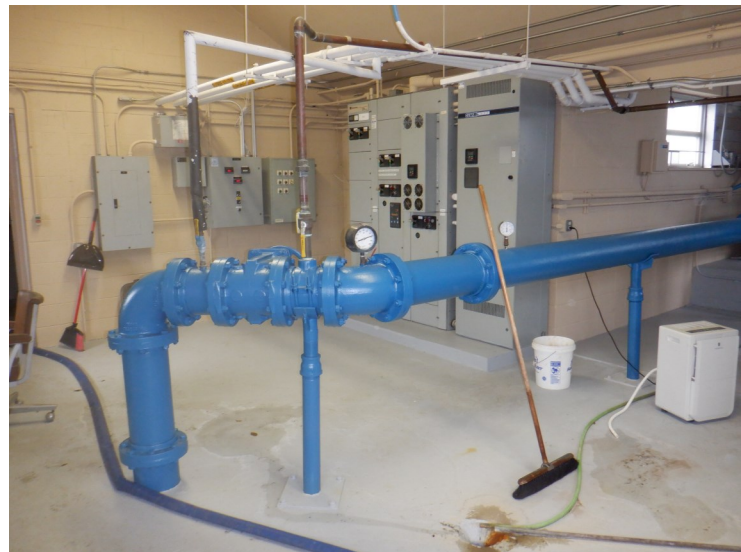
20) Same.

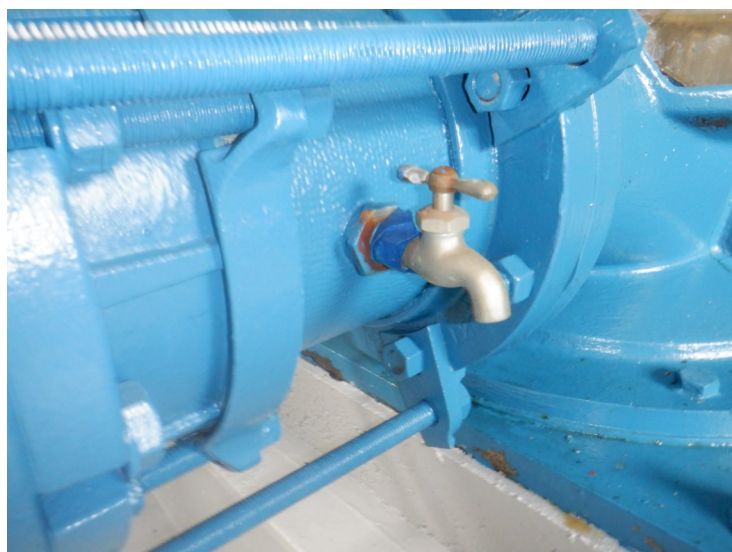
21) The sample tap in the pumphouse is in good condition.

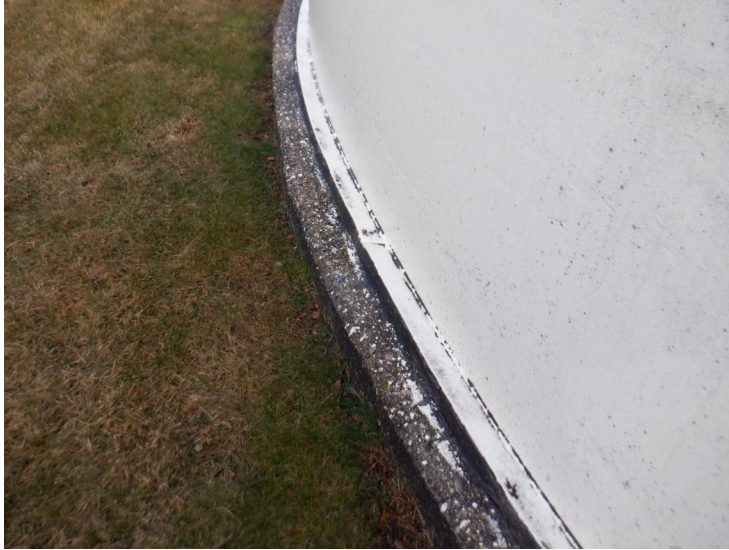
1) The foundation is in good condition overall.

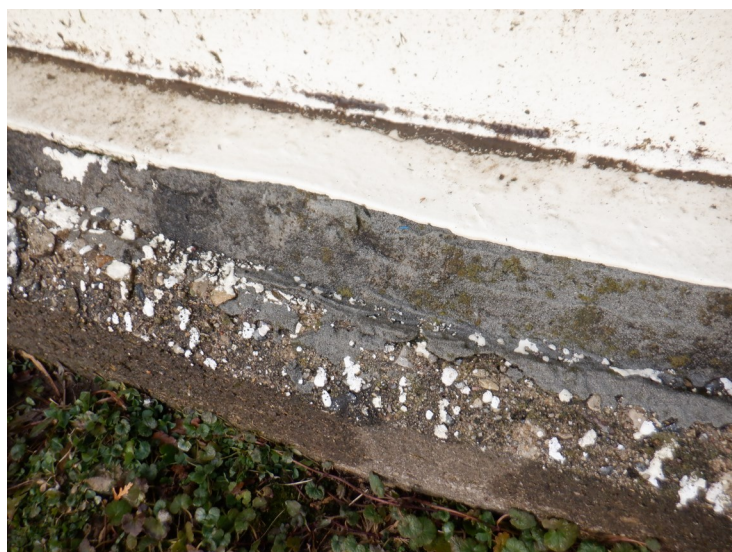
3) The grout between the baseplate and the foundation is in good condition with none missing or damaged.

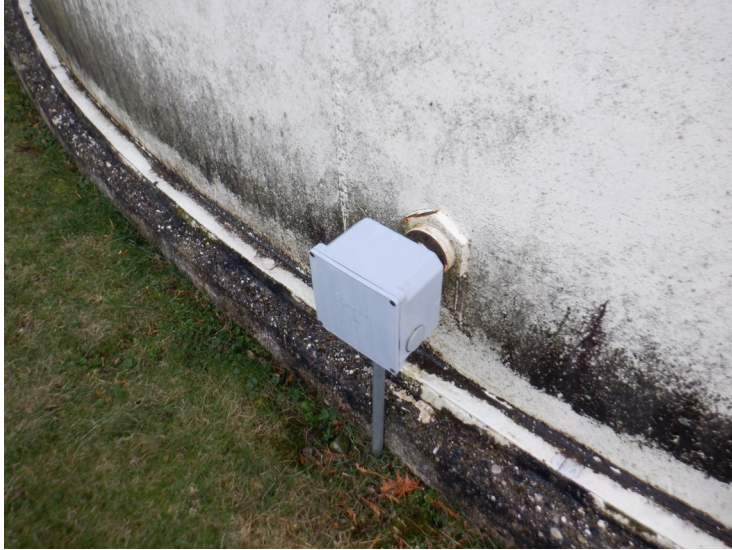
4) The cathodic protection pressure fitting is in good condition.

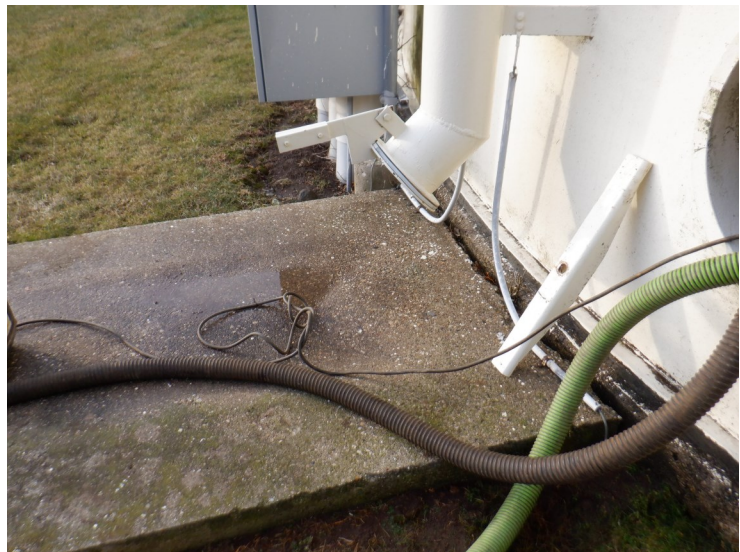
5) The overflow pipe discharges to a concrete splash pad.

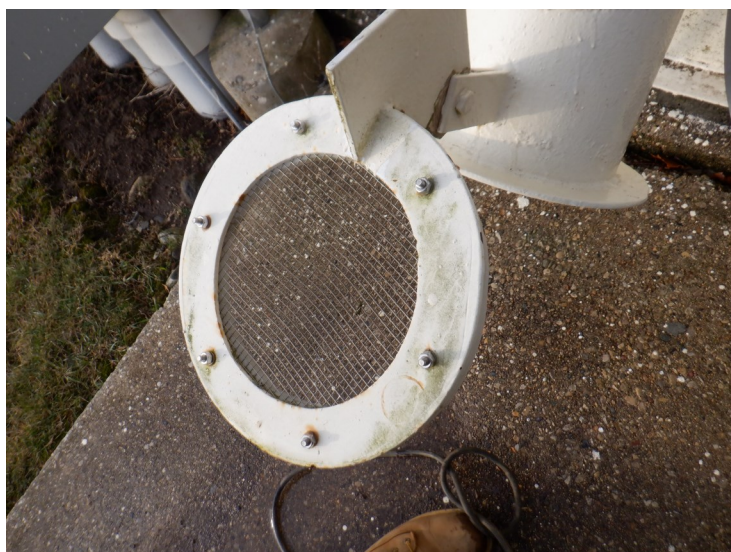
6) The screened flap gate is in good condition.

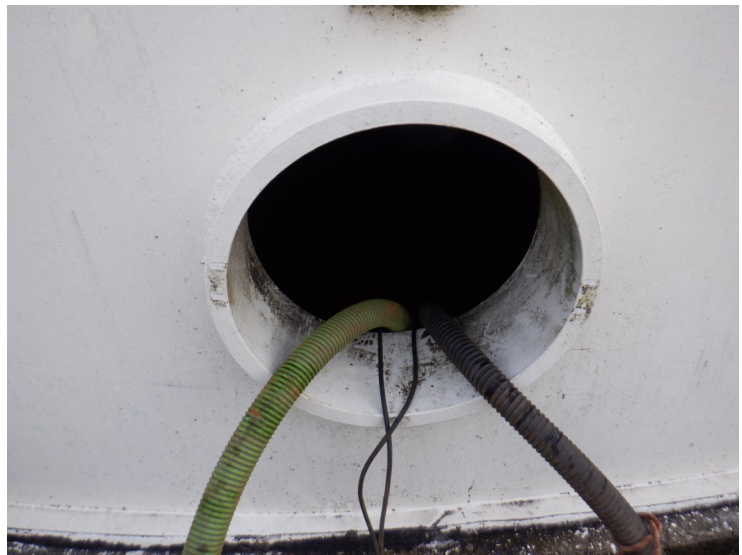
8) The two sidewall manways are in good condition.

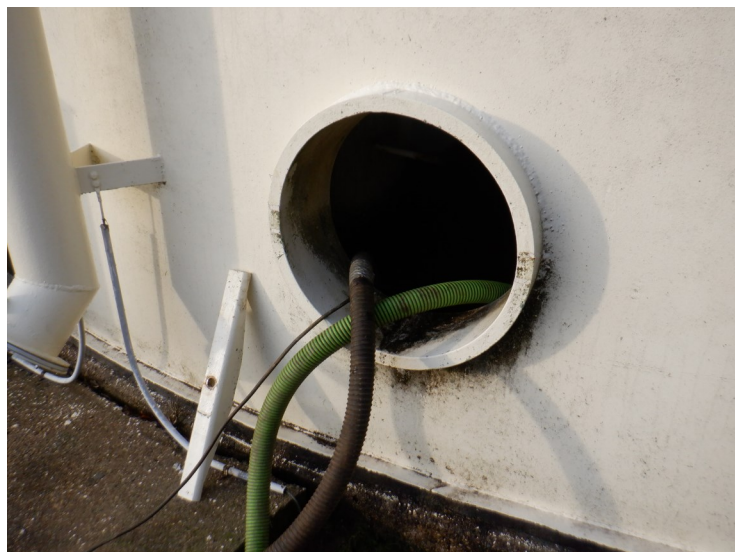
9) Same.

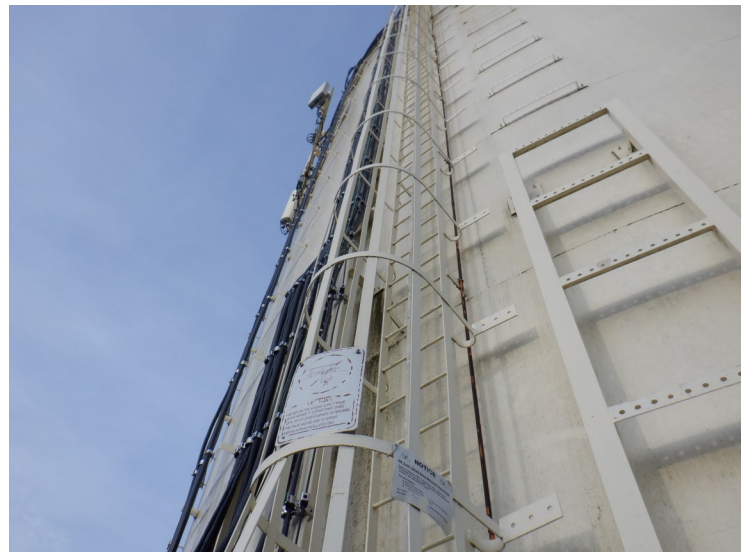
10) The sidewall ladder vandal guard is in good condition.

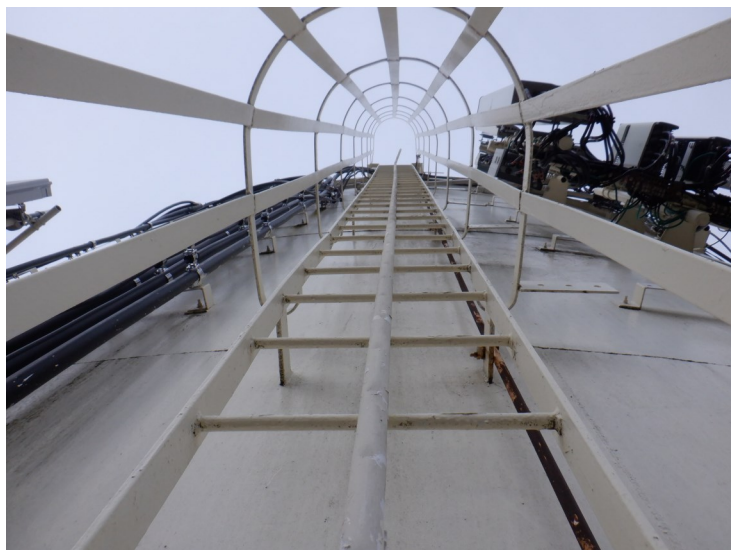
11) The sidewall ladder and cage are in good condition.

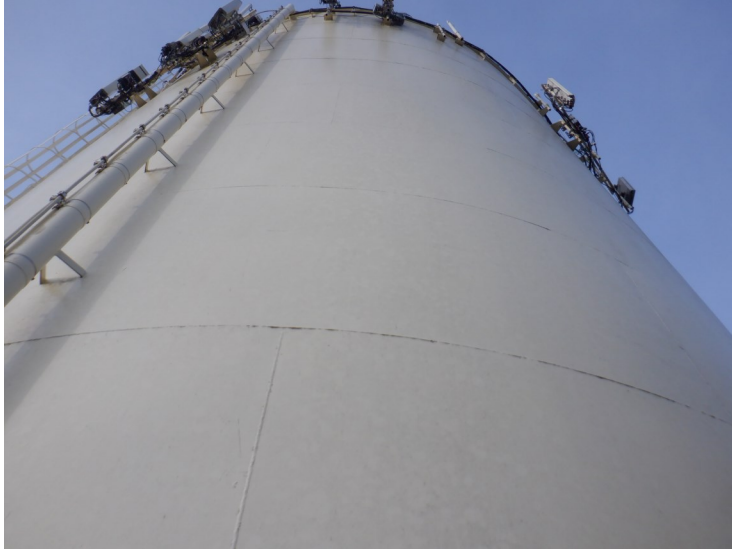
12) The sidewall ladder fall prevention device is coated.

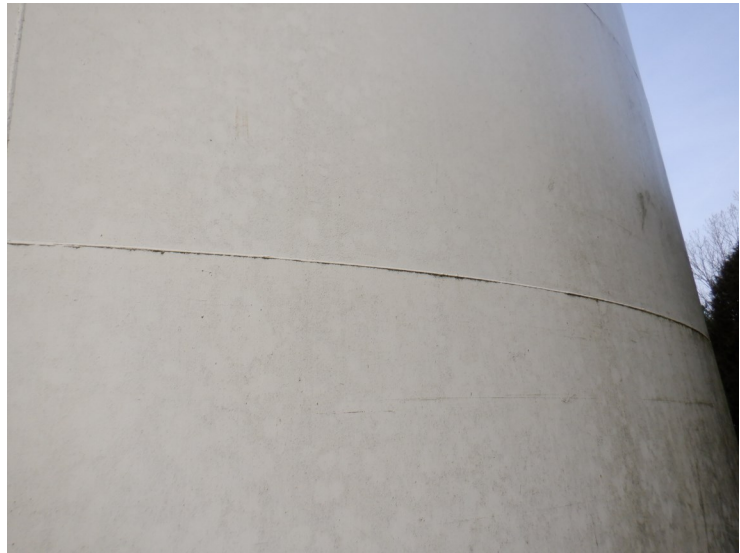
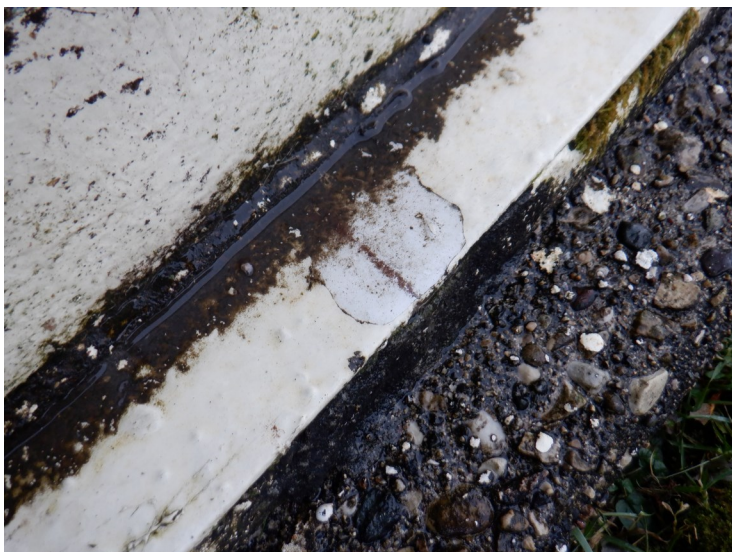
13) The coating on the sidewall is in good condition overall.

14) Same.

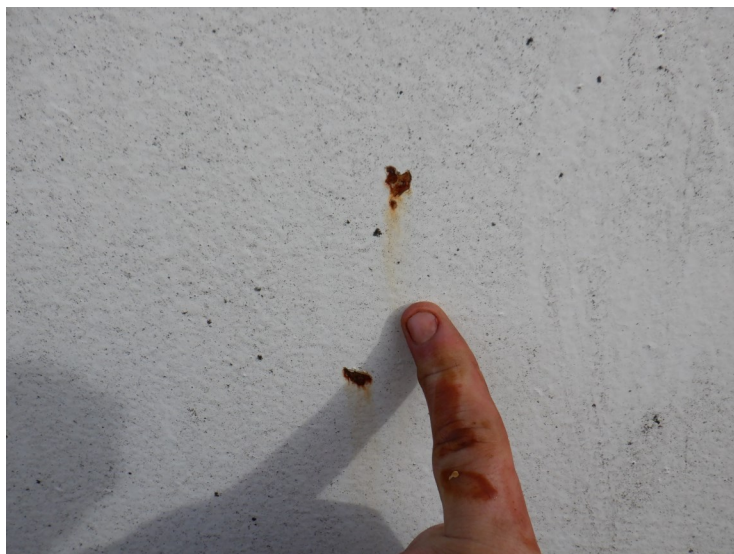
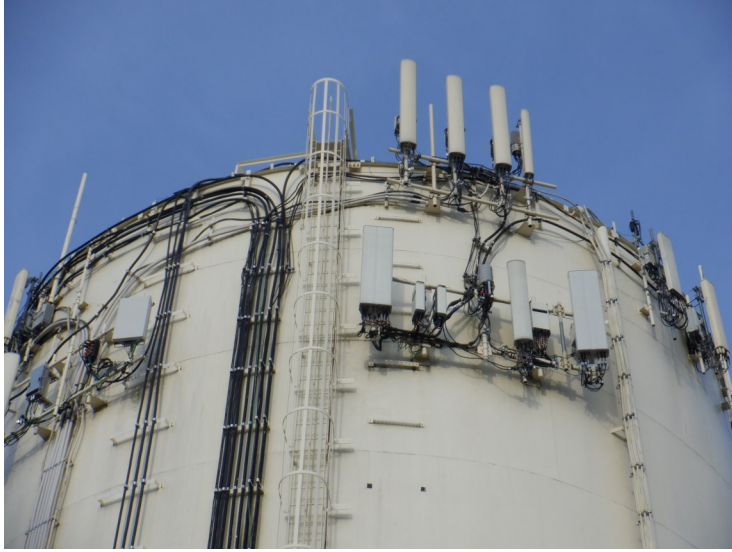
Sidewall comments: **There are approximately ten small spot coating failures that are ¼ inch diameter or less and one spot of delamination that is 2 inch diameter on the baseplate**

16) There are several small spot coating failures on the sidewall.

17) Same.

18) Same.

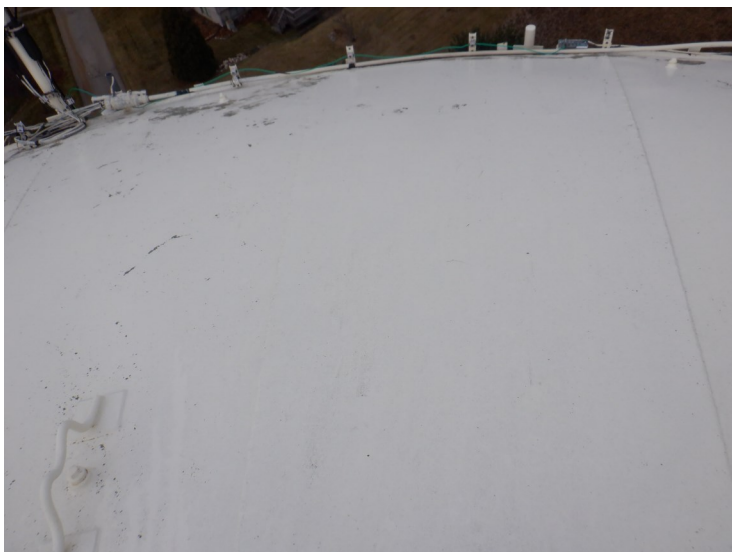
20) The coating on the roof is in good condition overall.

21) Same.

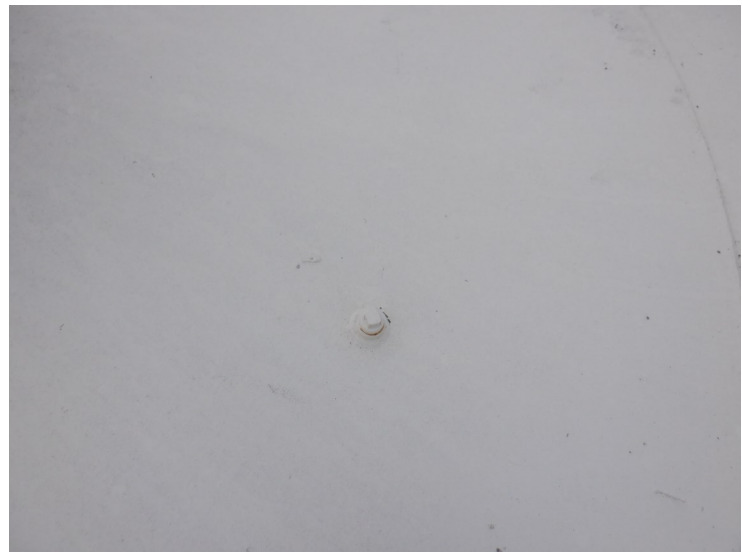
Roof comments: **There is delamination on the center handrail, several scratches in the topcoat at roof edge, antenna spot coating failures that are 1-2 inch diameter under the step off platform**

28) There is delamination along the handrail.

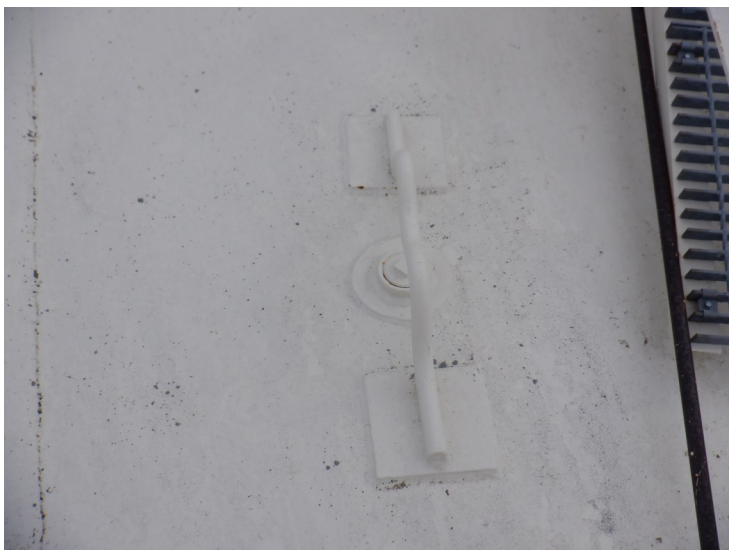
29) The roof rigging couplings are in good condition.

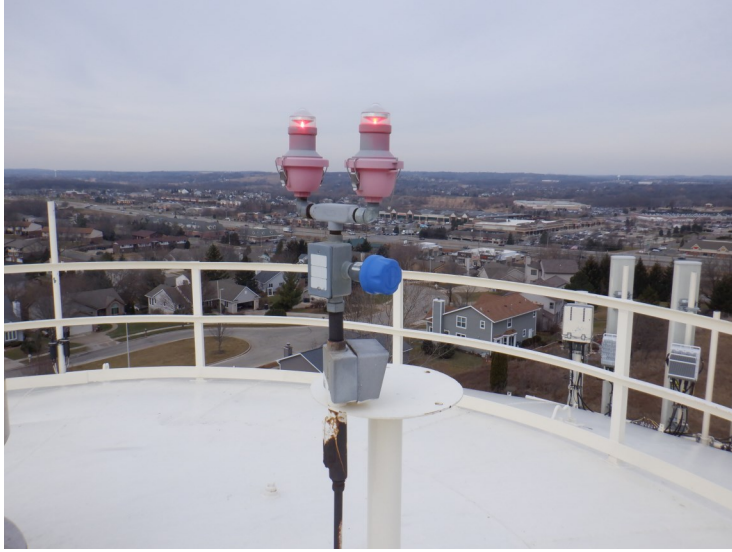
30) Some of the roof rigging couplings have safety clips that are in good condition.

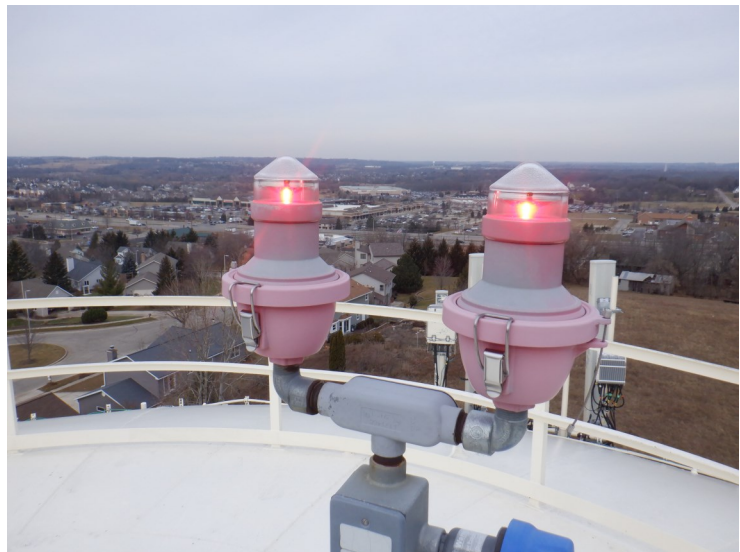
Design: **Double red**  
Location: **Free-standing mount**  
Functioning: **Yes**  
Globe condition: **Good**  
Photoelectric cell: **Yes**  
Location: **Roof**  
Aviation light comments: **Both LED lights are on**

31) The double aviation light is in good condition.

32) Same.

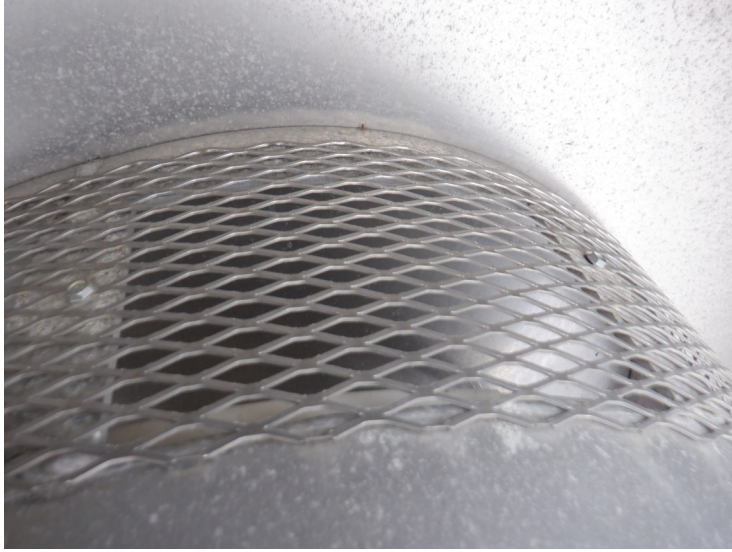
33) The roof vent is in good condition.

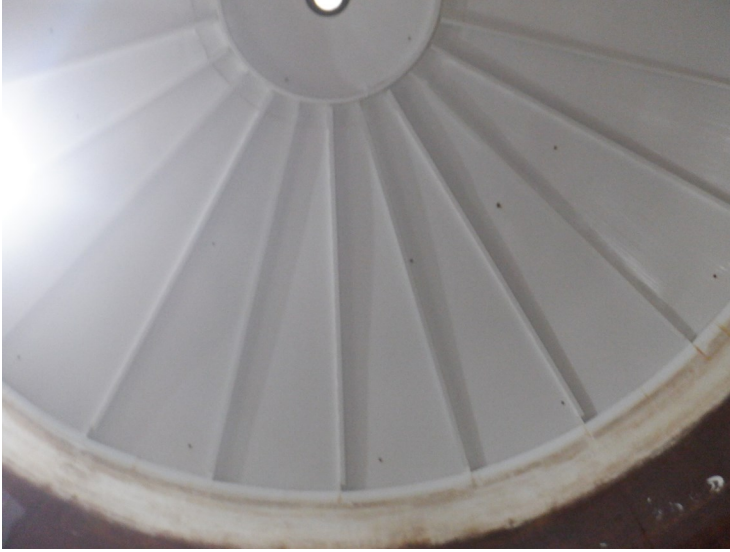
39) A roof hatch gasket was installed by the inspection crew.

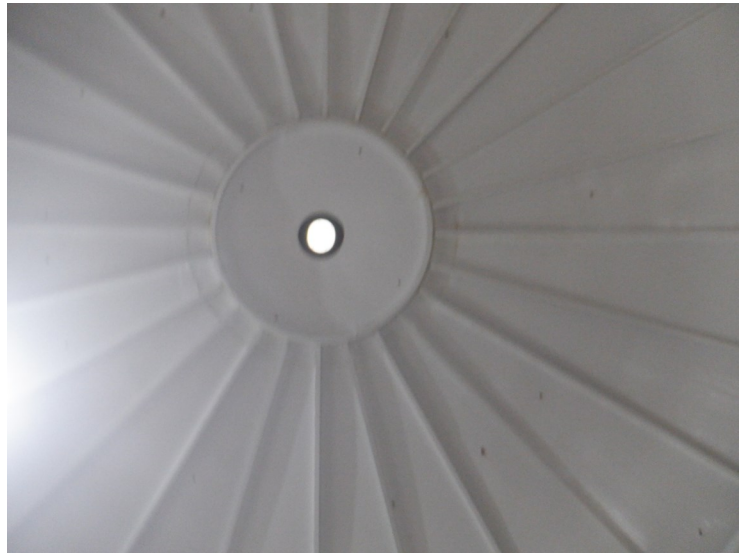
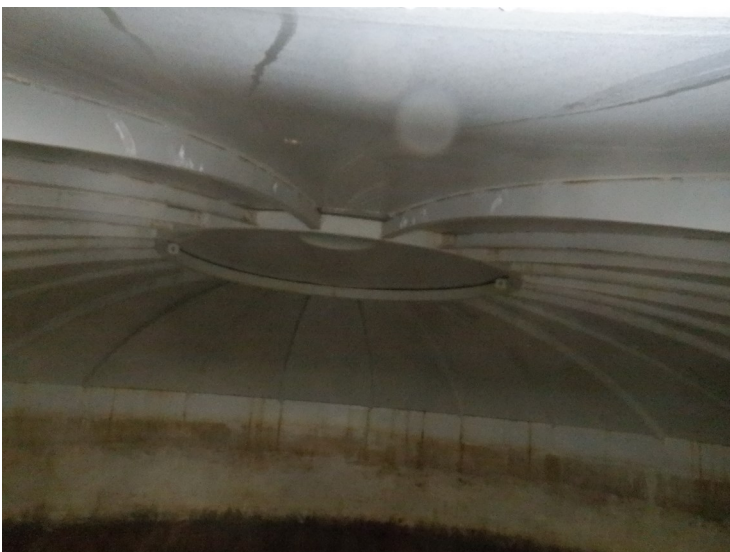
Topcoat condition: **Good**  
Primer coating condition: **Good**  
Describe coating: **Spot coating failures to substrate**  
Metal condition: **Good**  
Lap seams: **Caulked**  
Condition of lap seams: **Good**  
Roof comments: **There are only a few small spot coating failures mainly at the couplings**

40) The coating on the roof is in good condition overall.

41) Same.

42) Same.

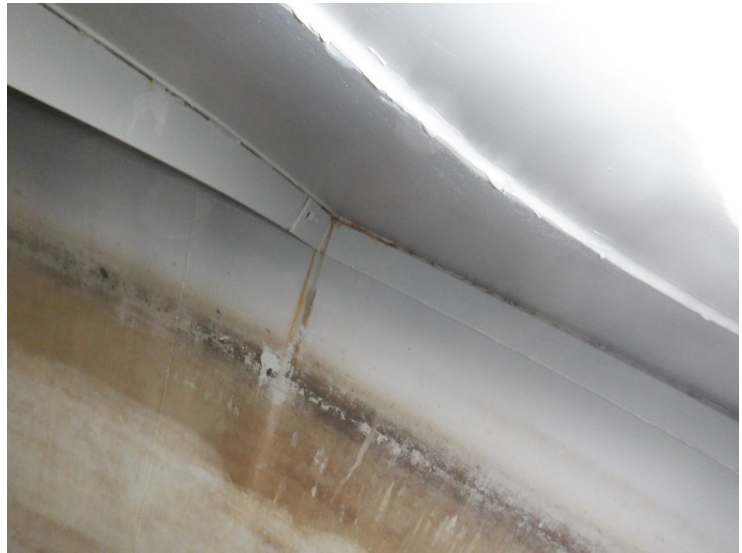
43) The roof stiffeners are in good condition.

44) Same.

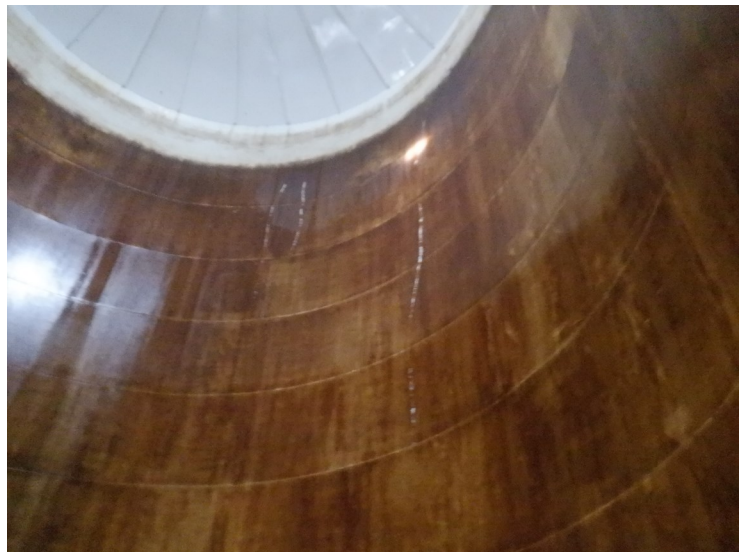
46) The coating on the sidewall is in good condition overall.

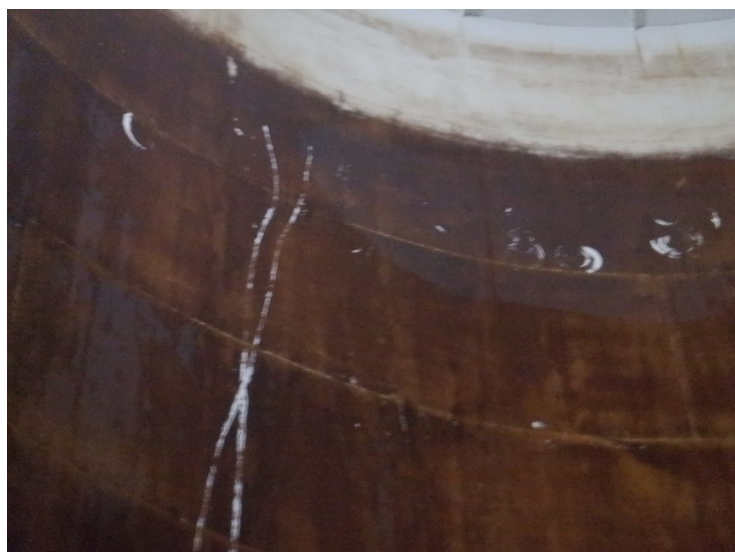
Sidewall comments: **There are 200+ blisters with a few broken on the lower sidewall. There are two areas where mineral staining is scraped away to paint, possibly due to ice movement**

47) There is heavy mineral staining on the sidewall.

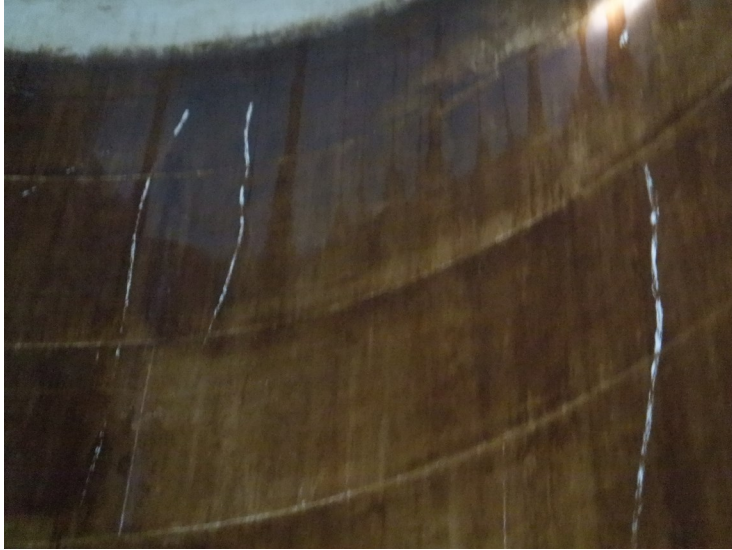
48) There are scratches in the mineral staining near the high-water level.

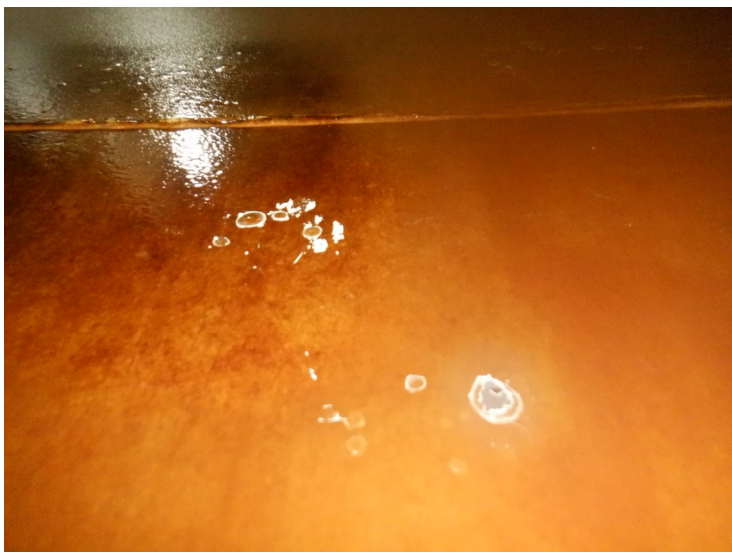
50) There are blisters in the sidewall coating on the lower sidewall panels.

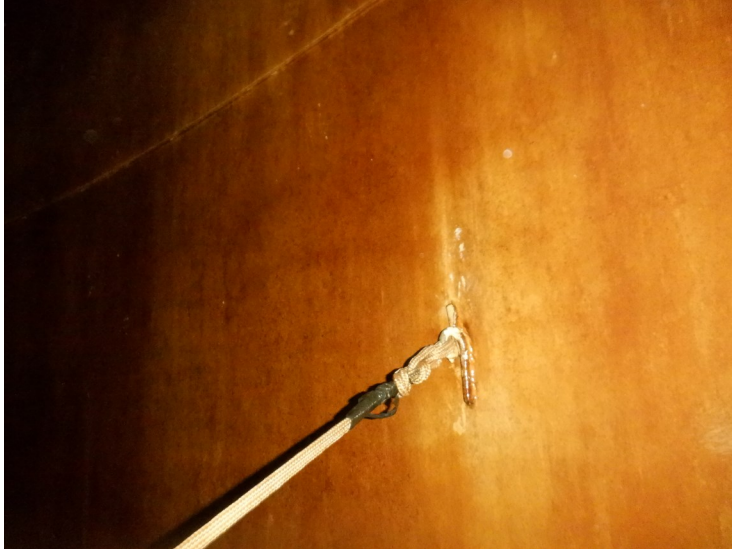
52) There are cathodic protection clips on the sidewall.

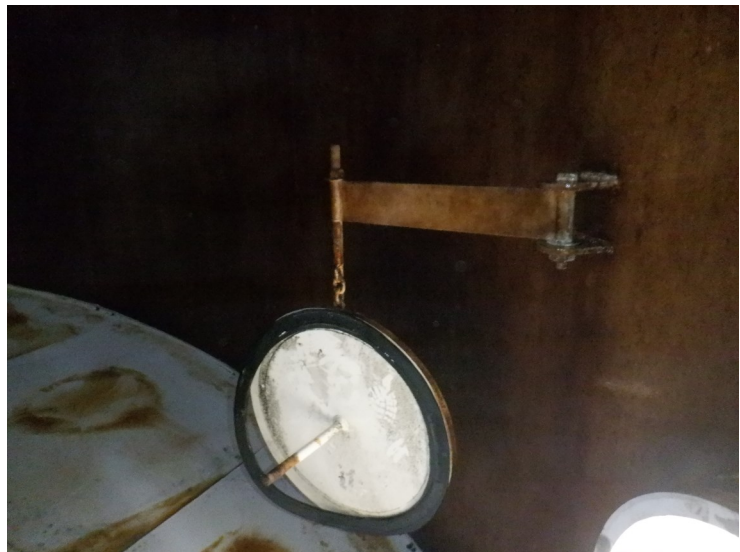
53) The manway covers are held by a davit arm that is in good condition.

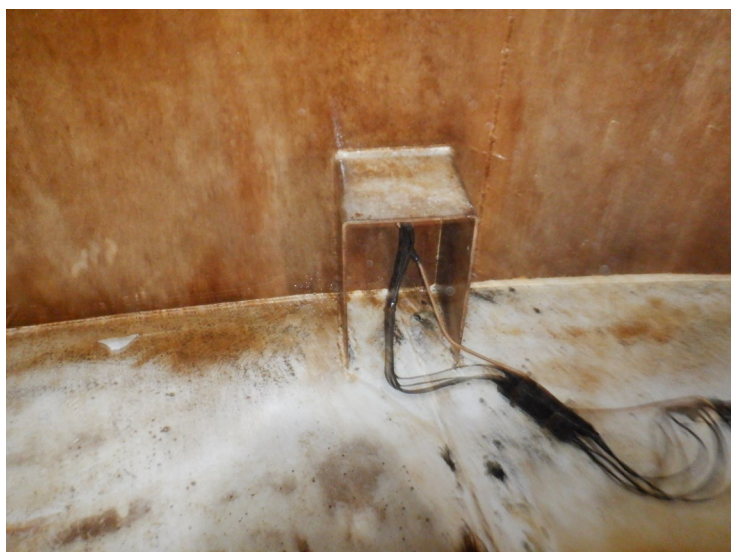
54) The cathodic protection pressure fitting has a deflector plate around it.

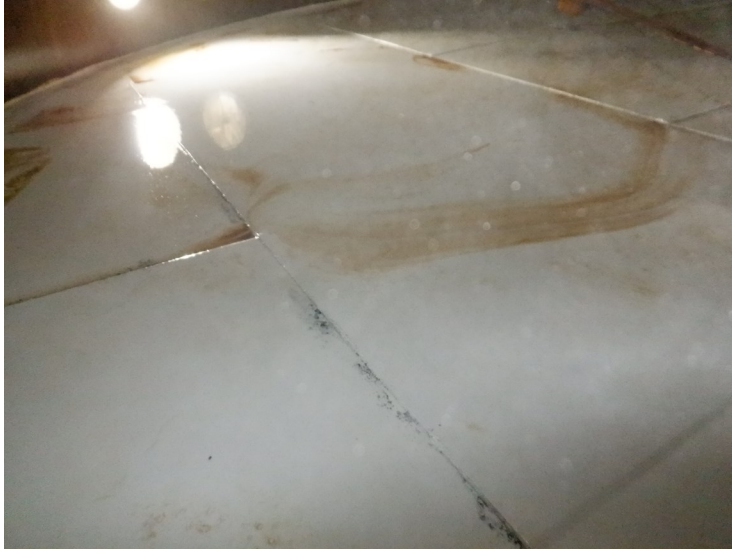
55) The coating on the floor is in good condition.

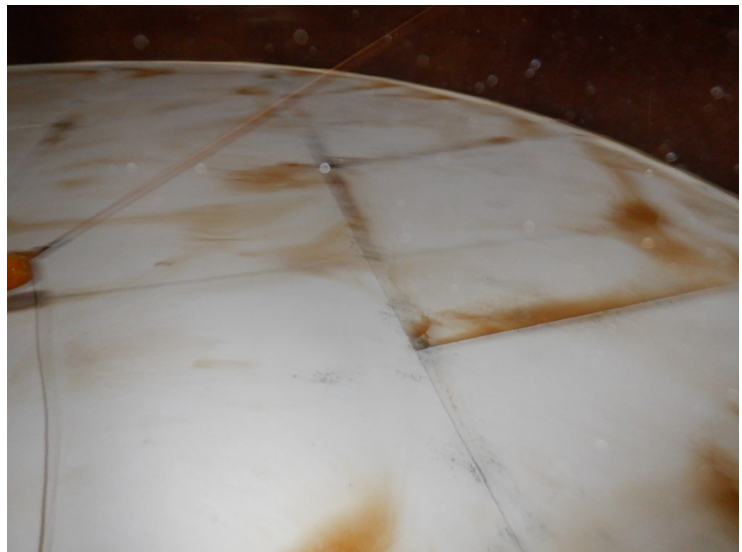
56) Same.

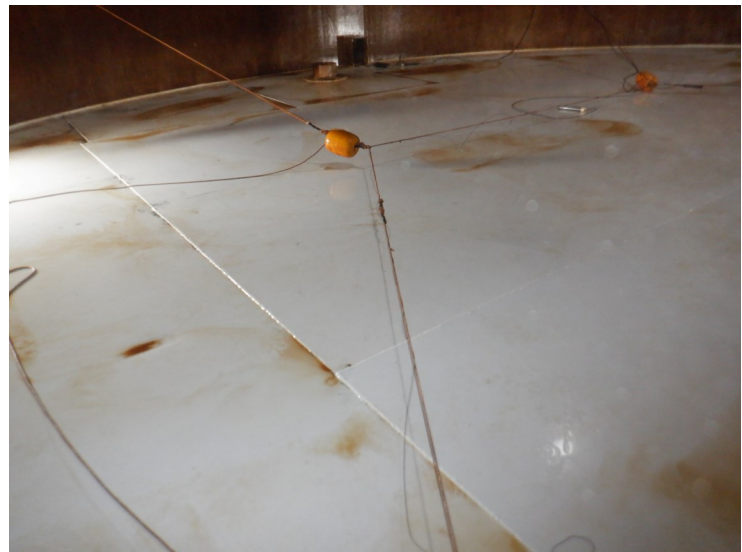
59) The cathodic protection system appears to be in good condition.

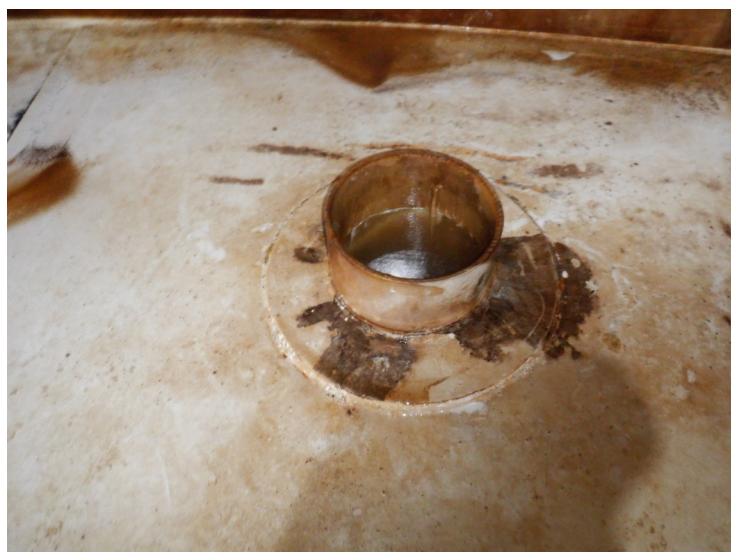
60) The fill/draw pipe is in good condition. There is not a deflector plate or bar over the top of the pipe.

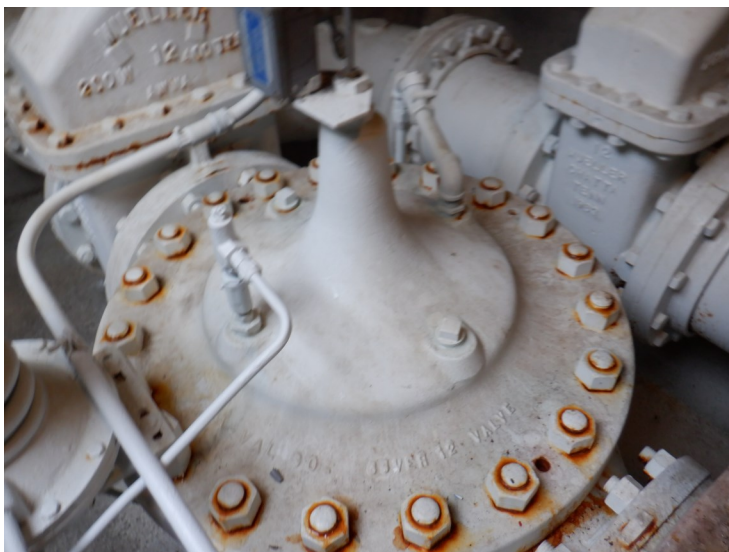
65) There are spot coating failures on the bolts and flanges.

66) Same.
