Water System Master Plan

April 2022

PREPARED FOR:
Village of Pewaukee
235 Hickory Street
Pewaukee, WI 53072

PREPARED BY:
Ruekert & Mielke, Inc.
W233 N2080 Ridgeview Parkway
Suite 300
Waukesha, WI 53188

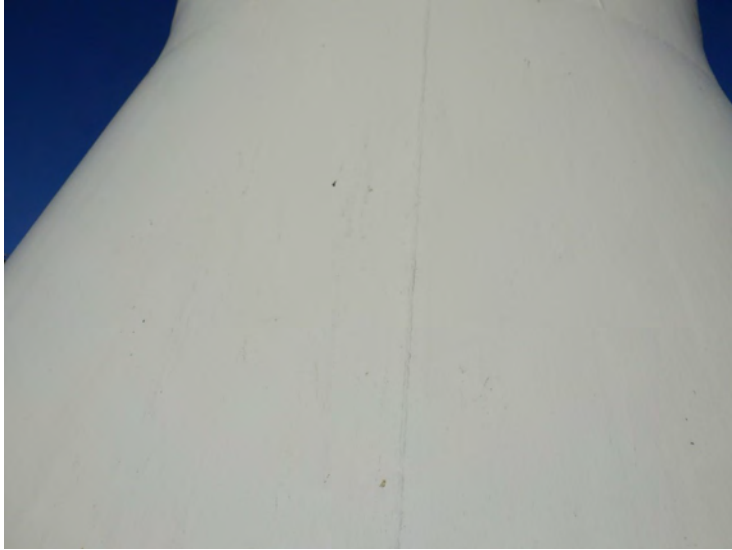
7) Same.

8) The riser coating is in good condition with no deterioration.

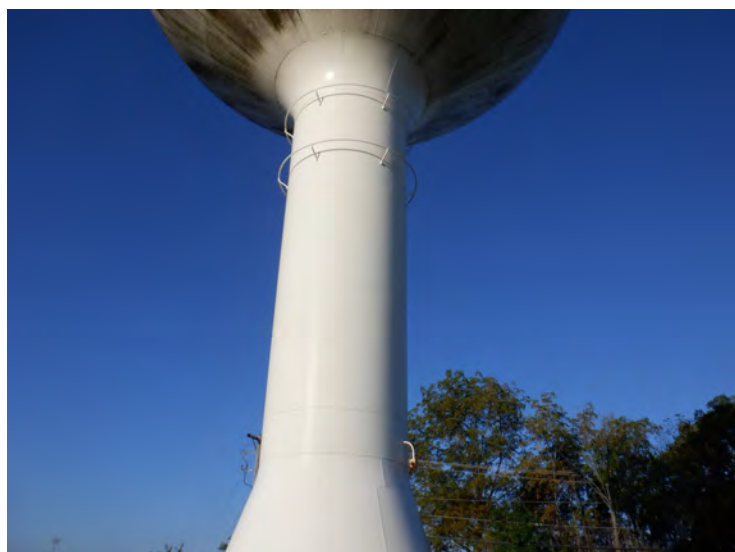
9) Same.

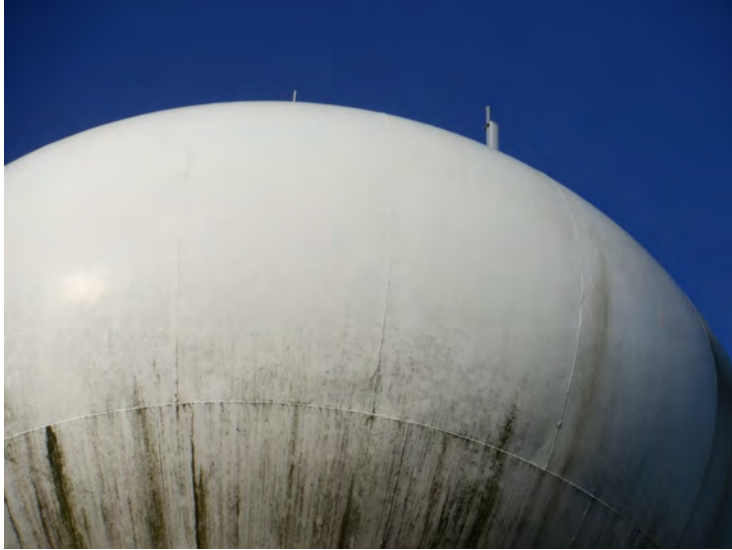
13) Same.

14) The roof coating has faded but there is no significant deterioration.

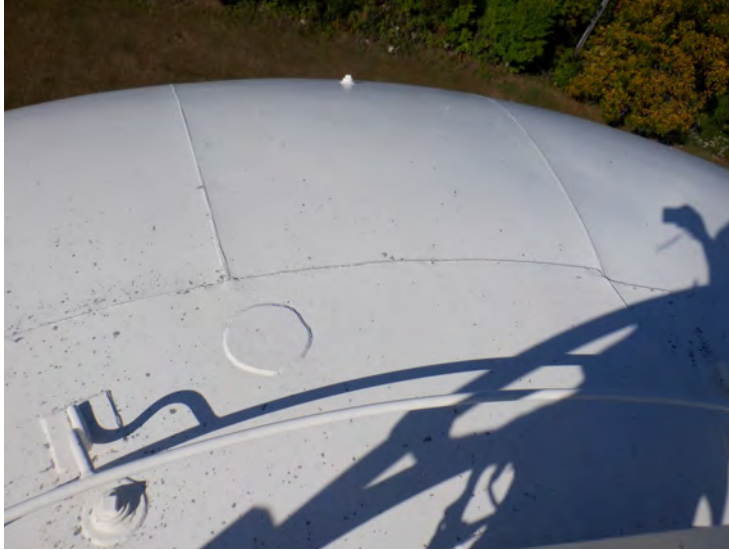
16) Same.

17) The roof handrail and painter's railing are in good condition.

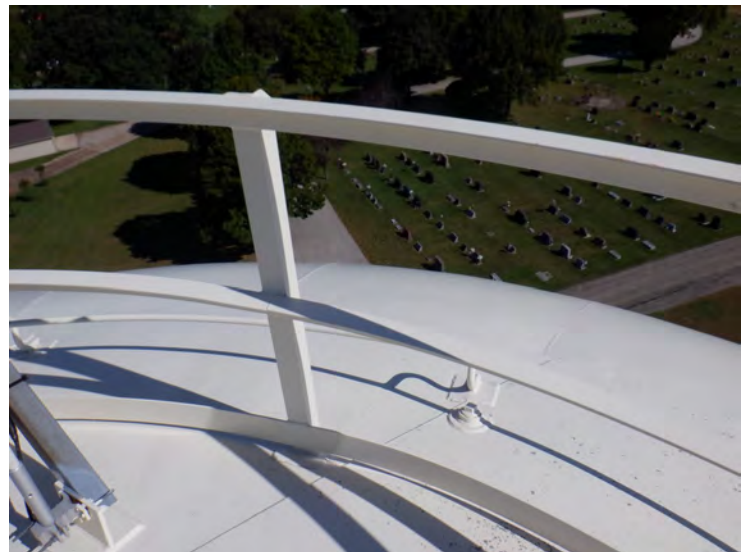
18) The wet interior roof hatch is in good condition. A gasket was installed on the hatch during the inspection.

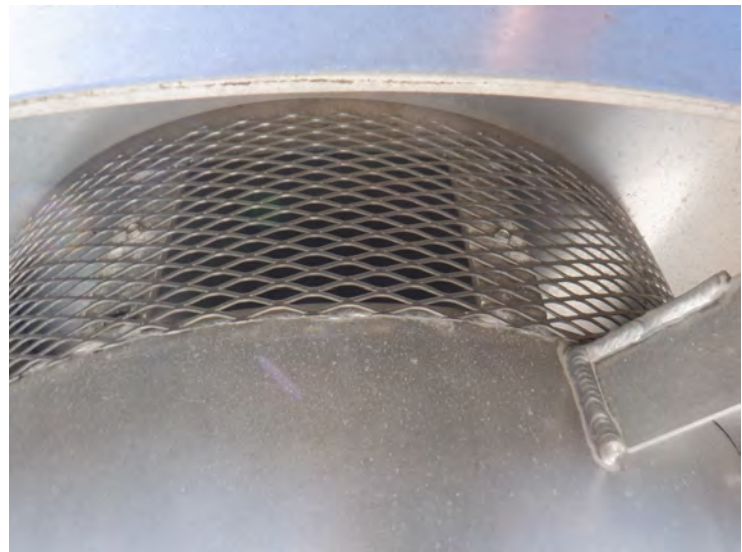
24) The interior roof vent screen is intact with no gaps.

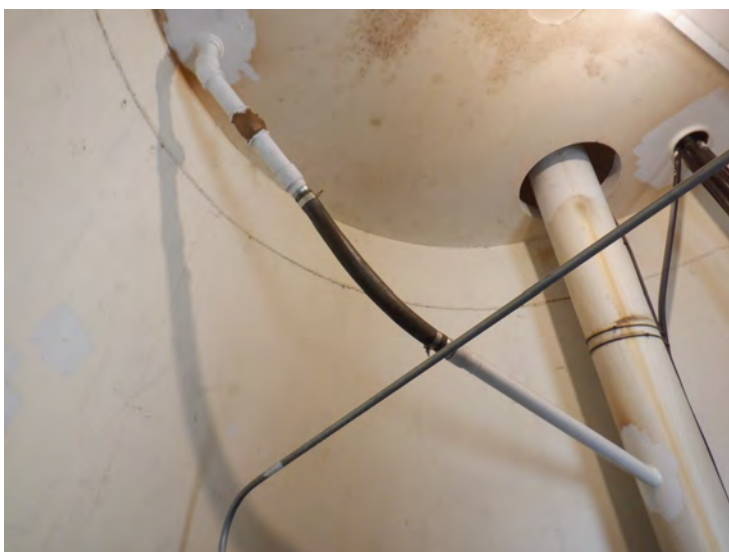
27) Same.

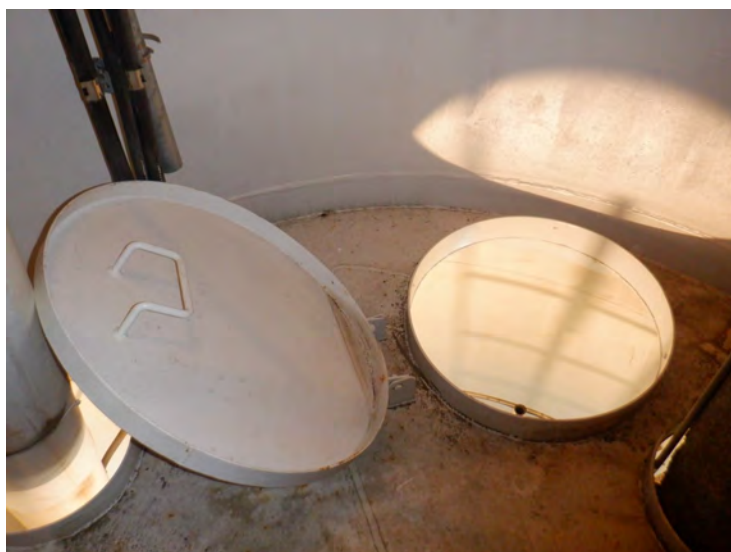
30) The ladder opening at the condensate platform is equipped with a hinged cover.

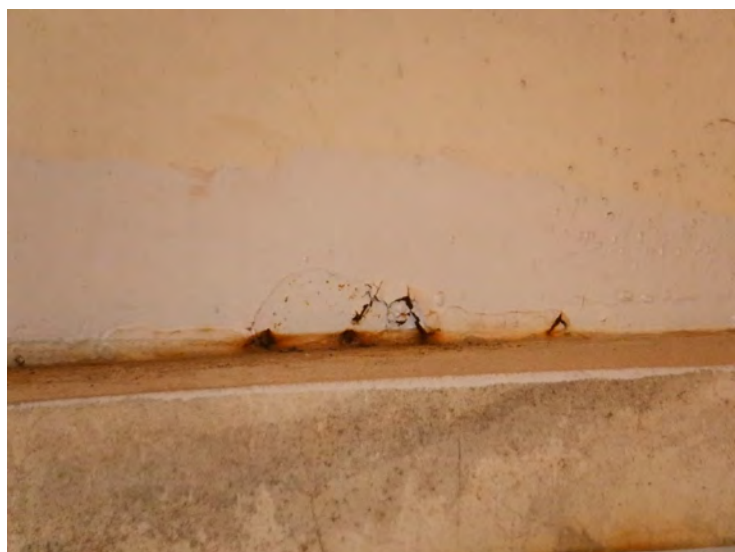
33) Coating failures along a stiffener in the dry riser.

The riser coating is in good condition with a few failures. Primary methods of deterioration are spot failures to the substrate and rust bleedthrough. Most of the failures are on the stiffeners.

2. Spot abrasive blast clean the topside of the platforms, the entire access tube, transition cone, and other spot coating failures in the dry interior. Spot repaint all prepared surfaces with an epoxy coating system. The estimated cost is \$30,000.

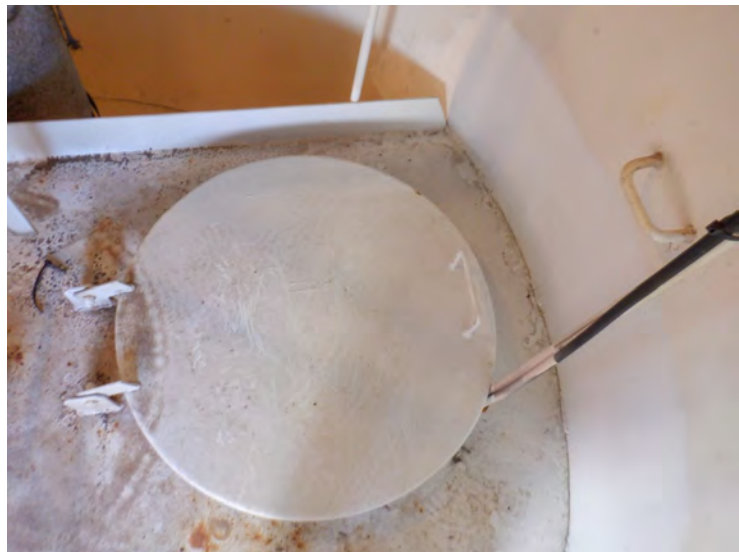
38) The ladder opening at the top platform is equipped with a hinged cover.

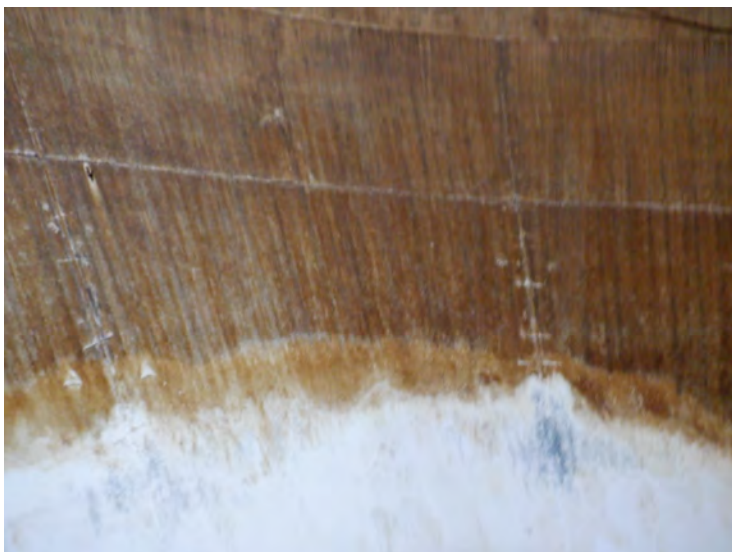
53) There is heavy mineral staining on the wet interior sidewall but no coating failures.

54) Same.

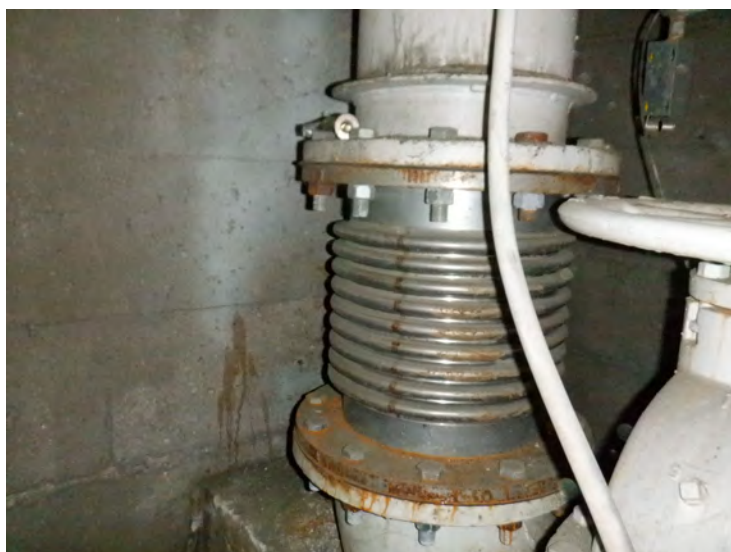
67) Minor coating failures on the pit piping.

68) Same.

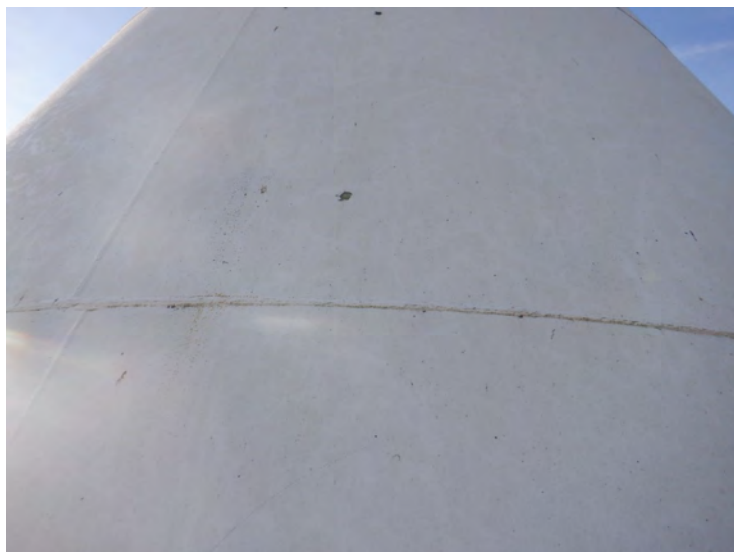
7) Coating failures on the basebell.

9) Same.

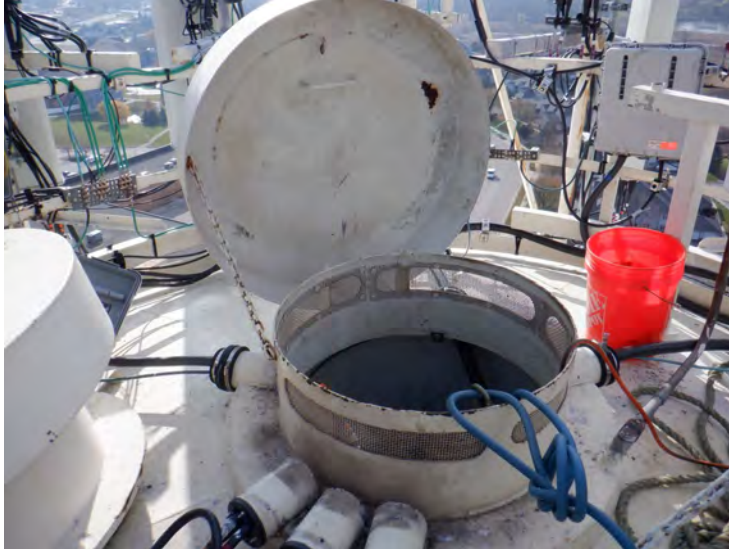
25) The dry interior roof hatch is in good condition.

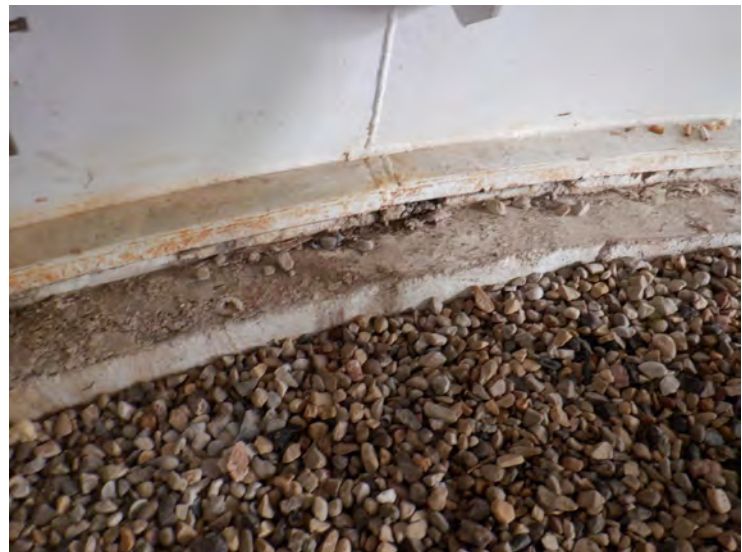
29) Coating failures on the baseplate in the dry interior.

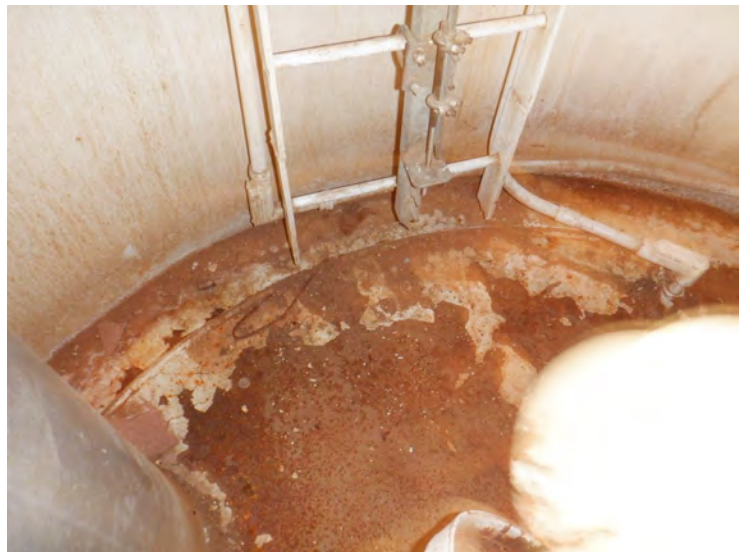
35) Coating failure on the condensate platform.

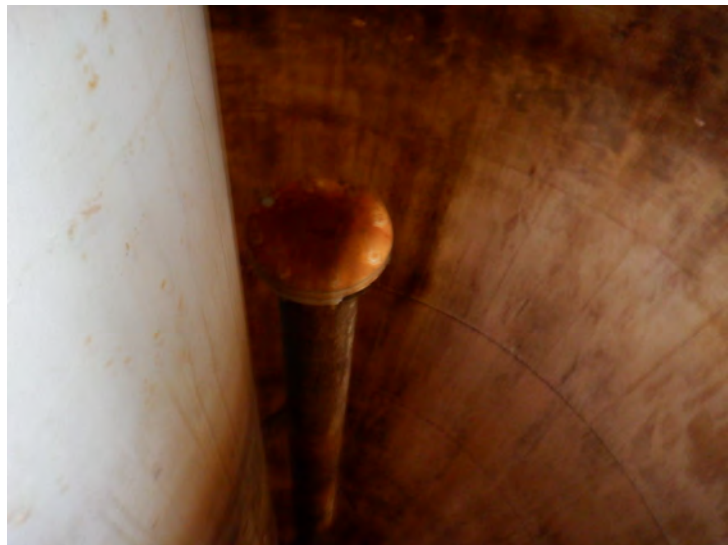
Metal condition: Poor – steel loss from corrosion on top 6 rungs

57) Steel loss from corrosion on the top rungs of the wet interior ladder.

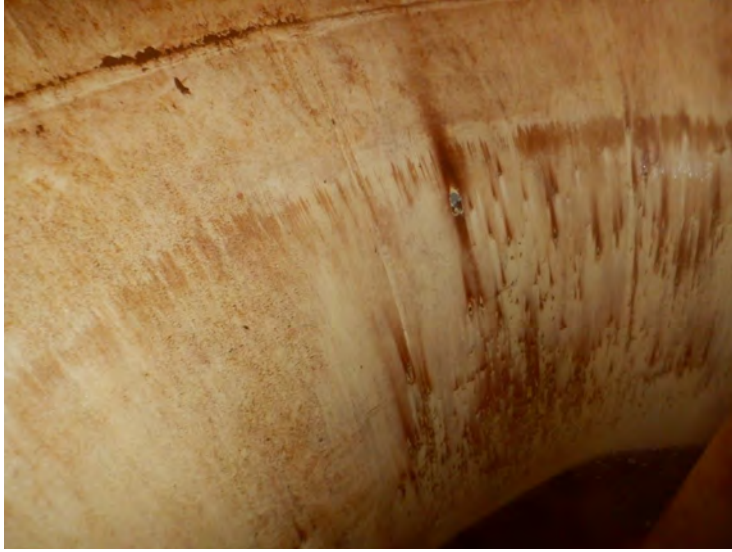
61) Coating failures in the transition cone.

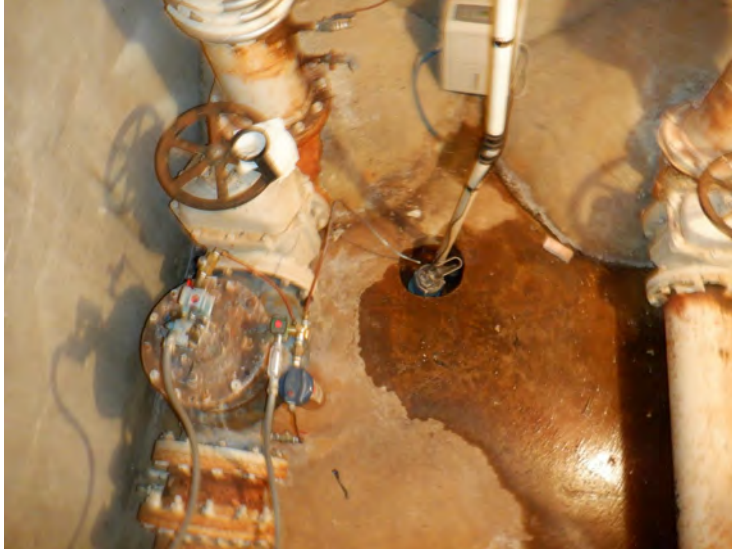
67) Same.

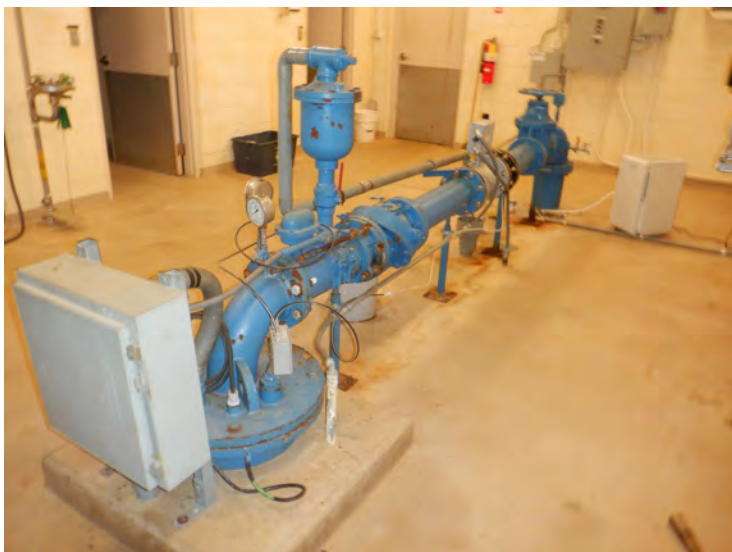
69) Coating on the piping in the building is in fair condition.

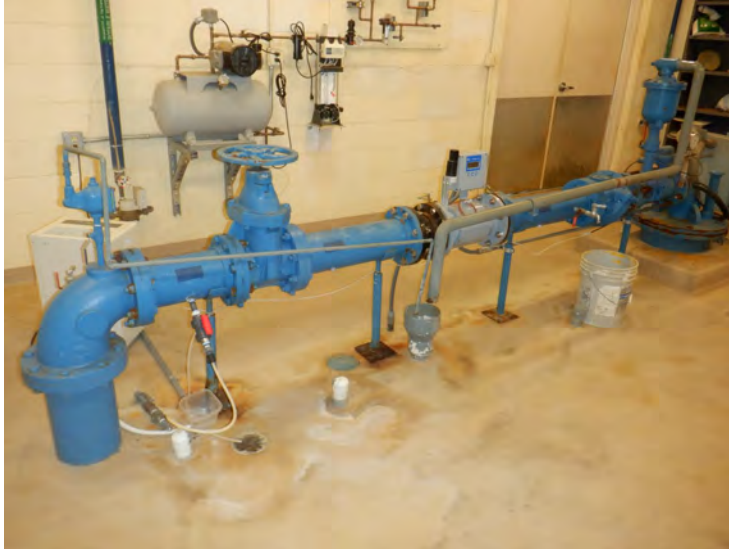
70) Same.

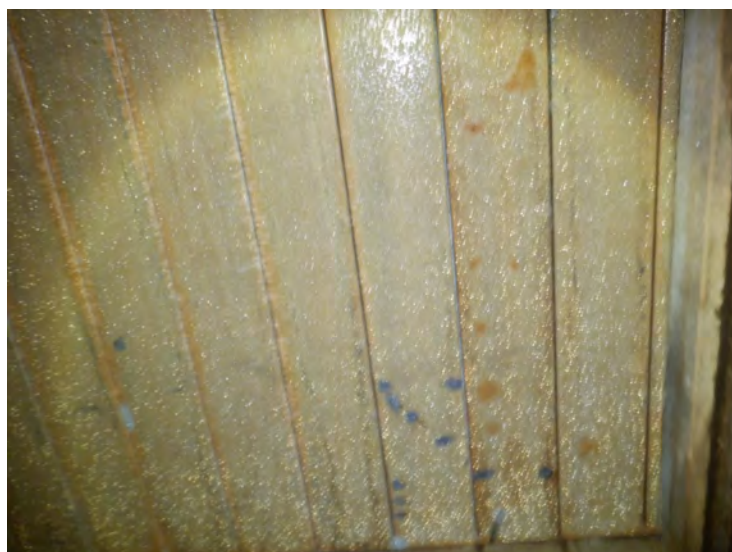
The roof is in good condition overall with no significant deterioration. There is some rusting at the surface from rebar chair bases and rebar.

9) Rusting at the surface of the wet interior roof.

Abrasive blast clean the exposed rebar in the wet interior and coat with an epoxy system. The repair is intended to extend the life of the structure by protecting the exposed rebar. The exposed rebar is due to lack of concrete cover during construction. The rebar near the surface has expanded and created a spall exposing the steel. There may be more exposed areas that will appear in the future. The estimated cost is \$5,000.

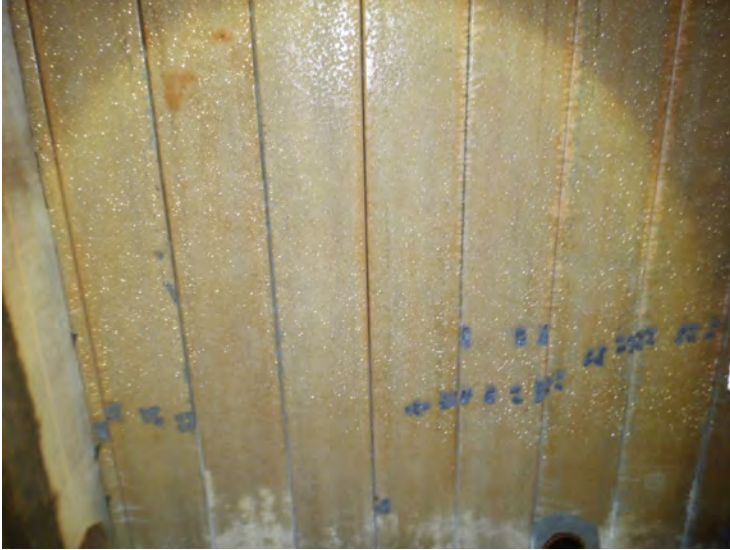
10) Same.

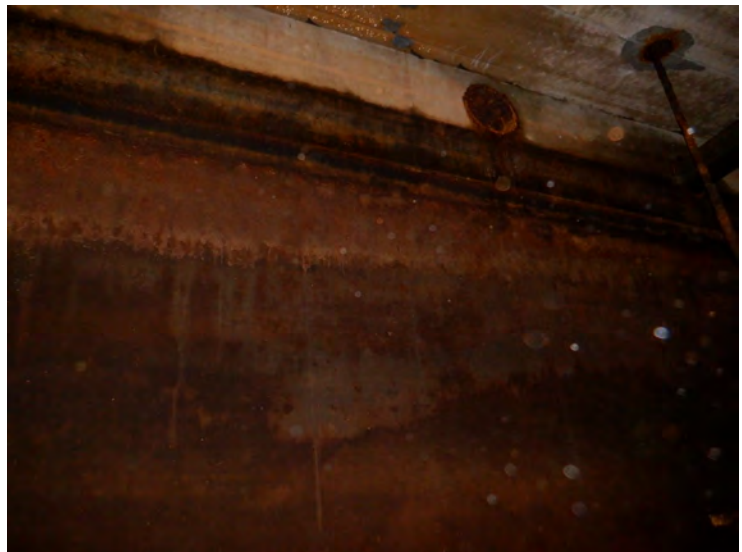
It is not known when the wet interior was last coated. The coating is likely an elastomeric system. The coating is located on the floor and sidewalls and is in fair condition. There are areas of delamination, spot failures, and erosion.

13) Elastomeric coating failures on the wet interior sidewall.

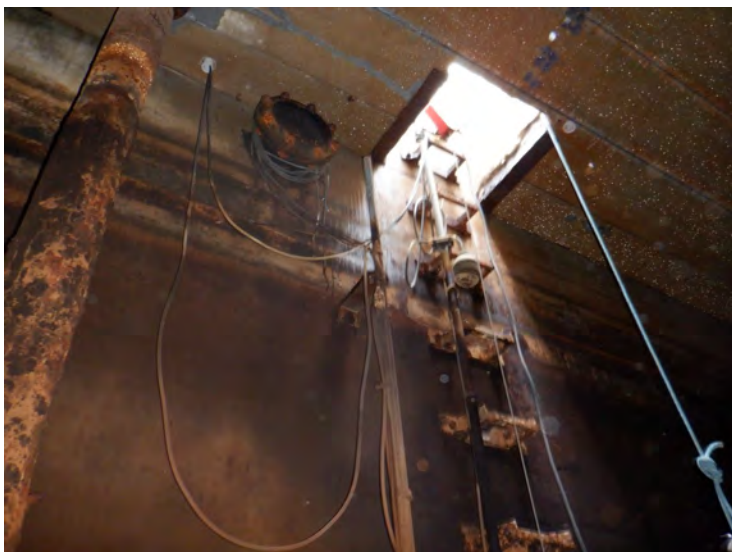
14) Same.

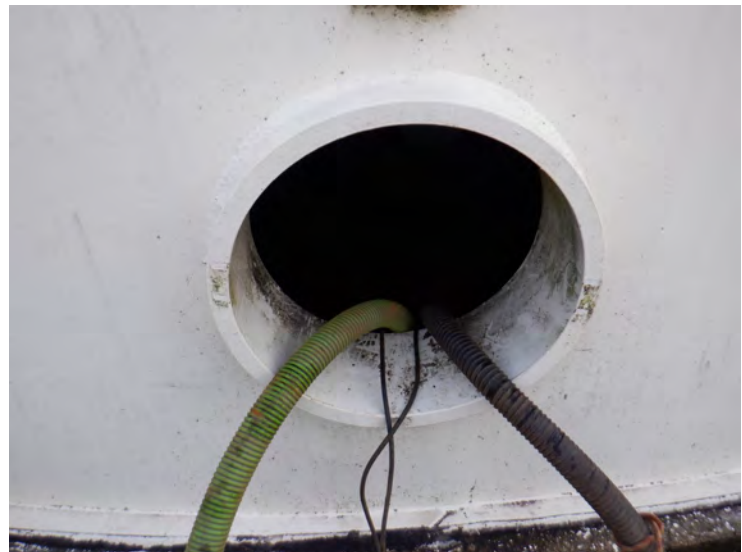
8) The two sidewall manways are in good condition.

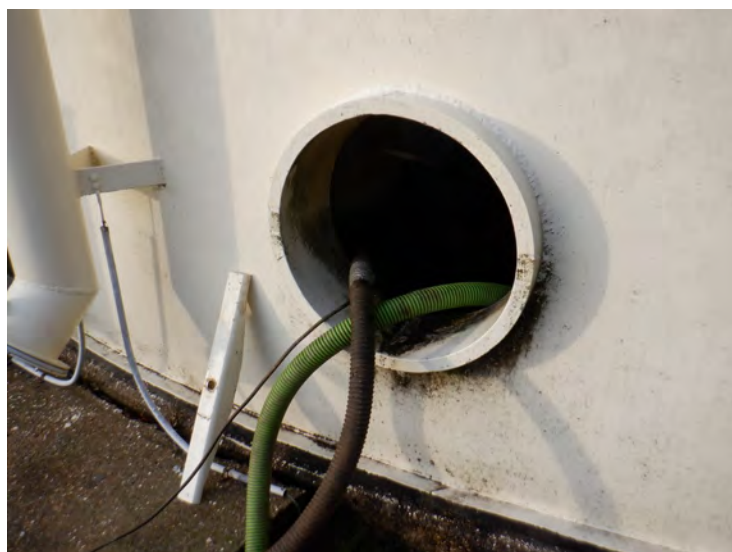
9) Same.

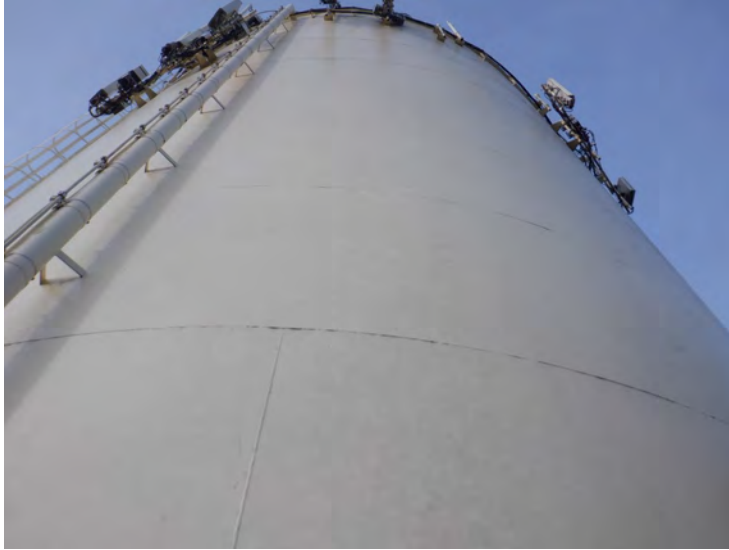
13) The coating on the sidewall is in good condition overall.

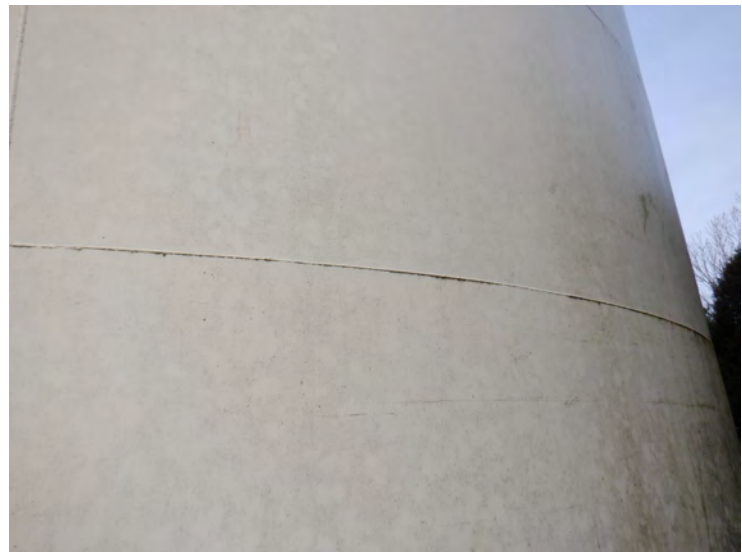
14) Same.

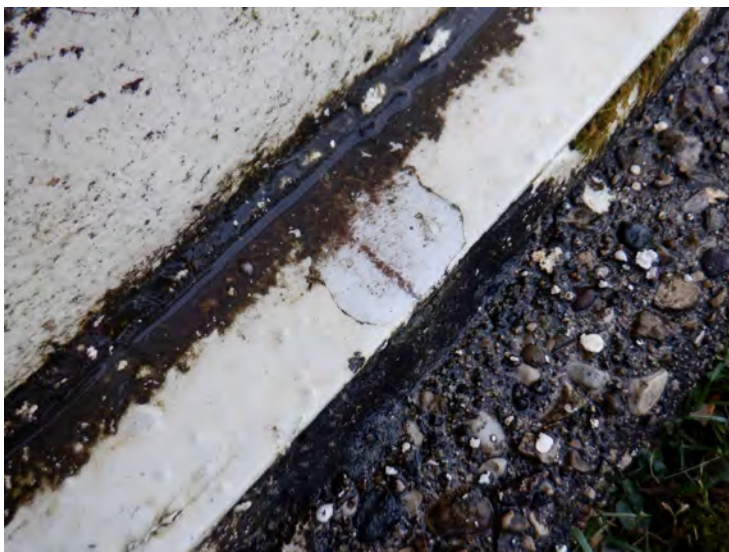
Sidewall comments: **There are approximately ten small spot coating failures that are ¼ inch diameter or less and one spot of delamination that is 2 inch diameter on the baseplate**

15) There is a small spot of delamination on the baseplate.

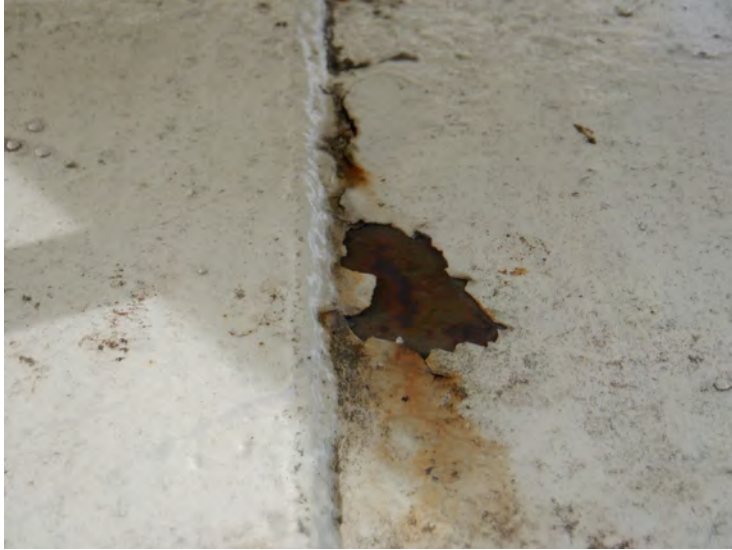
21) Same.

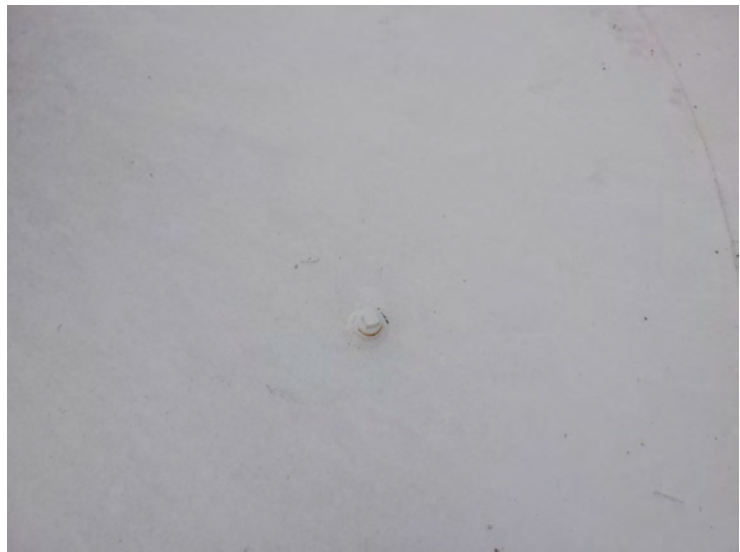
Roof comments: **There is delamination on the center handrail, several scratches in the topcoat at roof edge, antenna spot coating failures that are 1-2 inch diameter under the step off platform**

28) There is delamination along the handrail.

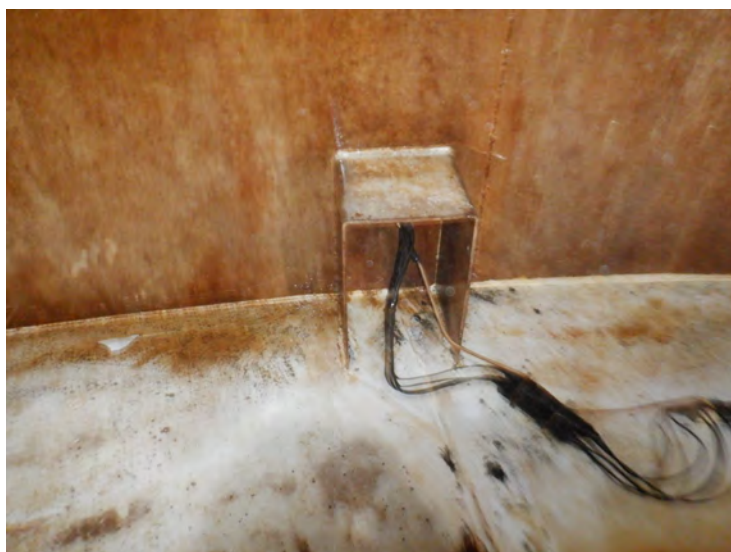
54) The cathodic protection pressure fitting has a deflector plate around it.

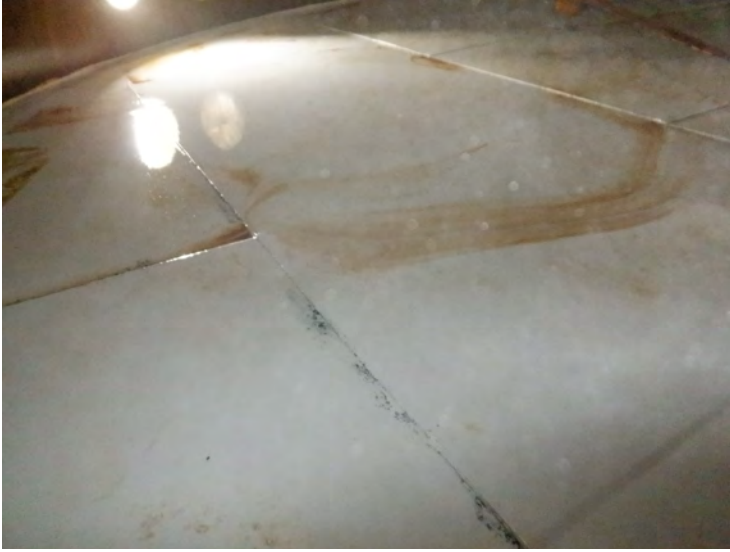
55) The coating on the floor is in good condition.

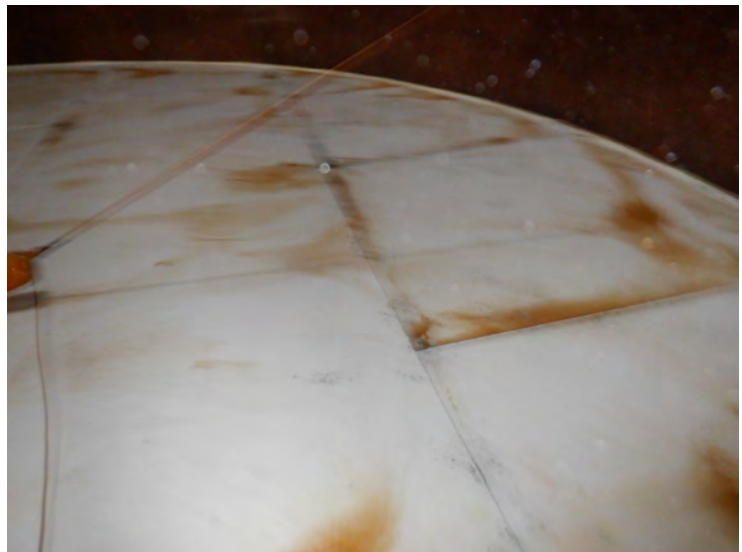
56) Same.

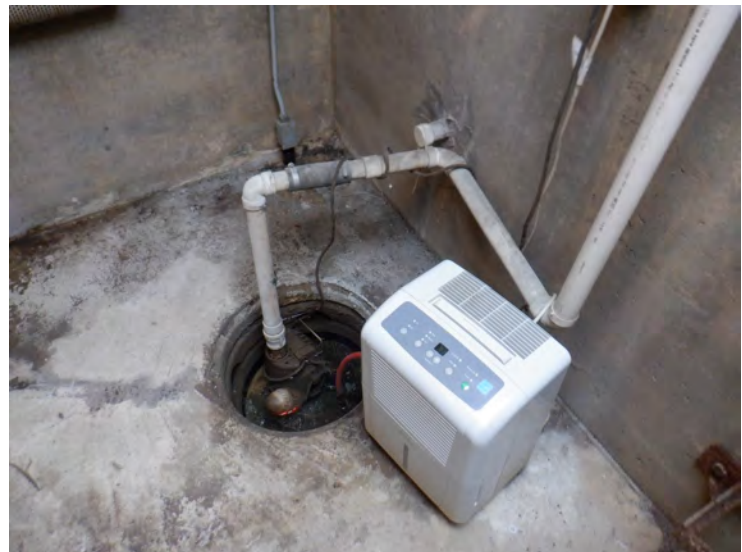
62) There is a sump pump in the pit.

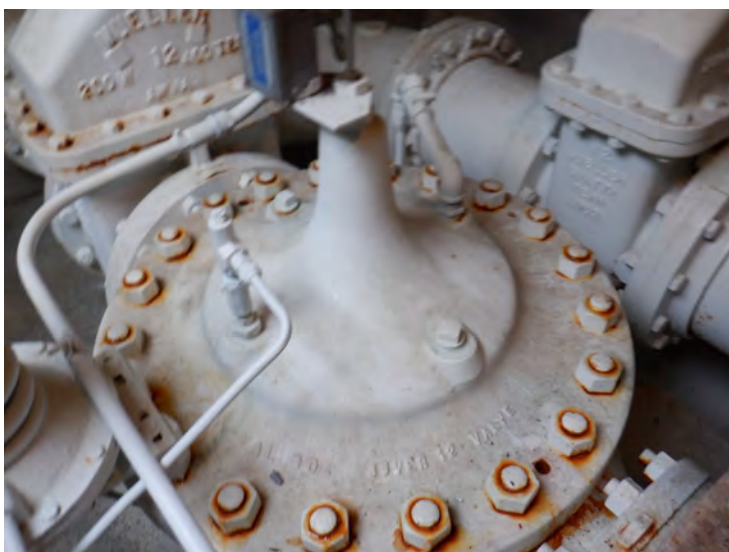
66) Same.
