Regular Village Board Meeting Agenda

July 19, 2022 – 7:00 pm
Village Hall, 235 Hickory Street, Pewaukee, WI 53072

250,000 gallon spheroid (Lake Street) elevated water storage tank owned by the Village of Pewaukee, Wisconsin.

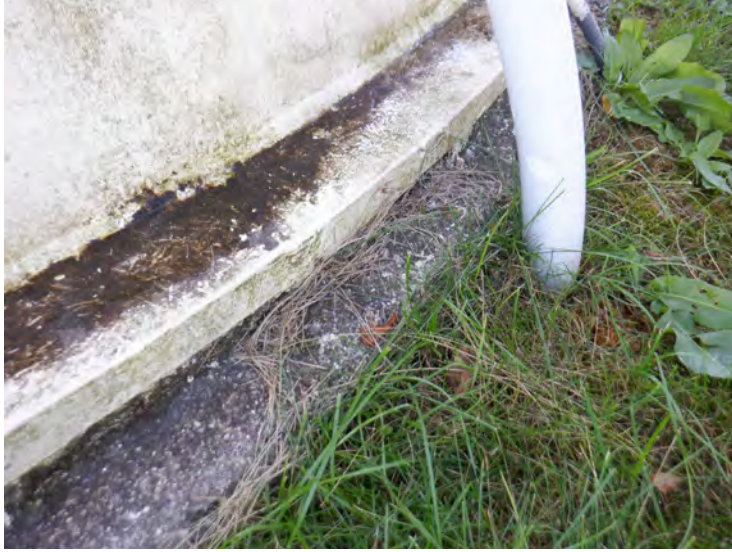
1) The concrete foundation is in good condition with no significant deterioration.

2) The anchor bolts are in good condition. There is no missing grout between the baseplate and foundation.

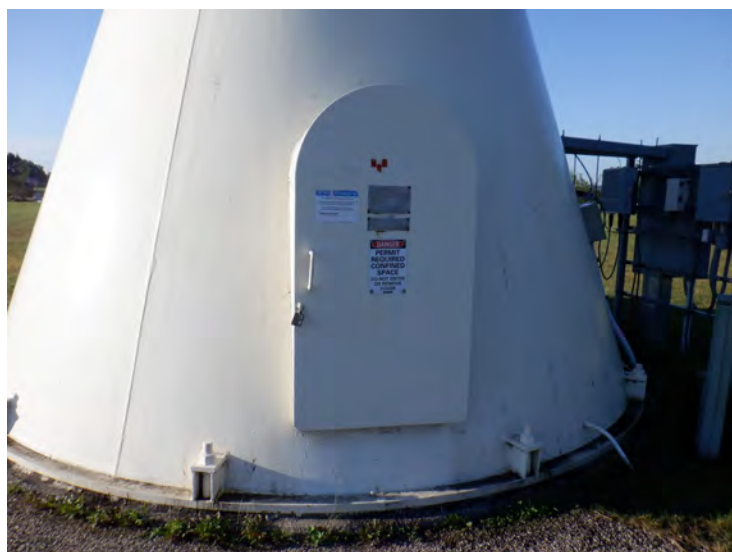
3) The service door operated properly during the inspection.

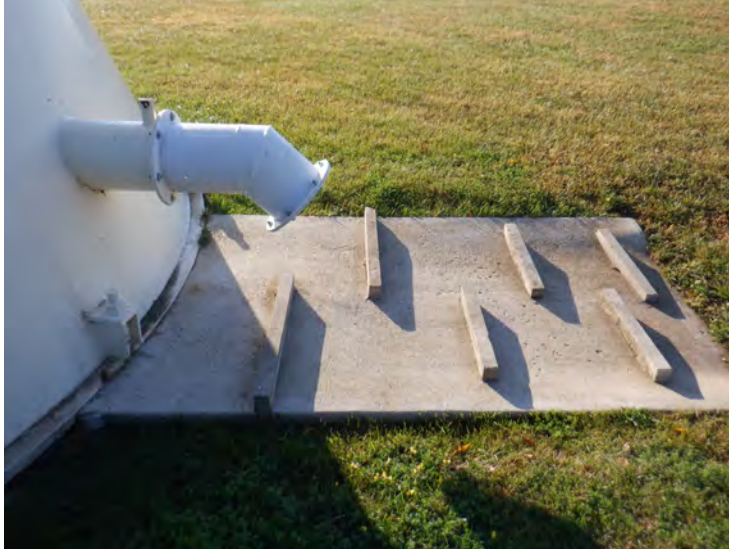
4) The overflow pipe discharges to a concrete splash pad.

5) The screen at the overflow discharge is intact but deformed and oversized.

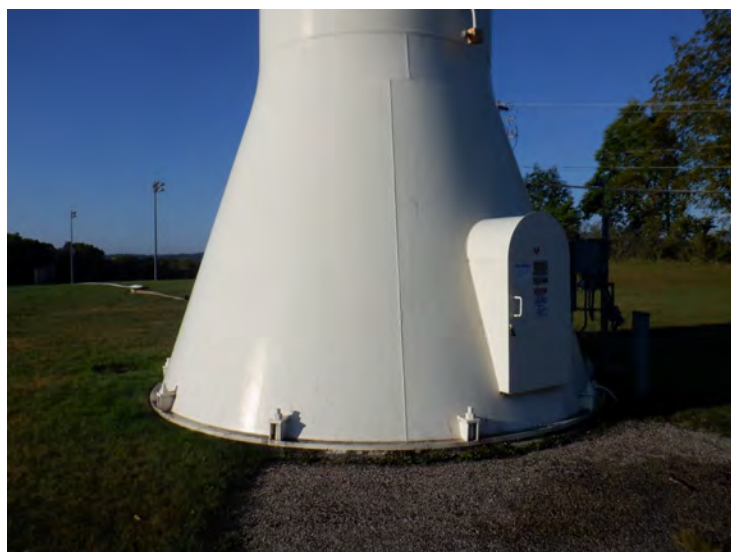
6) There are no coating failures on the basebell.

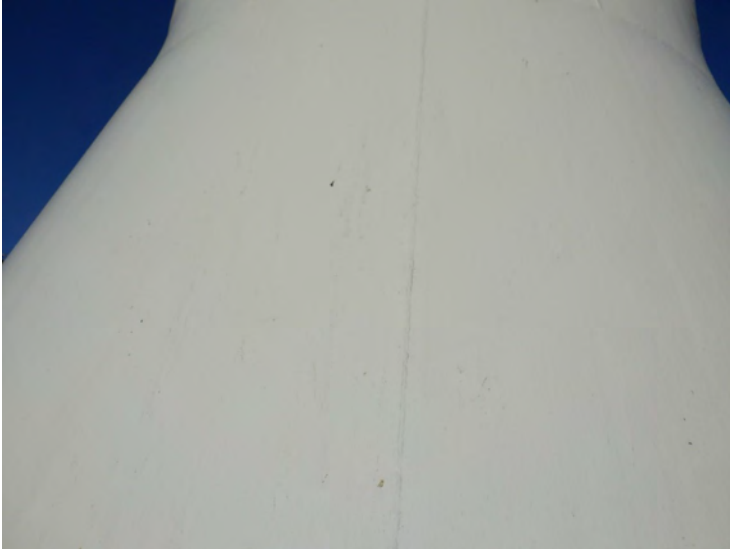
7) Same.

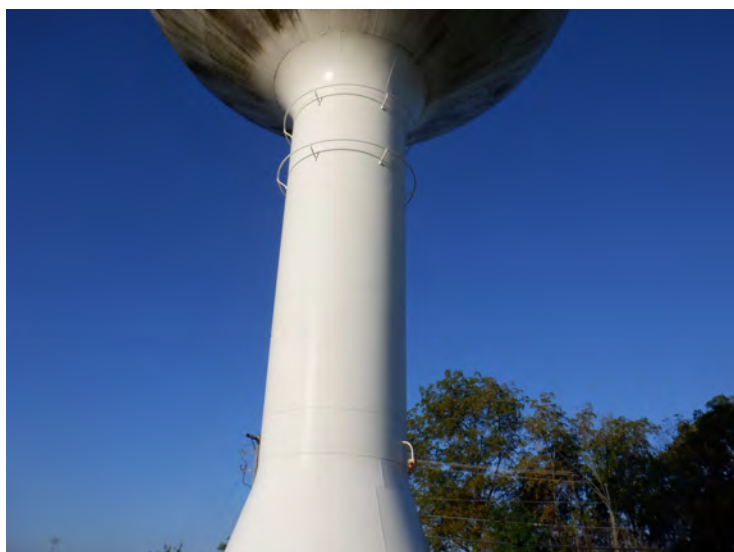
9) Same.

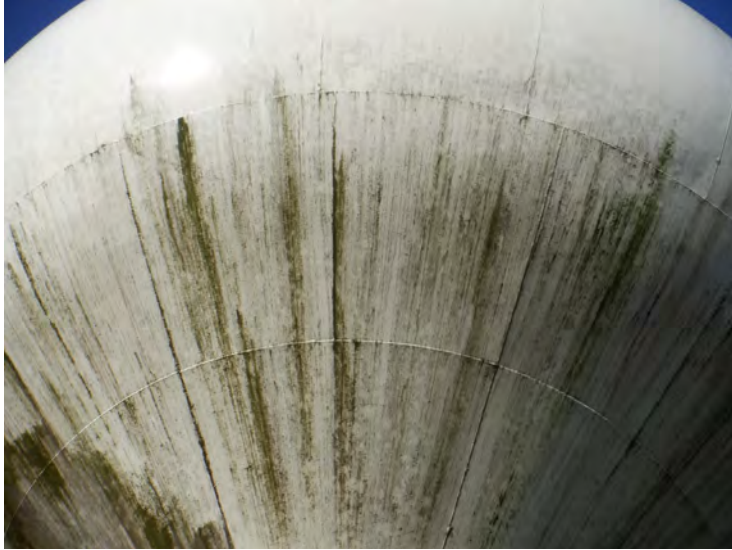
10) The bowl is covered with mildew growth but there are no visible coating failures.

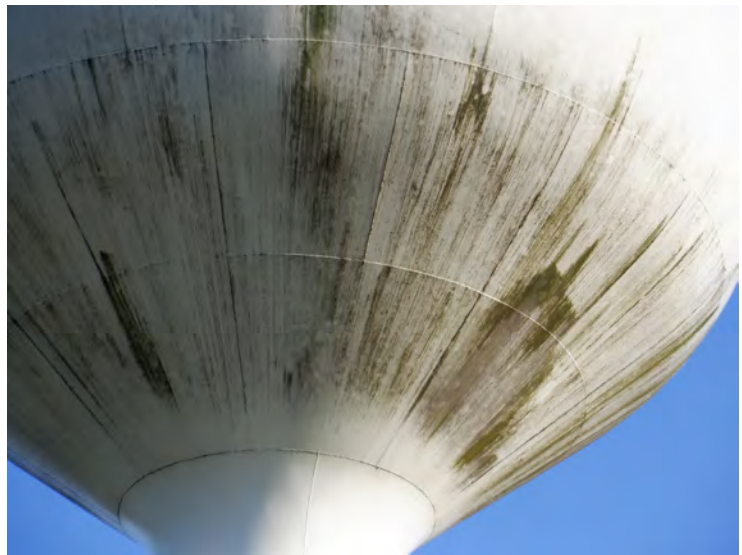
11) Same.

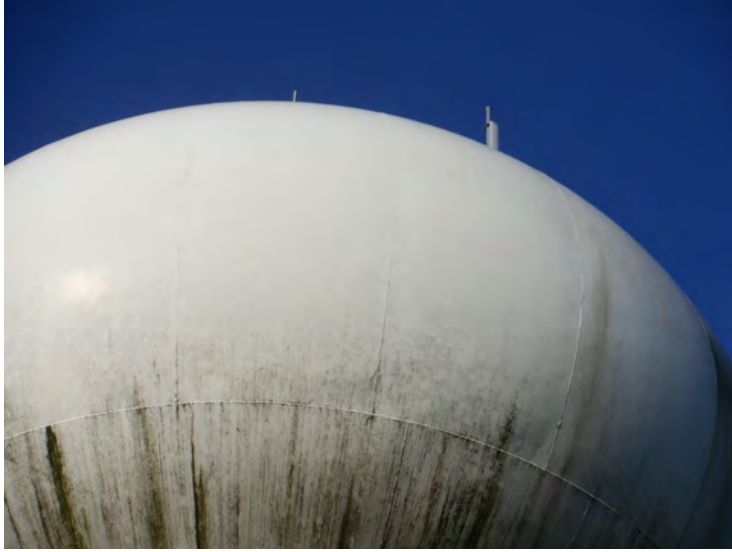
13) Same.

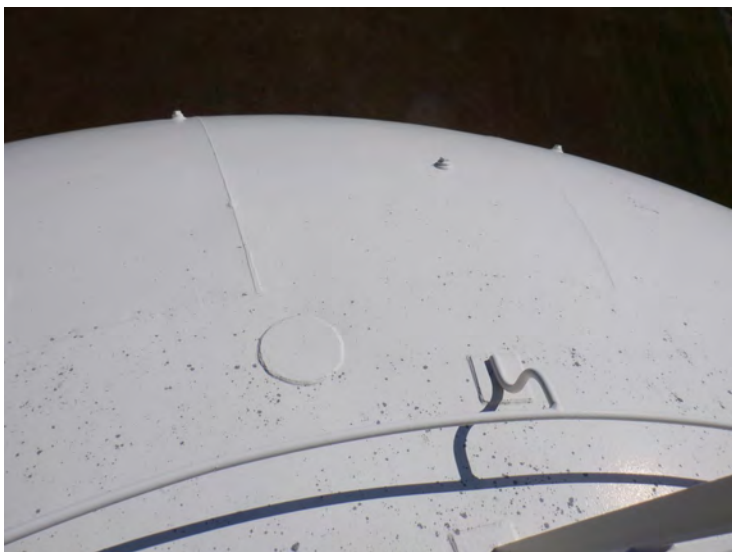
15) Same.

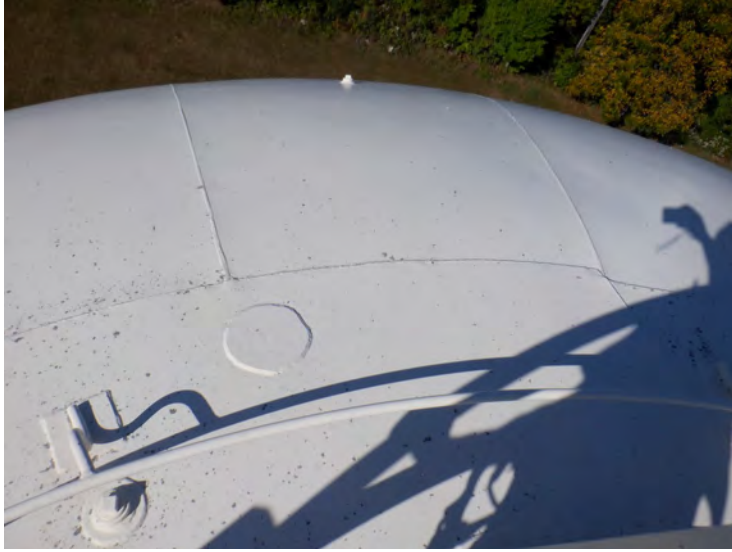
16) Same.

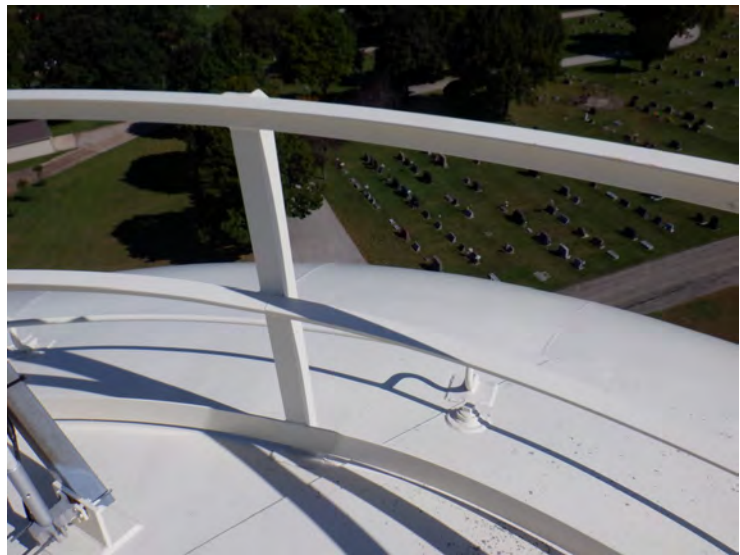
17) The roof handrail and painter's railing are in good condition.

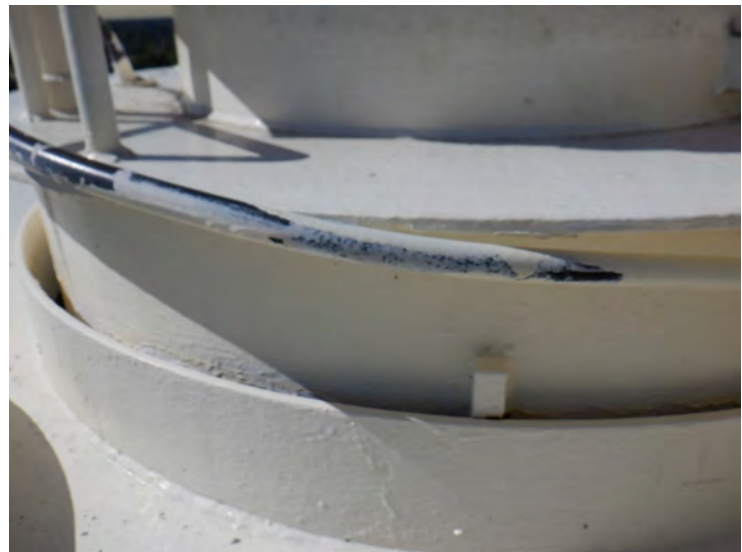
20) There is no cover over the access tube air gap.

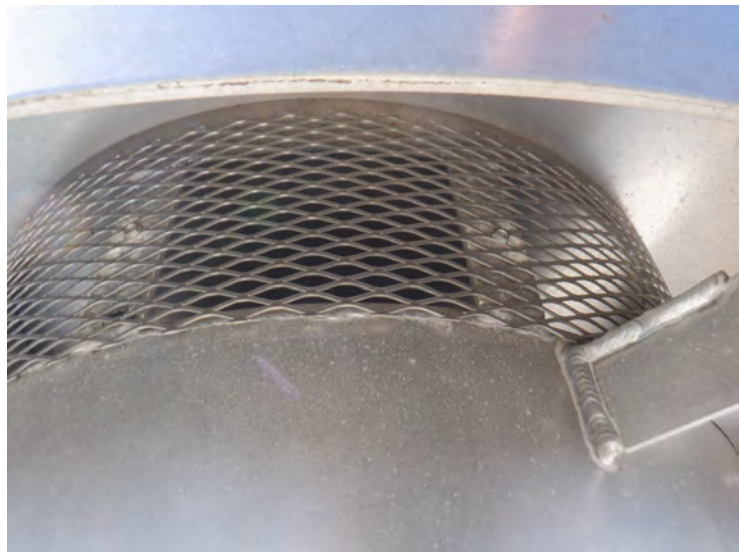
23) The vertical roof vent screen is in good condition.

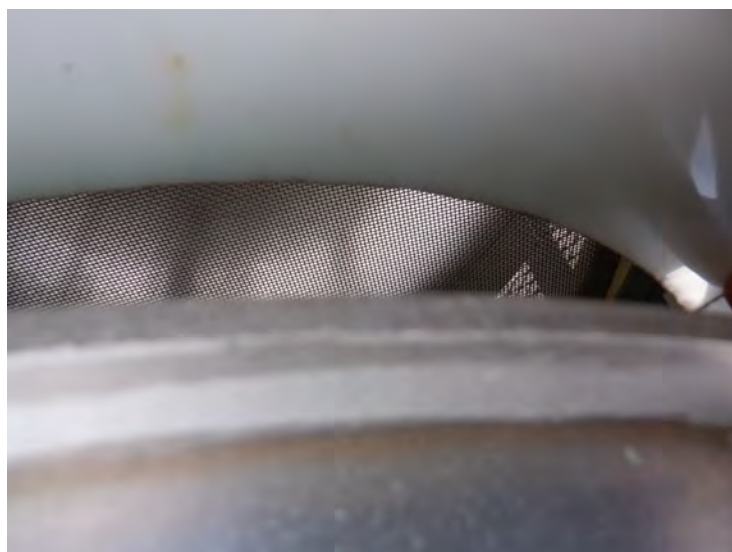
24) The interior roof vent screen is intact with no gaps.

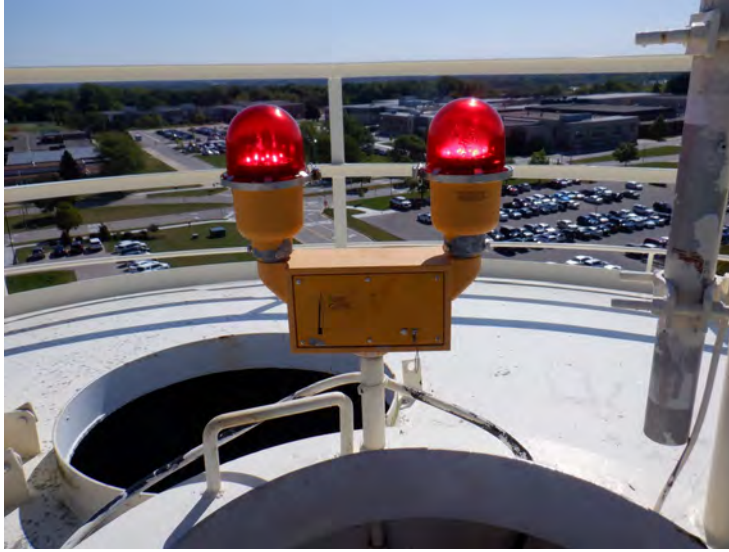
25) The double aviation light was operating properly during the inspection.

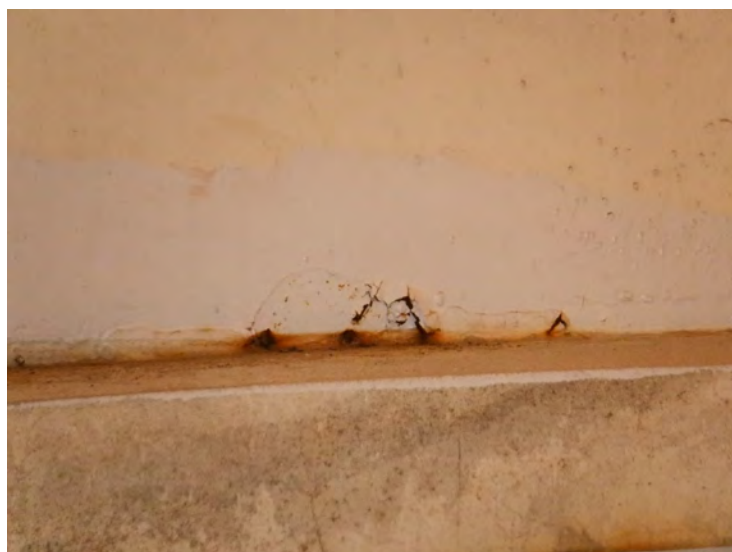
33) Coating failures along a stiffener in the dry riser.

2. Spot abrasive blast clean the topside of the platforms, the entire access tube, transition cone, and other spot coating failures in the dry interior. Spot repaint all prepared surfaces with an epoxy coating system. The estimated cost is \$30,000.

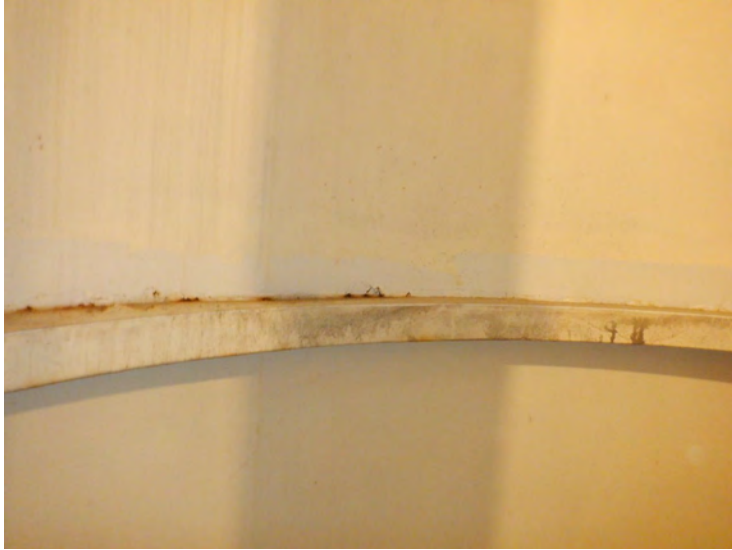
34) Same.

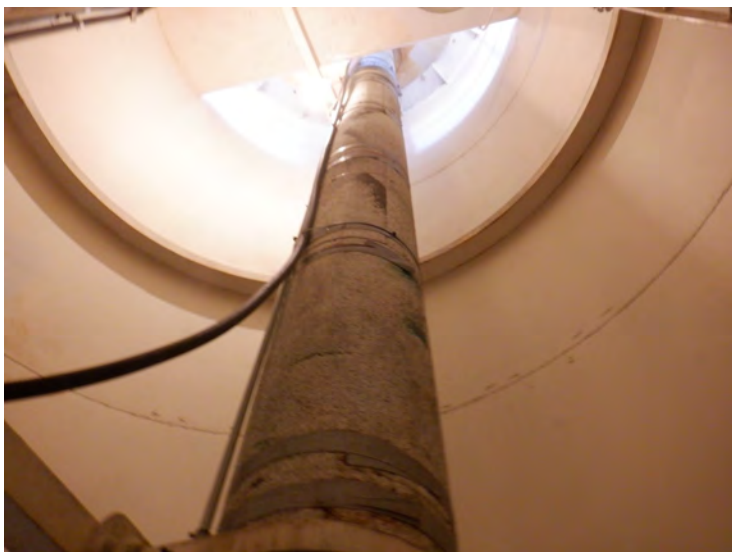
36) There is no cover over the fill/draw pipe insulation.

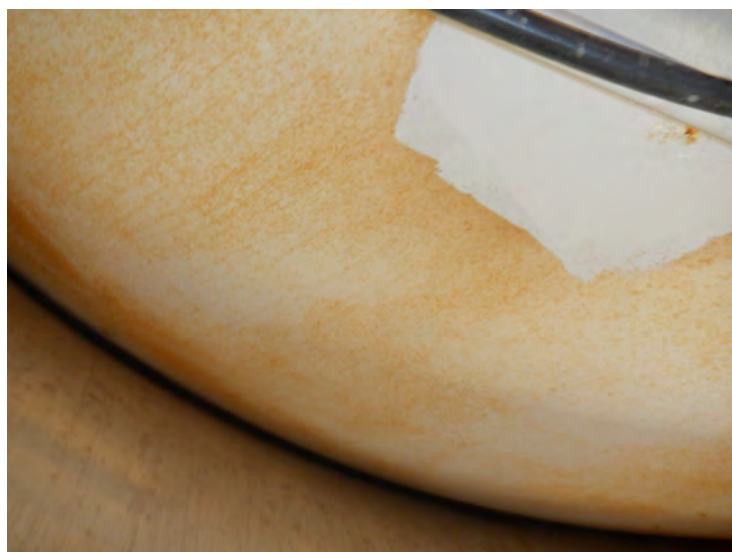
45) Same.

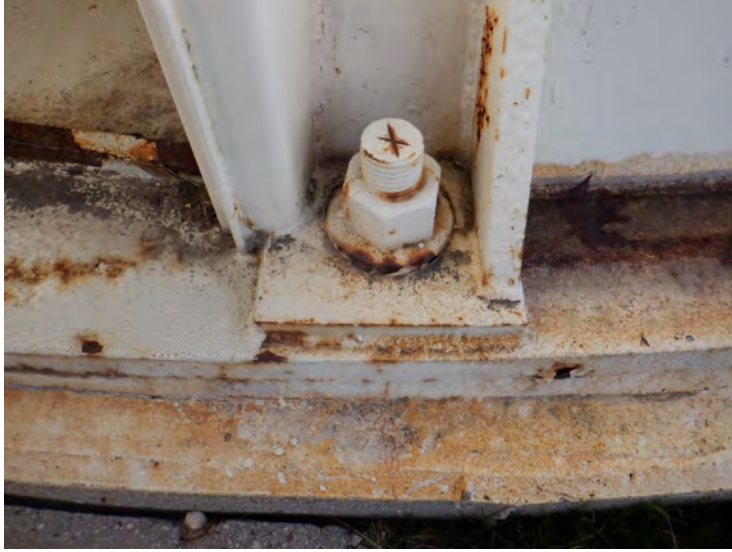
1) The foundation, grout, and anchor bolts are in good condition.

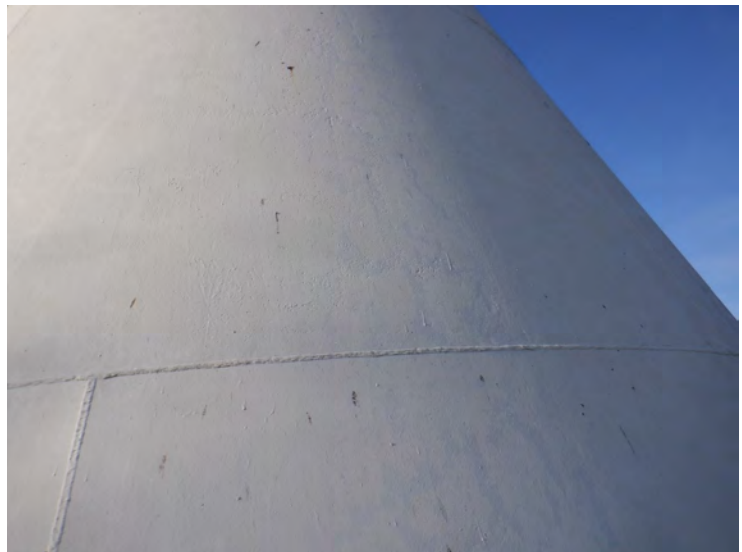
8) Same.

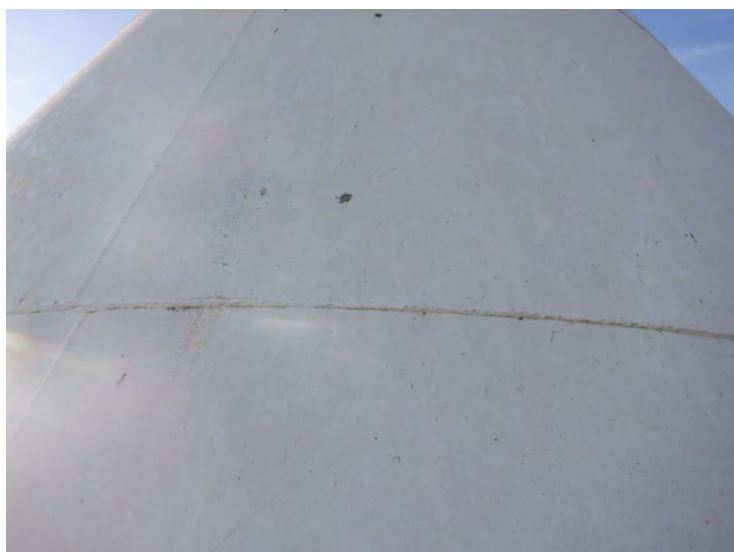
9) Same.

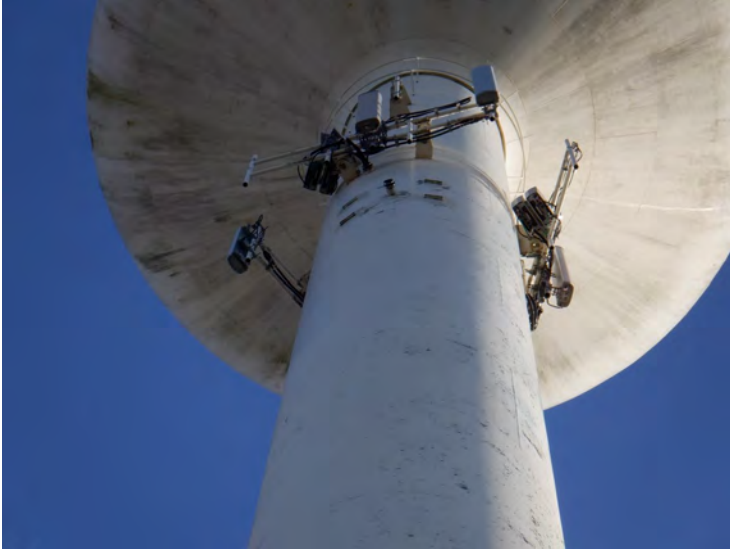
13) Same.

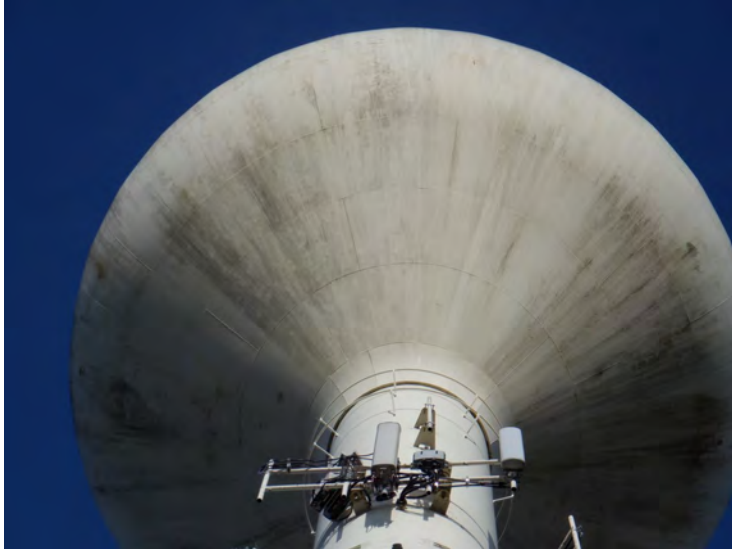
16) The bowl is covered with moderate mildew growth.

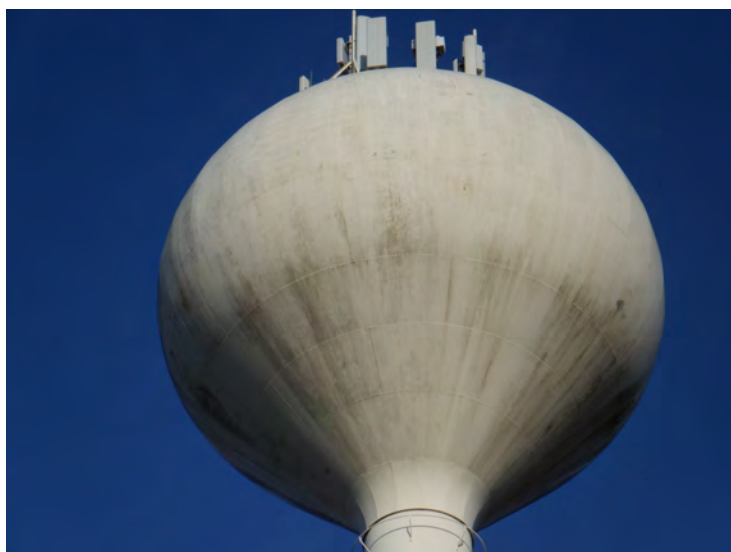
18) The sidewall coating is in good condition overall.

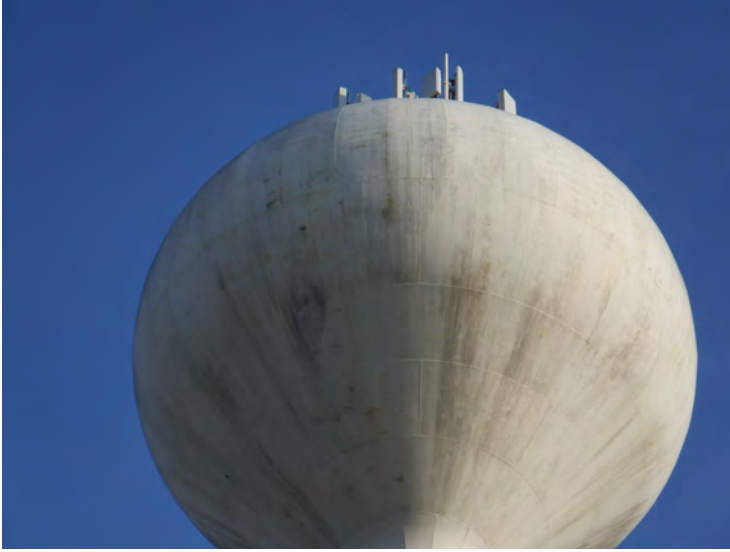
19) Same.

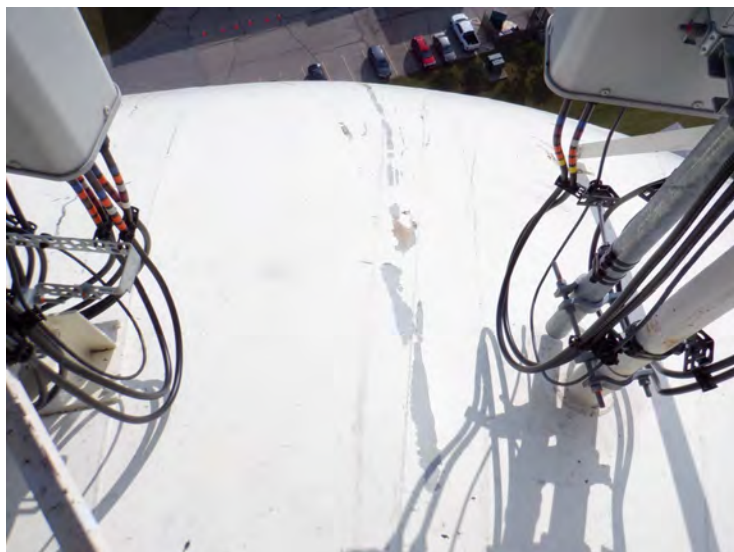
21) Same.

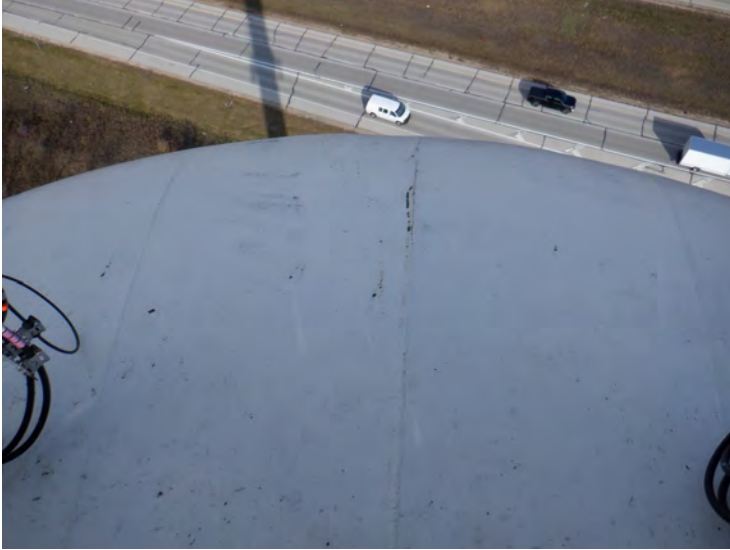
22) Same.

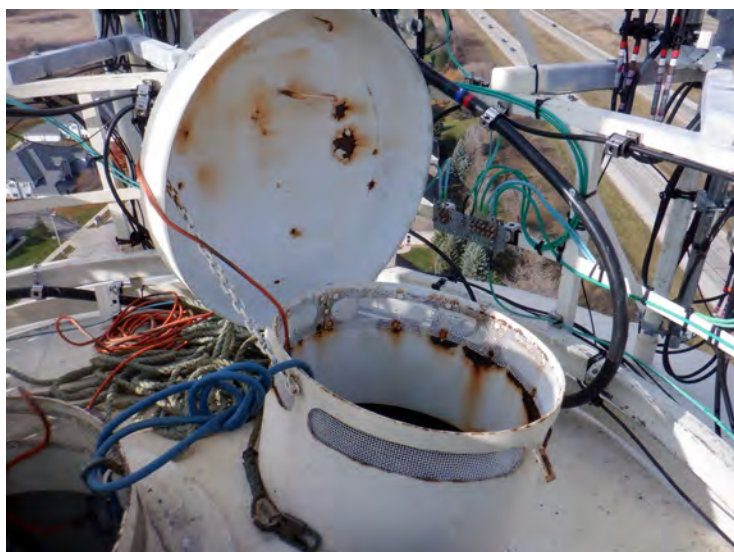
24) There is not a gasket on the wet interior roof hatch.

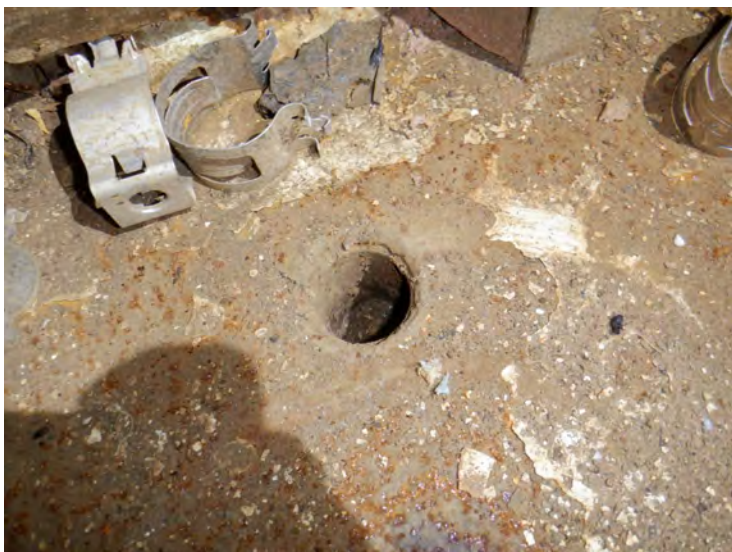
36) Same.

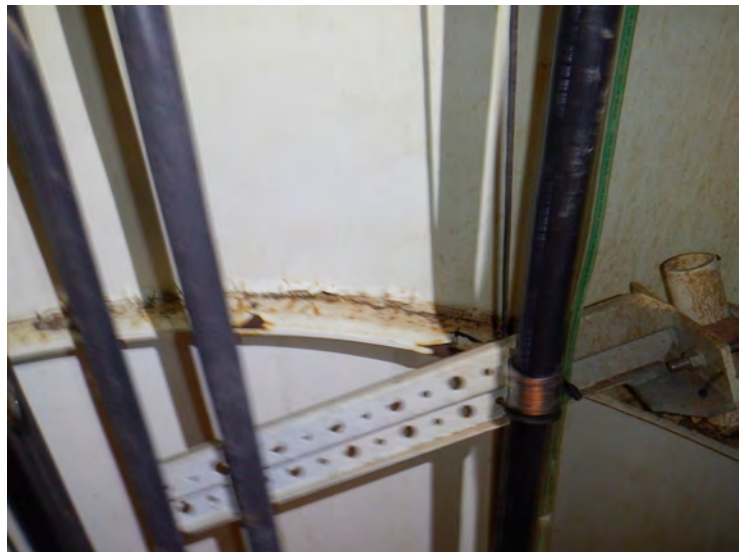
38) Same.

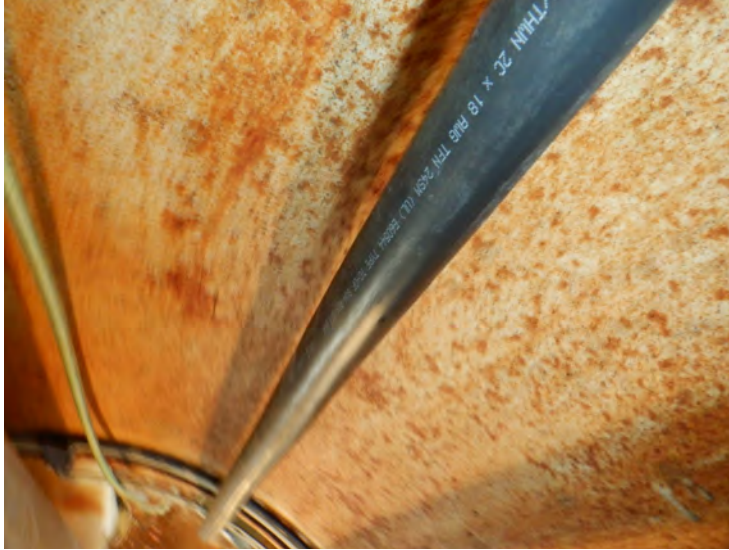
49) Same.

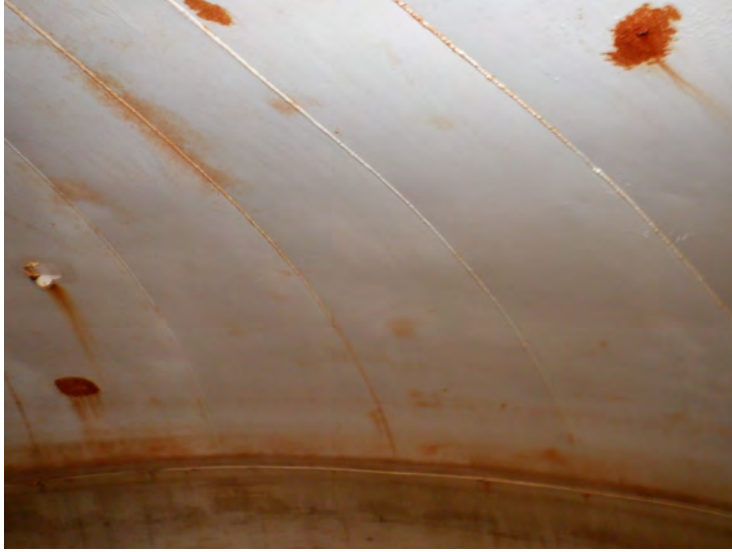
52) Same.

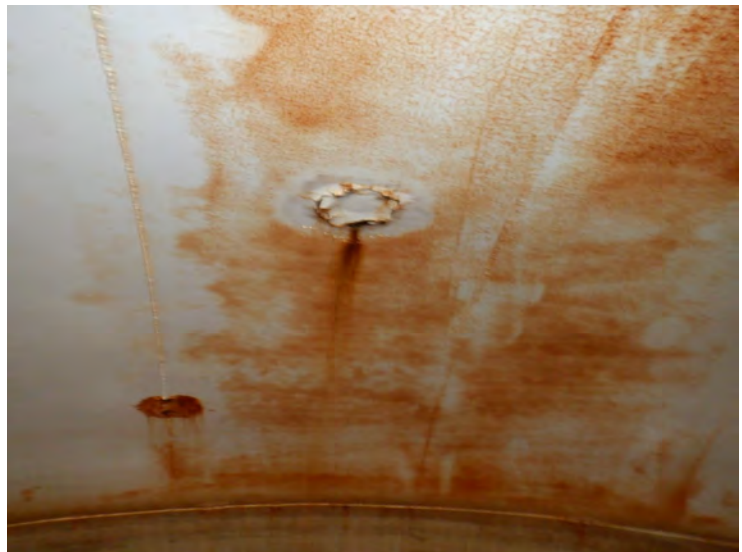
53) Same.

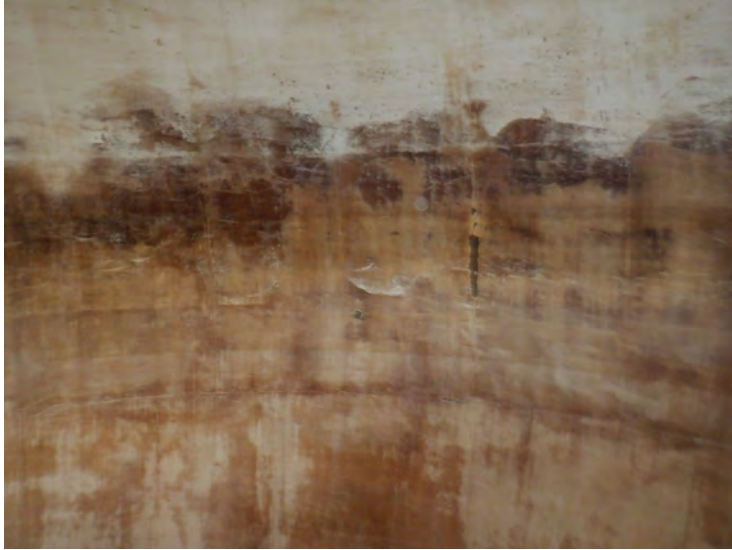
55) Same.

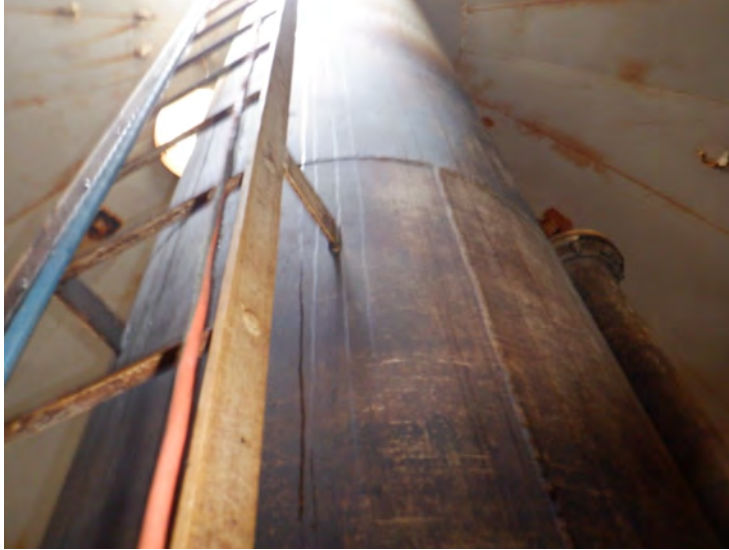
59) There is no significant coating deterioration on the access tube.

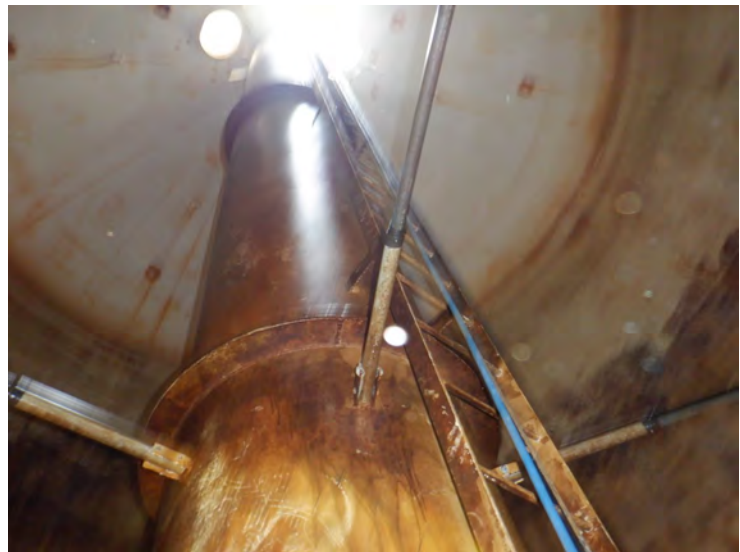
60) The cathodic protection system appears to be in good condition.

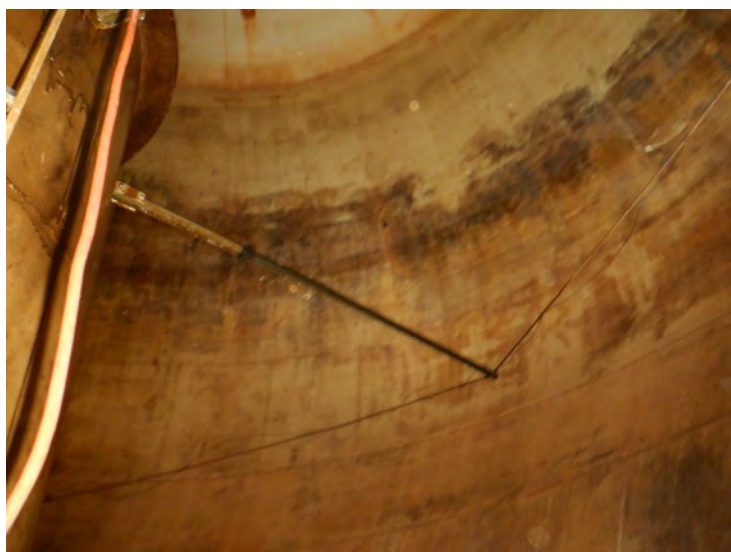
61) Coating failures in the transition cone.

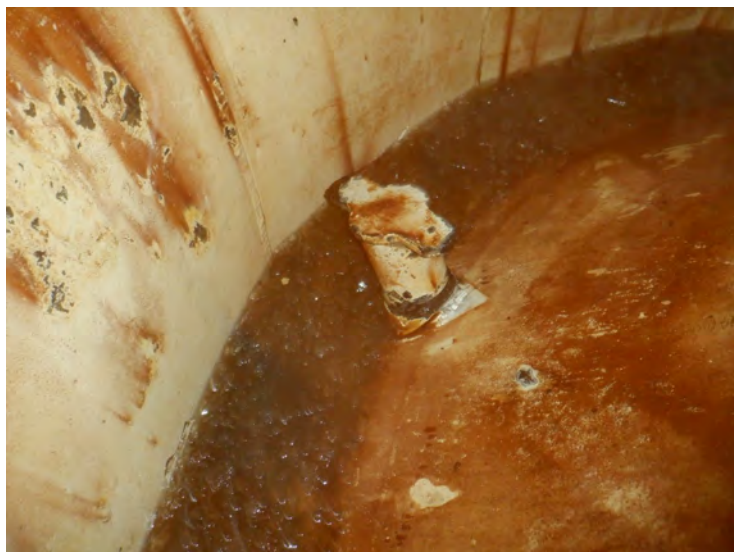
64) There are deflector bars over the fill/draw pipe in the wet interior.

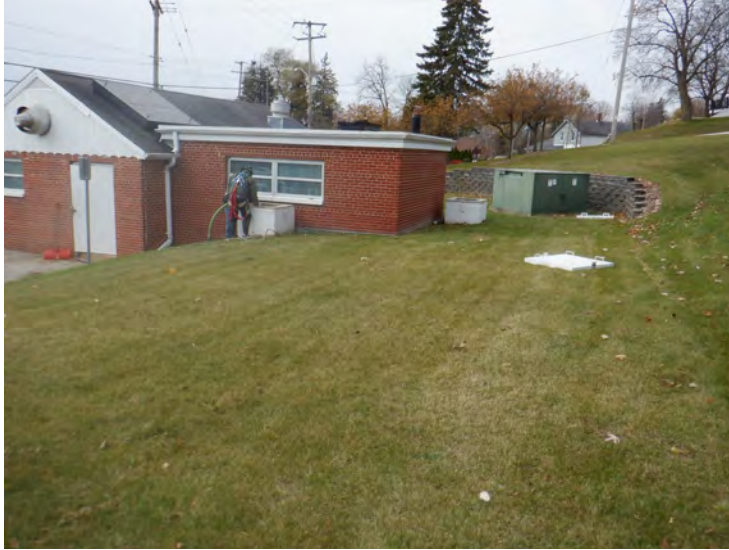
1) 125,000 gallon underground concrete water storage reservoir (Well 2) owned by the Village of Pewaukee, Wisconsin.

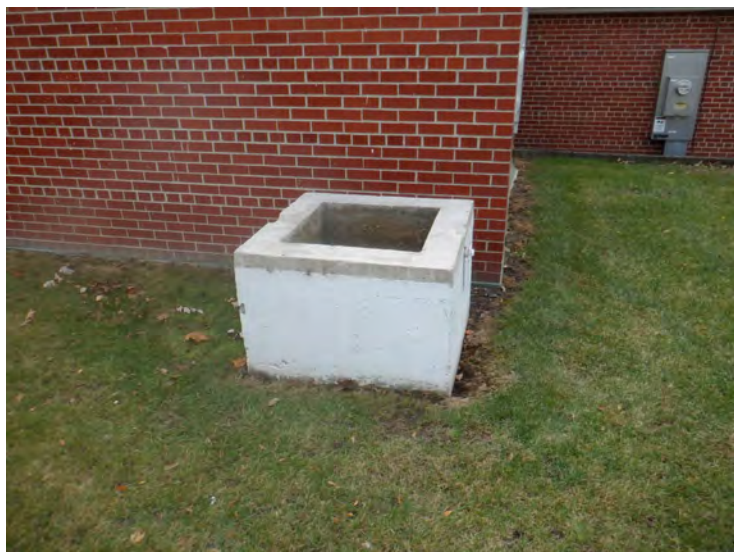
6) The roof hatch curb is more than 24 inches above grade.

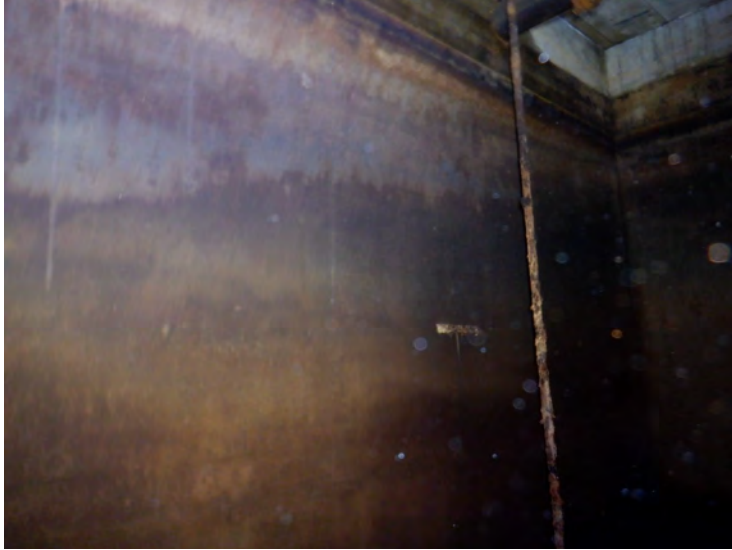
It is not known when the wet interior was last coated. The coating is likely an elastomeric system. The coating is located on the floor and sidewalls and is in fair condition. There are areas of delamination, spot failures, and erosion.

13) Elastomeric coating failures on the wet interior sidewall.

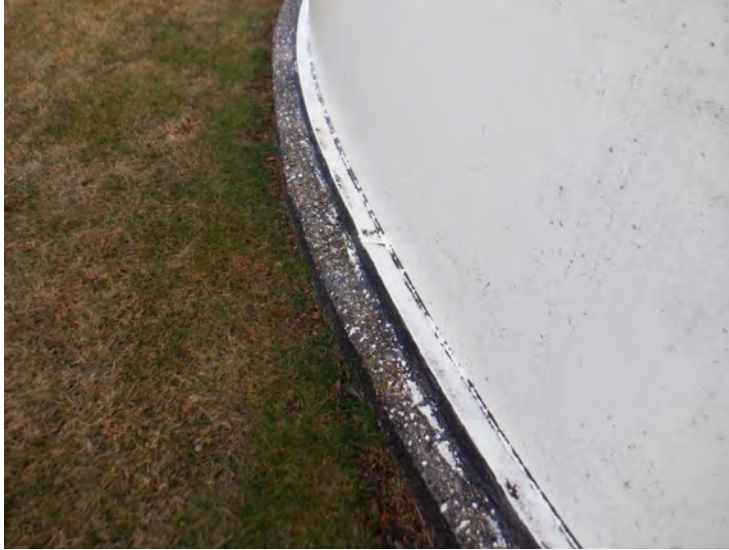
1) The foundation is in good condition overall.

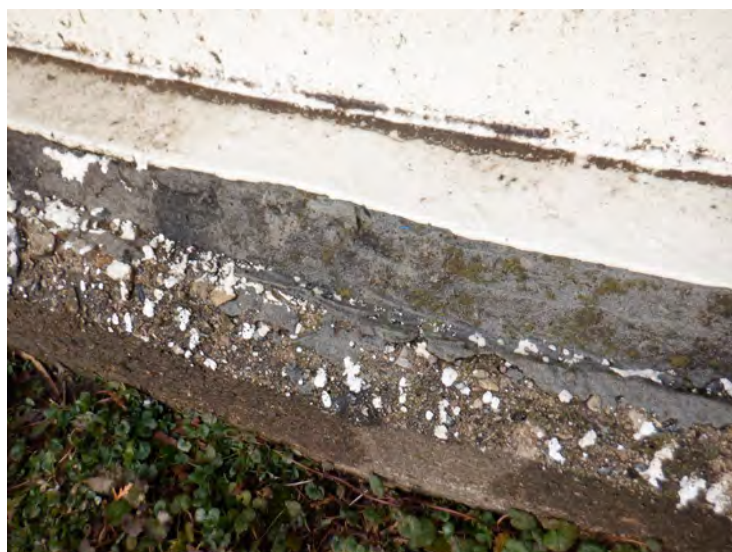
3) The grout between the baseplate and the foundation is in good condition with none missing or damaged.

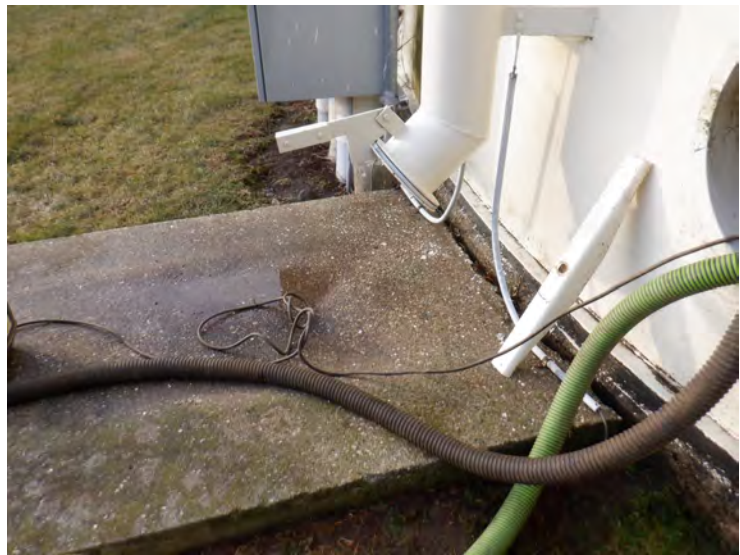
5) The overflow pipe discharges to a concrete splash pad.

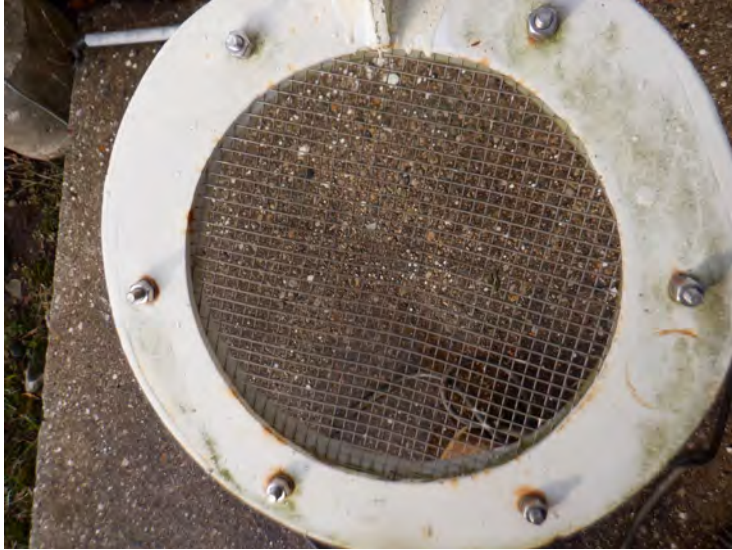
7) The screen is in good condition.

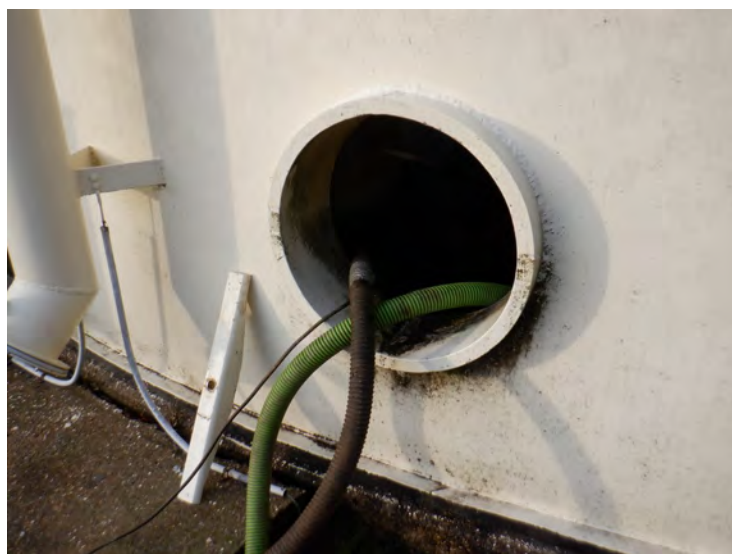
8) The two sidewall manways are in good condition.

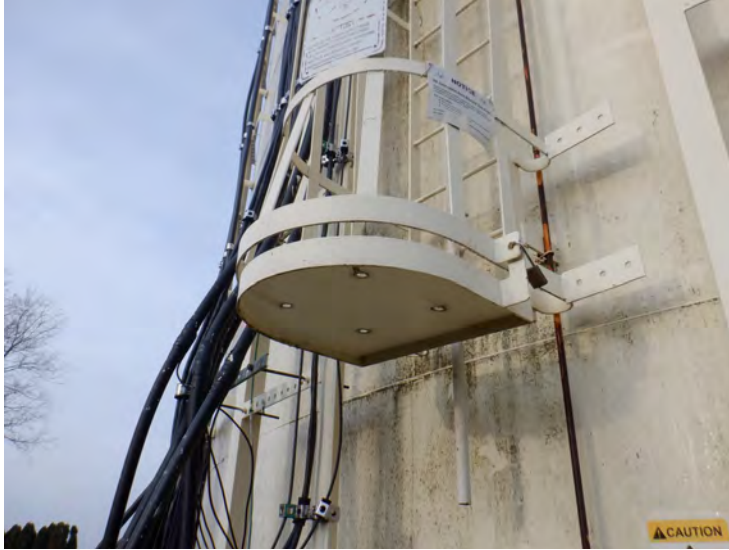
10) The sidewall ladder vandal guard is in good condition.

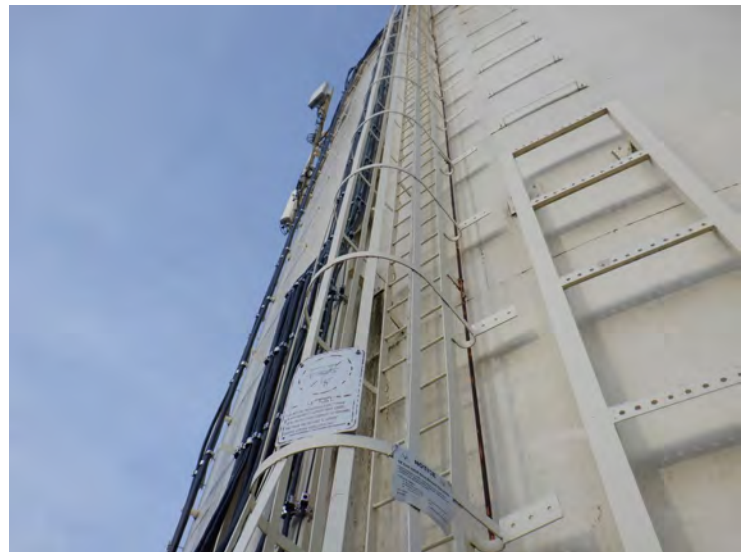
11) The sidewall ladder and cage are in good condition.

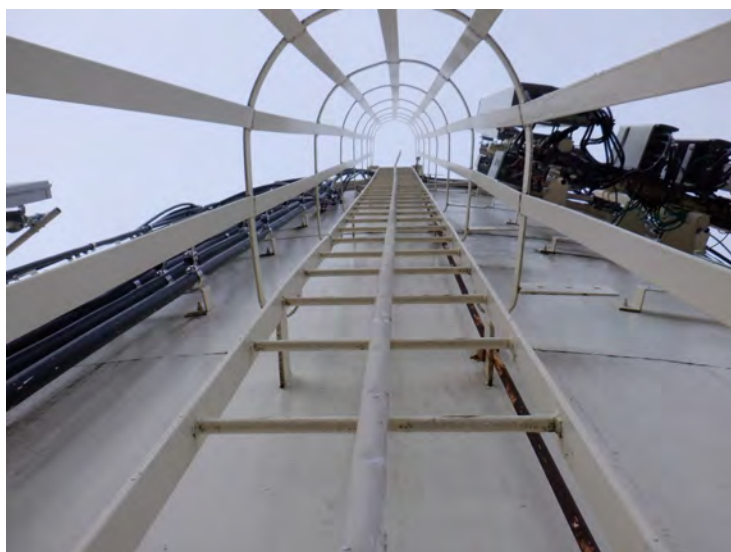
12) The sidewall ladder fall prevention device is coated.

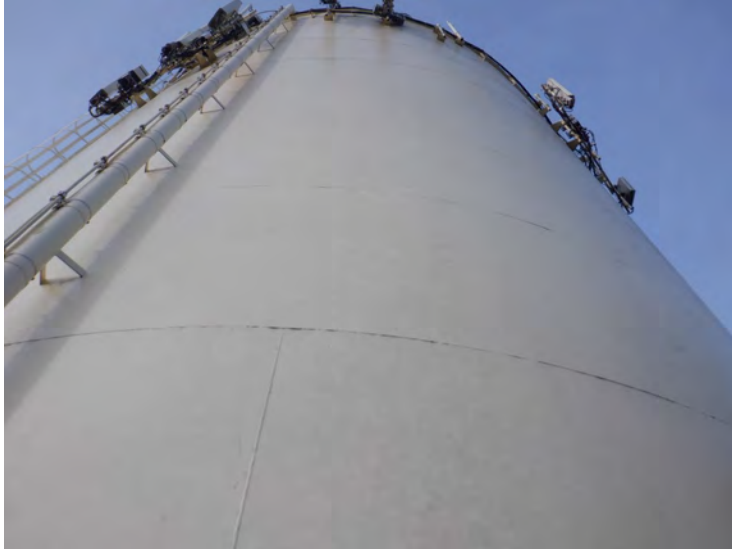
13) The coating on the sidewall is in good condition overall.

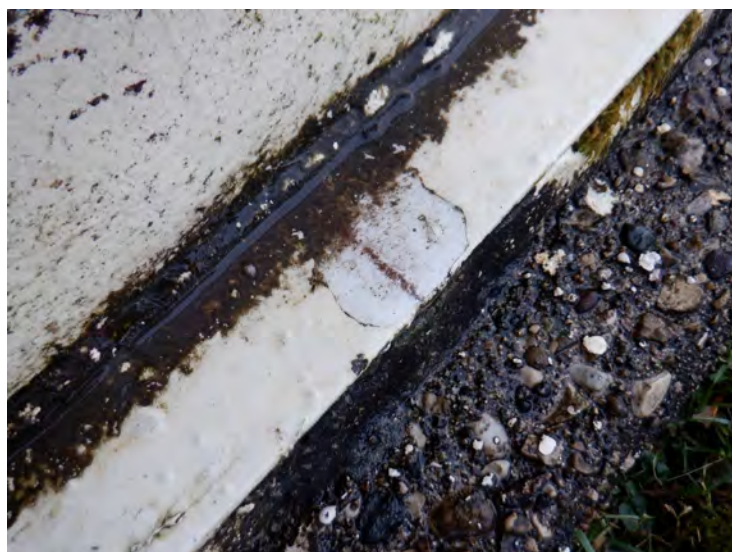
15) There is a small spot of delamination on the baseplate.

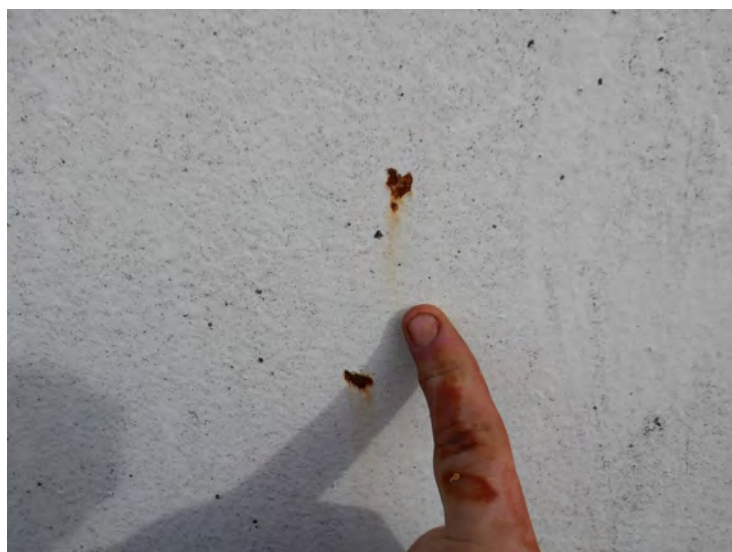
16) There are several small spot coating failures on the sidewall.

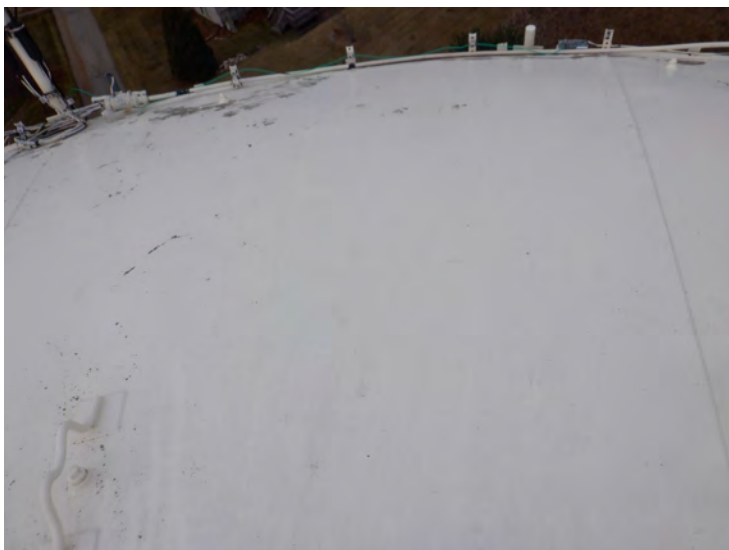
20) The coating on the roof is in good condition overall.
