Regular Village Board Meeting Agenda

July 19, 2022 – 7:00 pm
Village Hall, 235 Hickory Street, Pewaukee, WI 53072

250,000 gallon spheroid (Lake Street) elevated water storage tank owned by the Village of Pewaukee, Wisconsin.

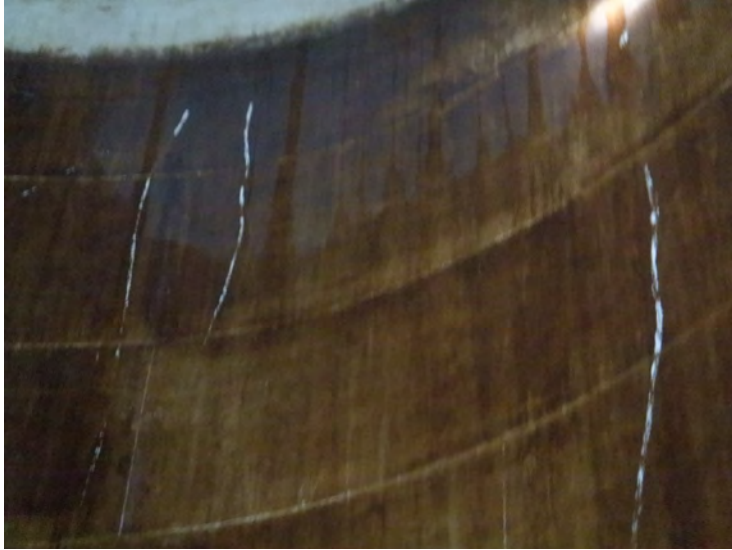
49) The scratches could be a sign of ice movement.

50) There are blisters in the sidewall coating on the lower sidewall panels.

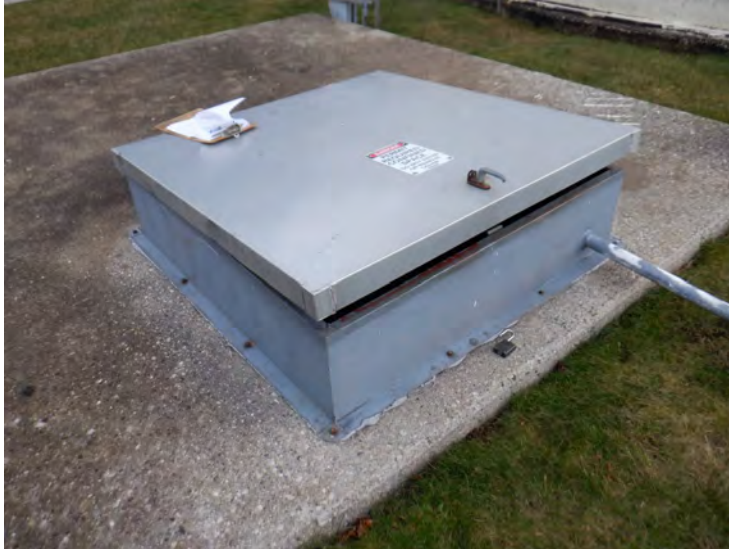
61) There is a pit adjacent to the tank. The pit has a metal hatch that is in good condition.

62) There is a sump pump in the pit.

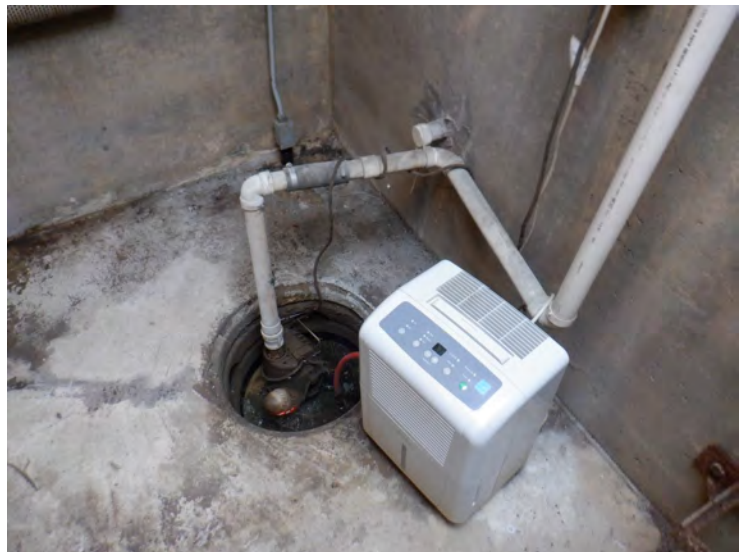
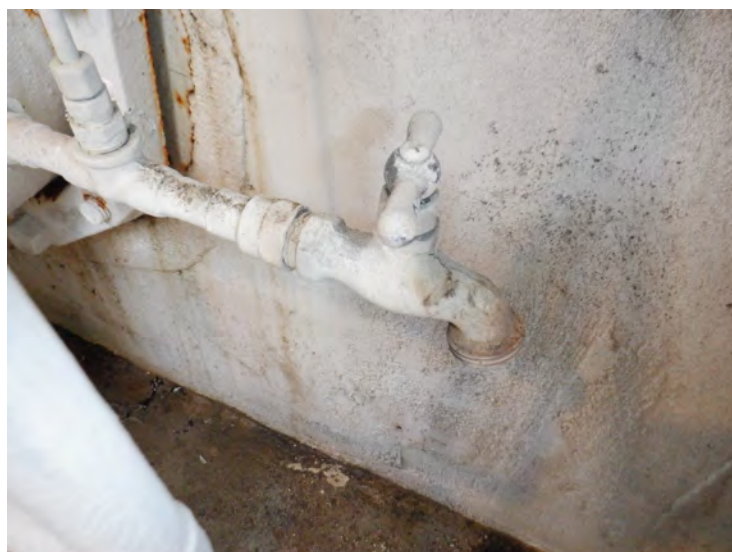
63) The sample tap is in good condition but has a threaded end.

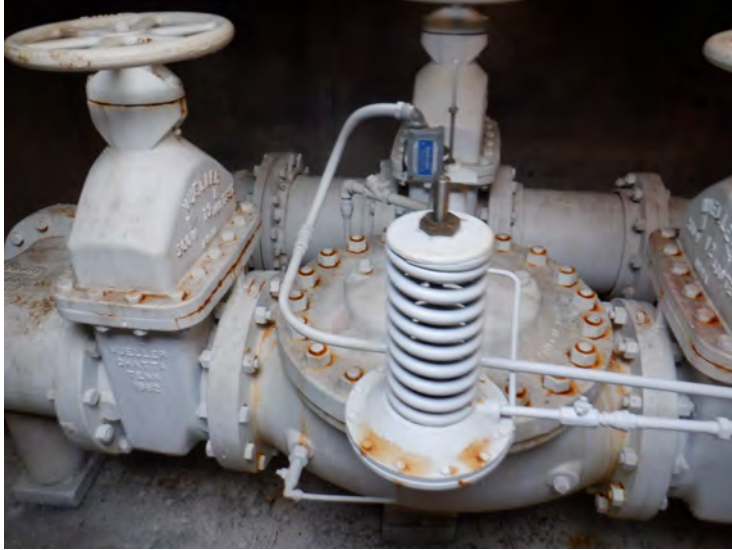
64) The coating on the piping is in good condition overall.

65) There are spot coating failures on the bolts and flanges.

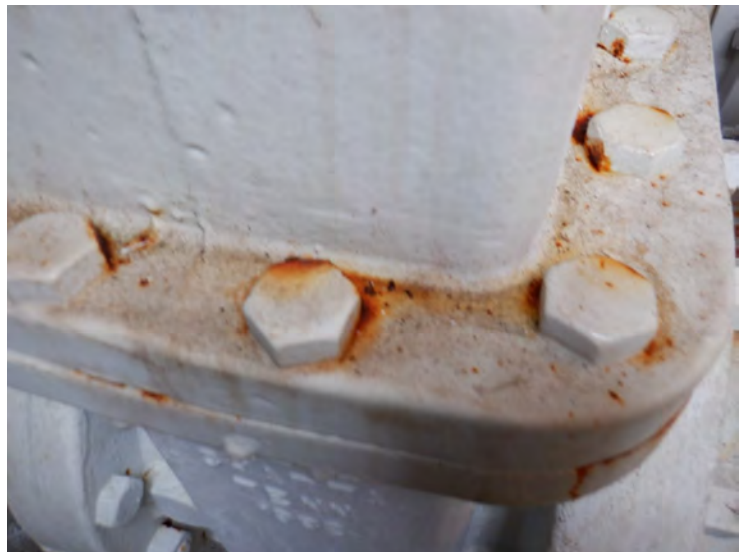
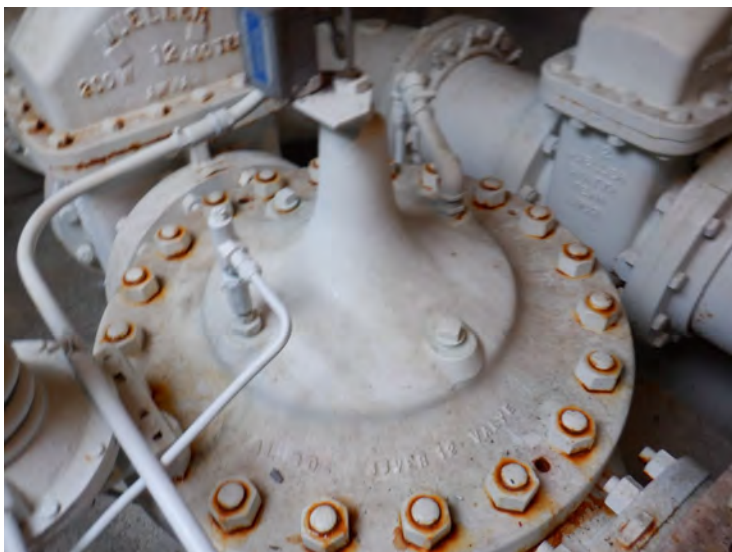
66) Same.
