Water System Master Plan

June 7, 2022

PREPARED FOR:
Village of Pewaukee
235 Hickory Street
Pewaukee, WI 53072

PREPARED BY:
Ruekert & Mielke, Inc.
W233 N2080 Ridgeview Parkway
Suite 300
Waukesha, WI 53188

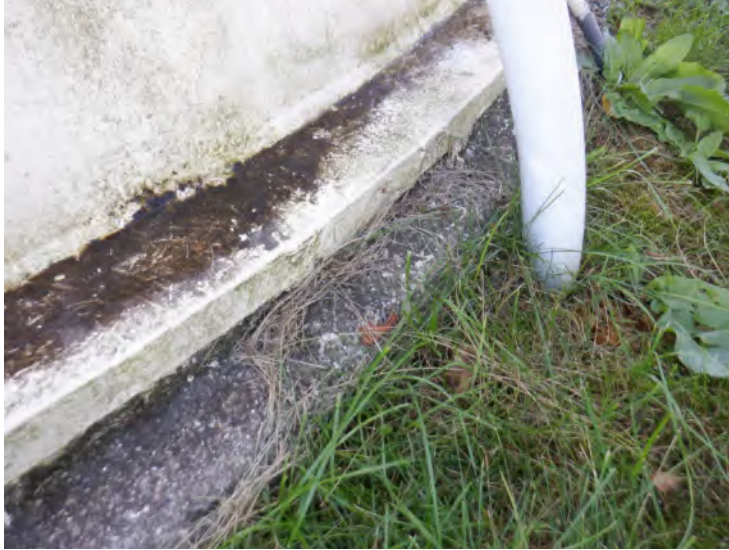
1) The concrete foundation is in good condition with no significant deterioration.

2) The anchor bolts are in good condition. There is no missing grout between the baseplate and foundation.

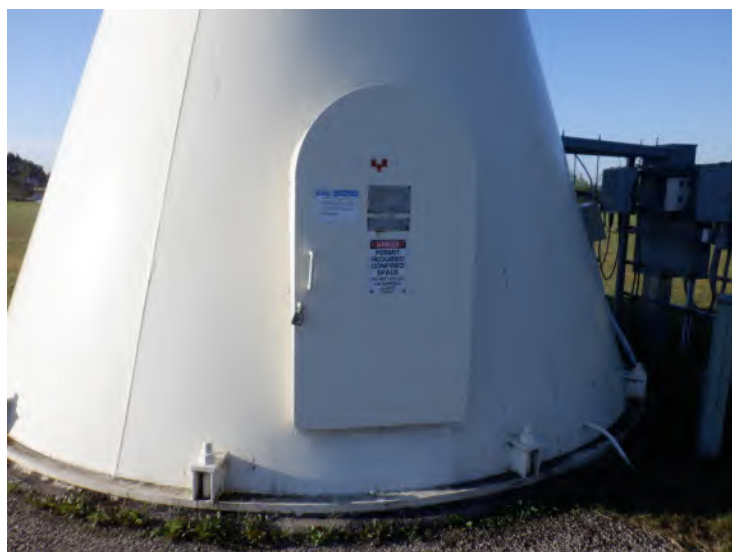
3) The service door operated properly during the inspection.

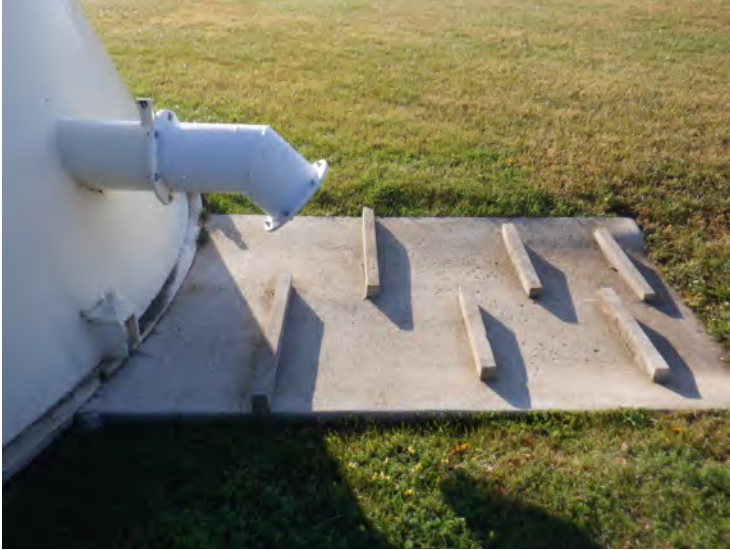
4) The overflow pipe discharges to a concrete splash pad.

5) The screen at the overflow discharge is intact but deformed and oversized.

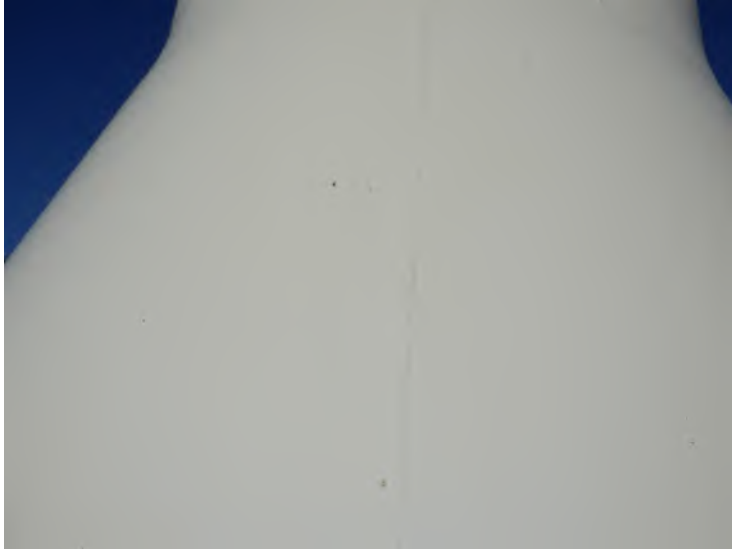
7) Same.

8) The riser coating is in good condition with no deterioration.

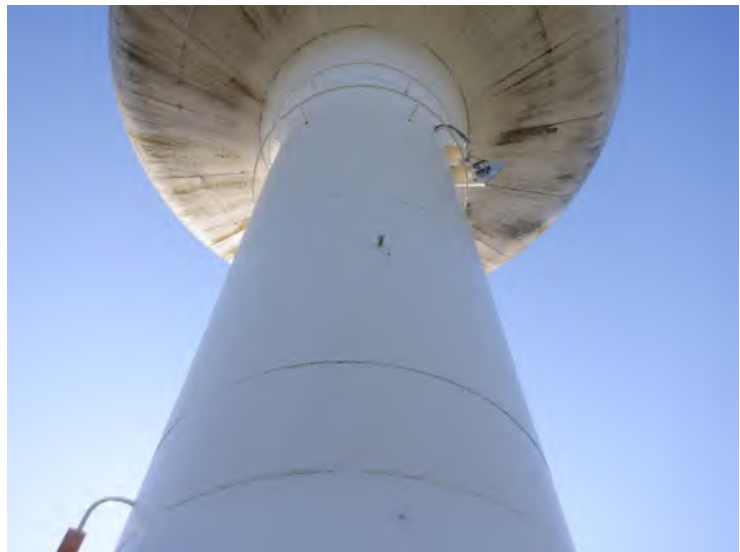
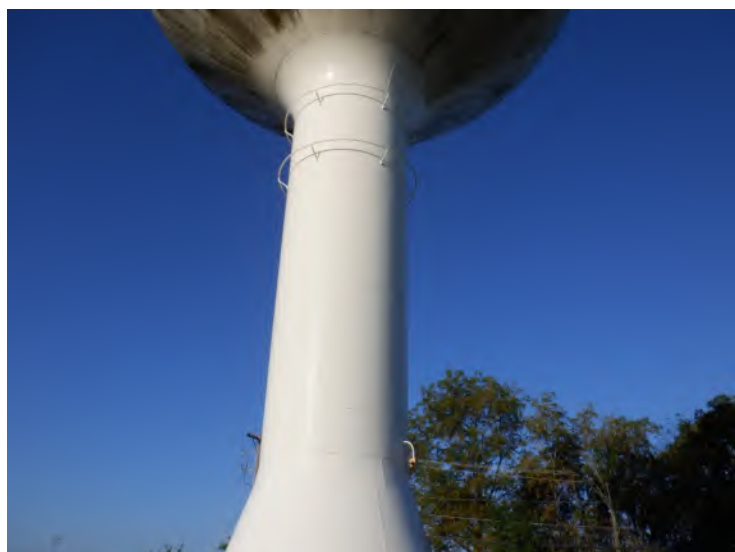
9) Same.

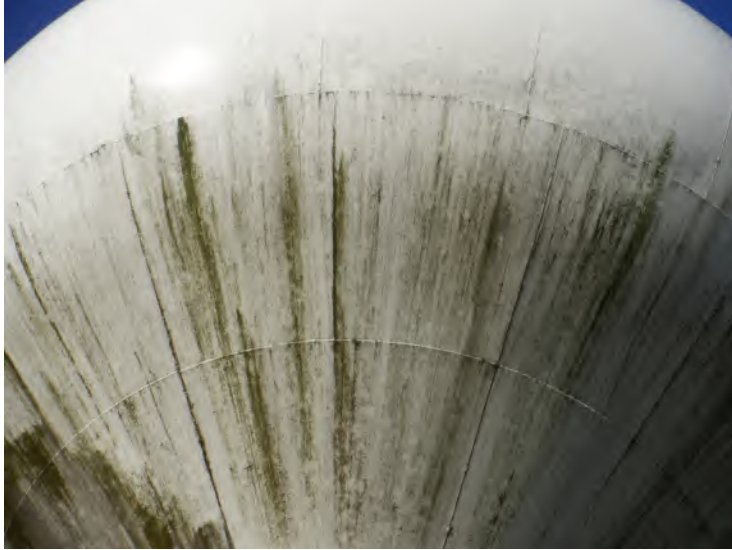
10) The bowl is covered with mildew growth but there are no visible coating failures.

11) Same.

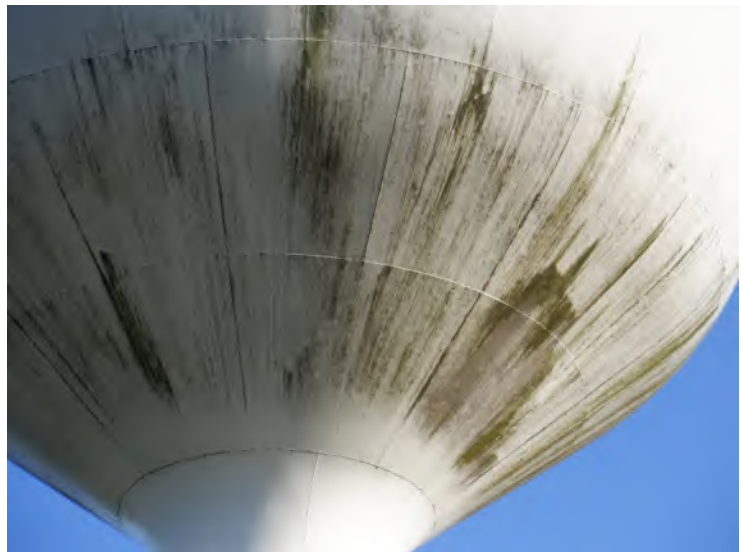
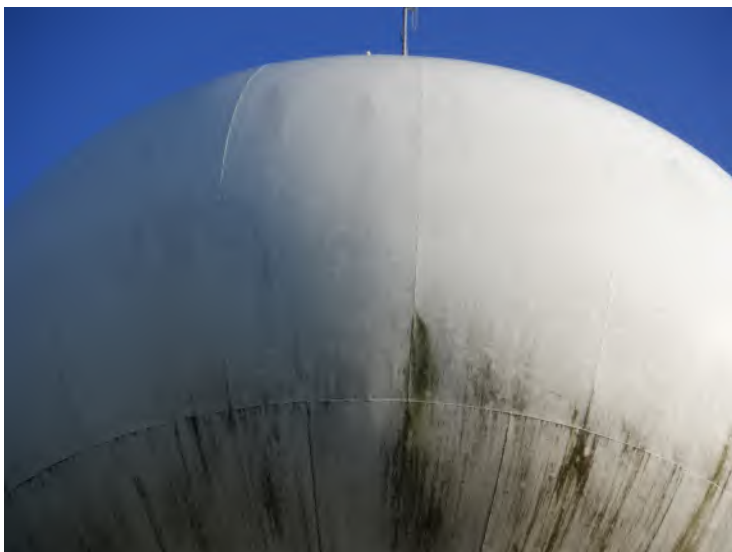
12) The sidewall coating is in good condition overall.

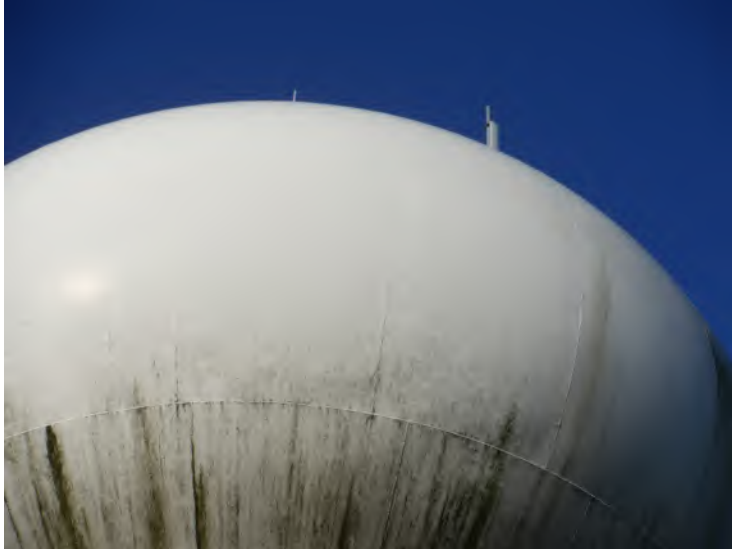
13) Same.

14) The roof coating has faded but there is no significant deterioration.

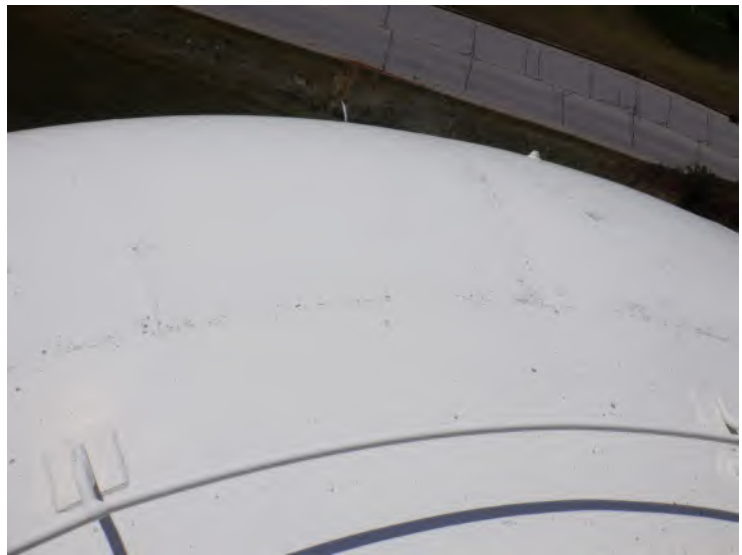
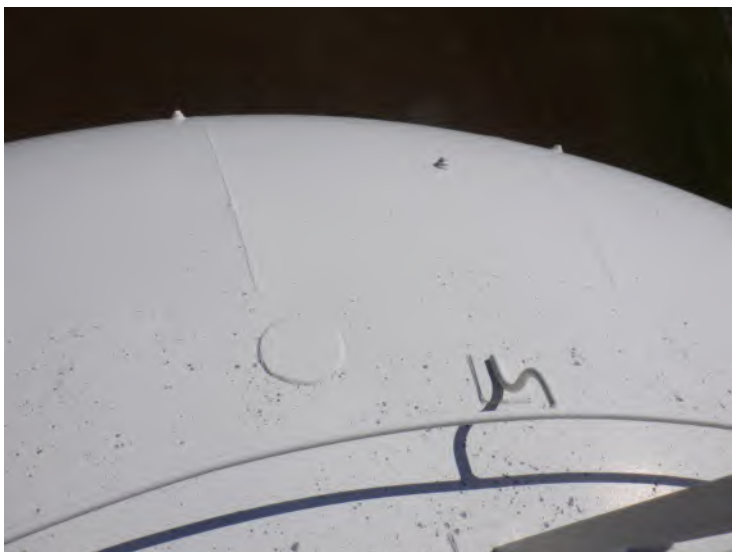
15) Same.

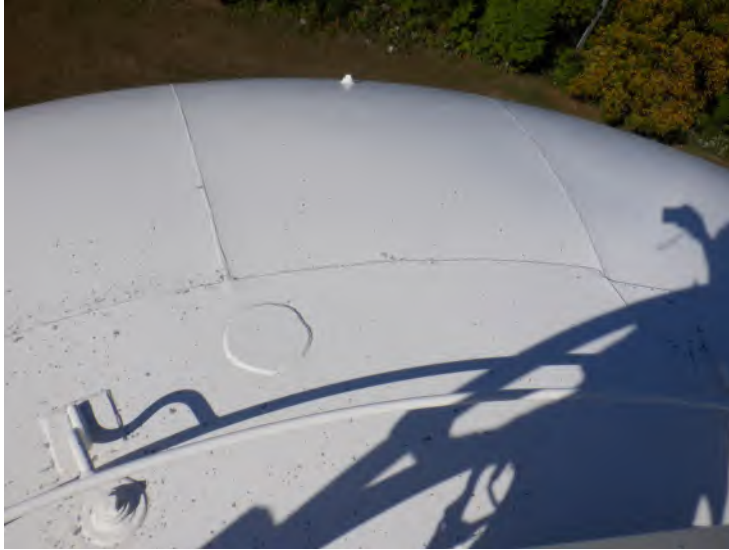
16) Same.

17) The roof handrail and painter's railing are in good condition.

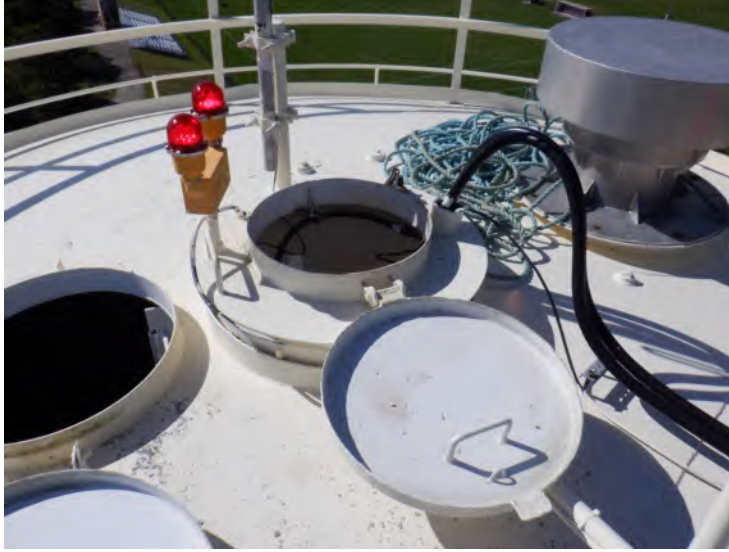
19) The dry interior roof hatch is in good condition.

20) There is no cover over the access tube air gap.

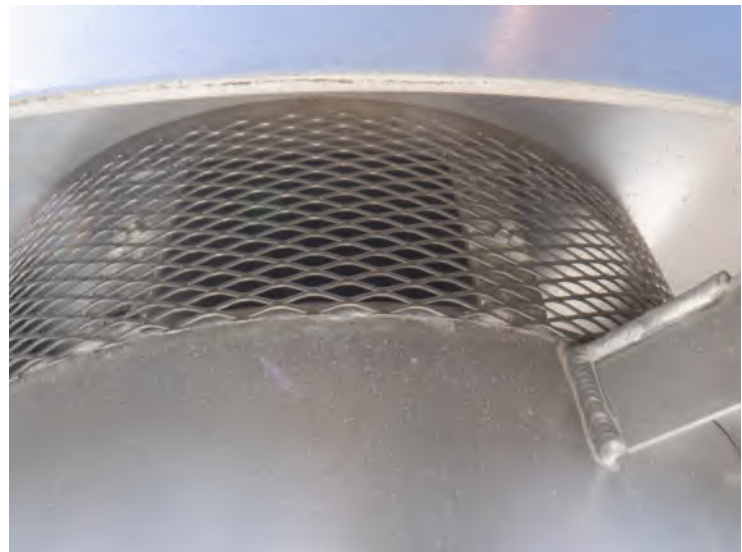
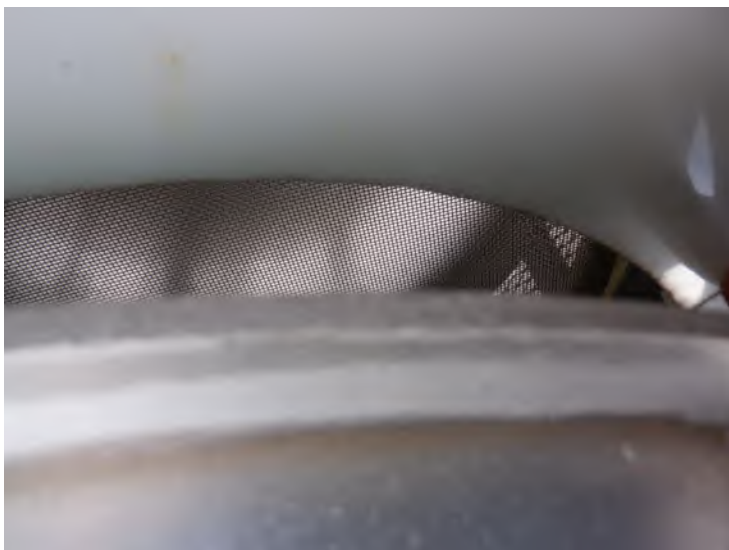
24) The interior roof vent screen is intact with no gaps.

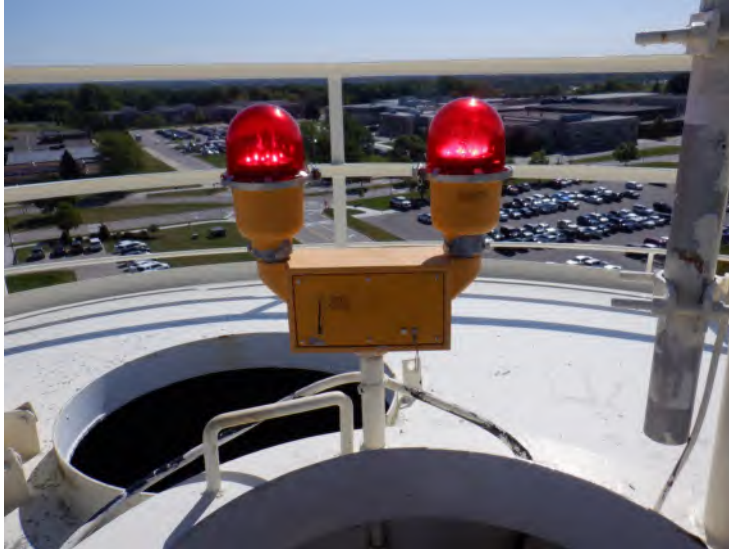
25) The double aviation light was operating properly during the inspection.

26) The dry interior basebell coating is in good condition overall with no significant deterioration.

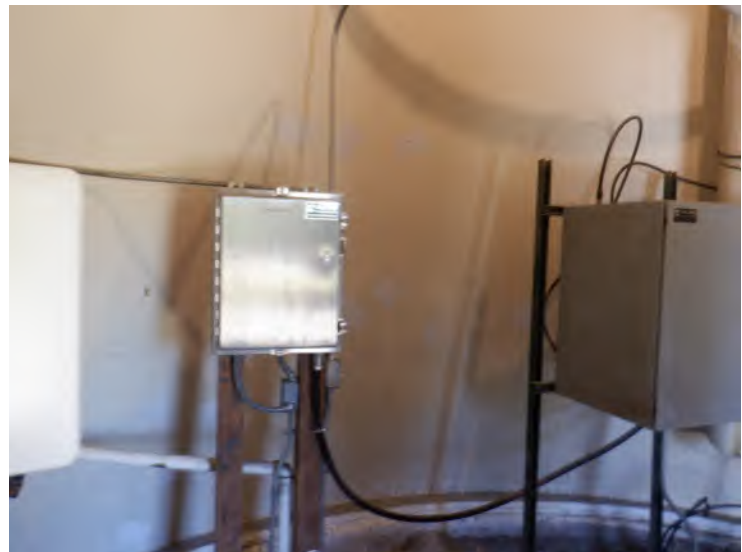
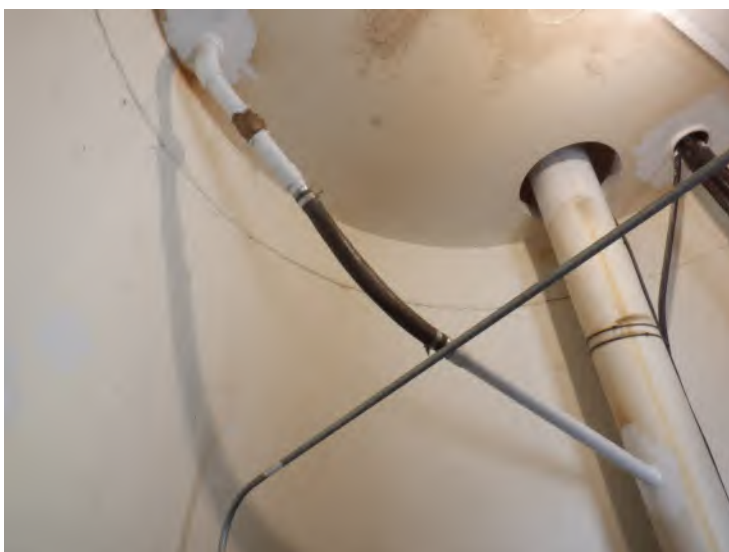
27) Same.

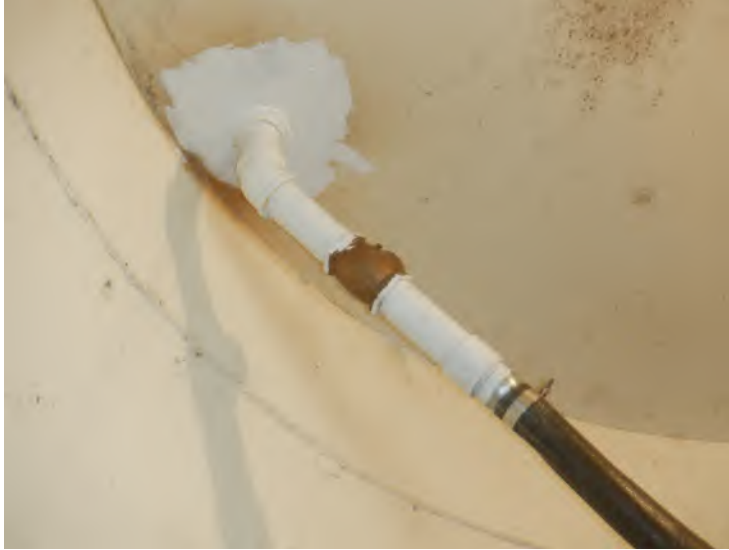
28) There is a check valve on the condensate platform drain.

29) The baseball ladder is in good condition. The ladder is equipped with a fall prevention device.

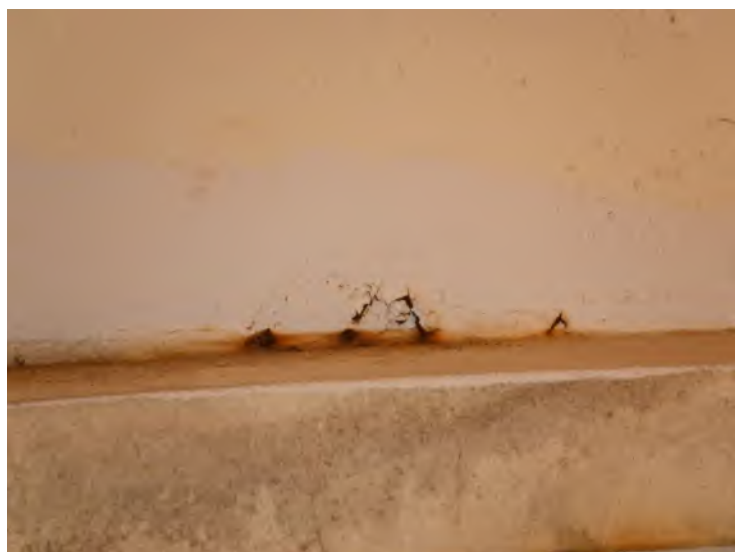
33) Coating failures along a stiffener in the dry riser.

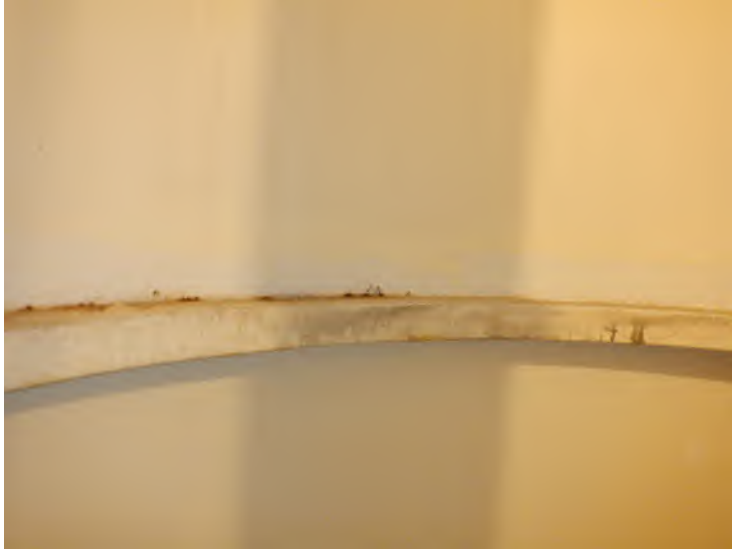
34) Same.

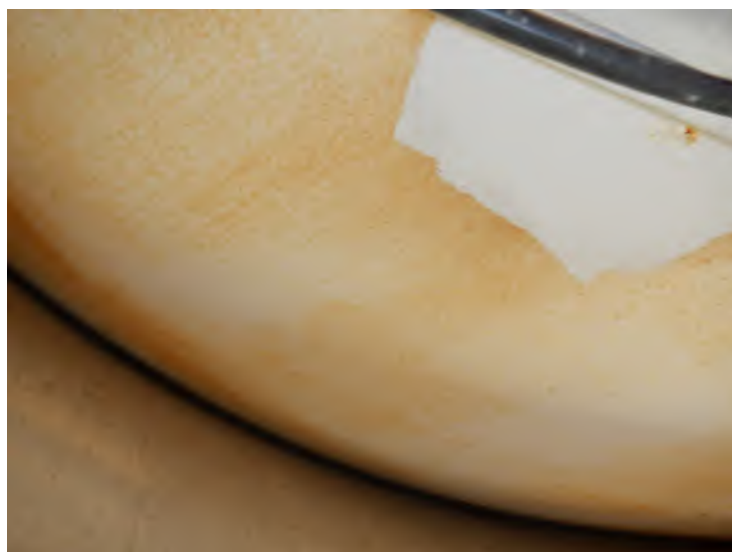
44) Extensive rust bleedthrough on the bowl.

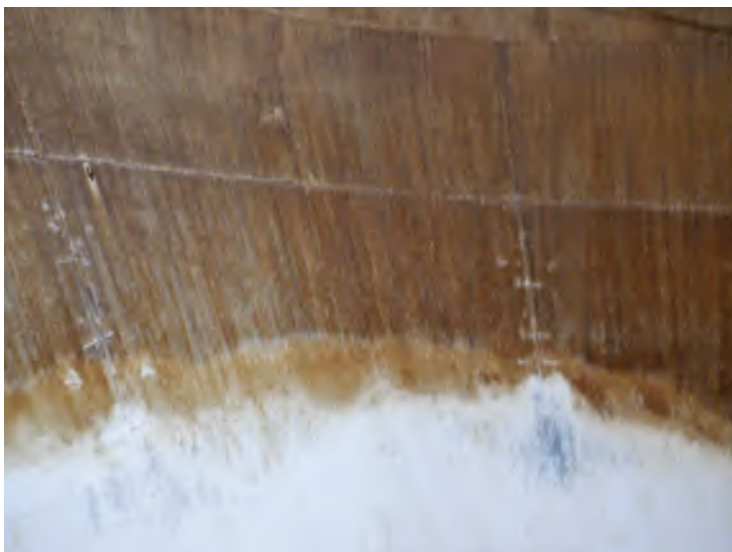
53) There is heavy mineral staining on the wet interior sidewall but no coating failures.

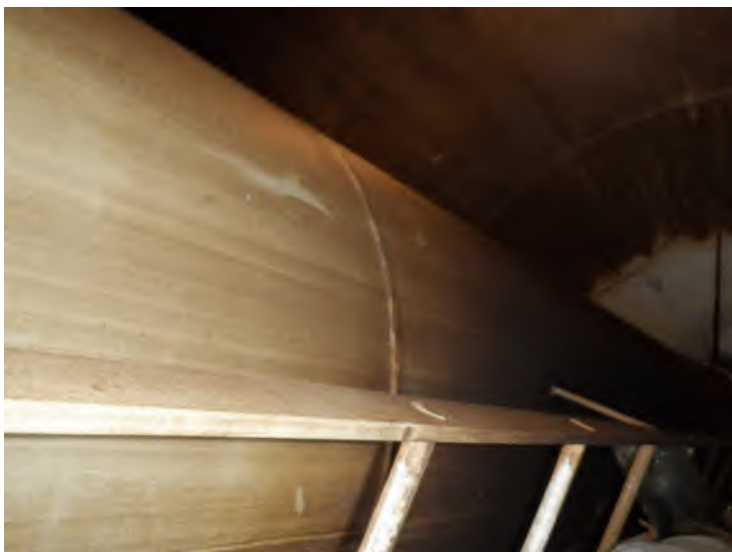
58) The cathodic protection system appears to be in good condition.

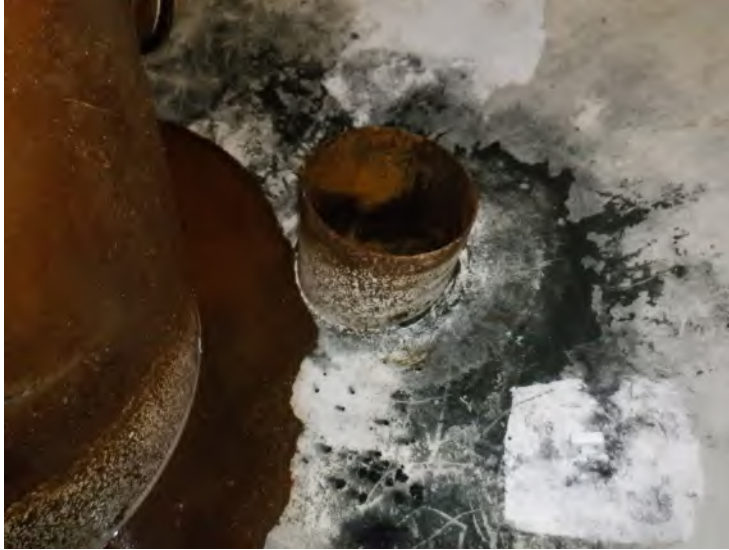
64) There are no deflector bars over the fill/draw pipe in the wet interior.

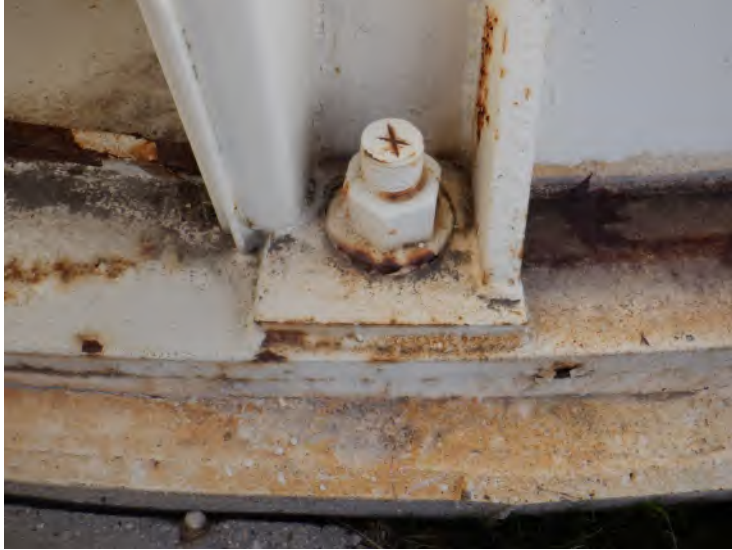
1) The foundation, grout, and anchor bolts are in good condition.

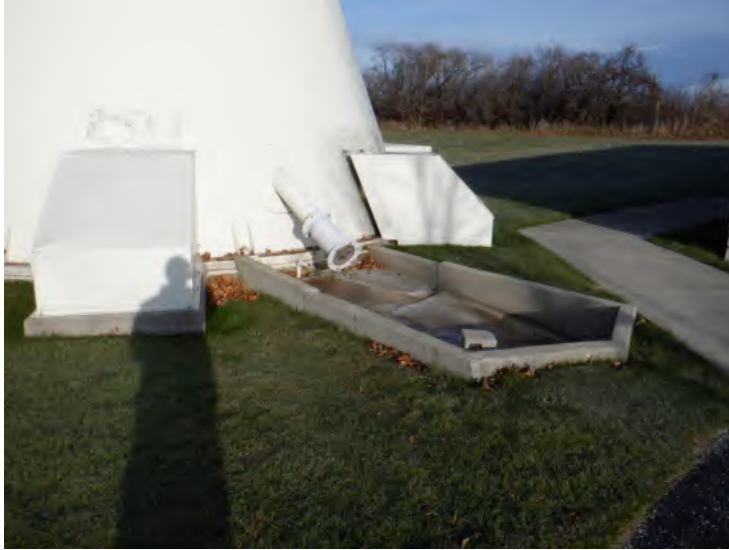
4) The overflow pipe discharges to a splash pad.

1. Modify the overflow pipe discharge so it points downward and so the air gap is 12 to 24 inches to bring it into compliance with current Wisconsin DNR requirements. The estimated cost is \$2,000.
2. Install a gasket on the wet interior roof hatch to meet current Wisconsin DNR requirements. The cost would be incidental to the next painting project or could be performed by in-house personnel.
3. Replace the roof vent with a pressure vacuum vent to meet current Wisconsin DNR requirements. The estimated cost is \$6,000.

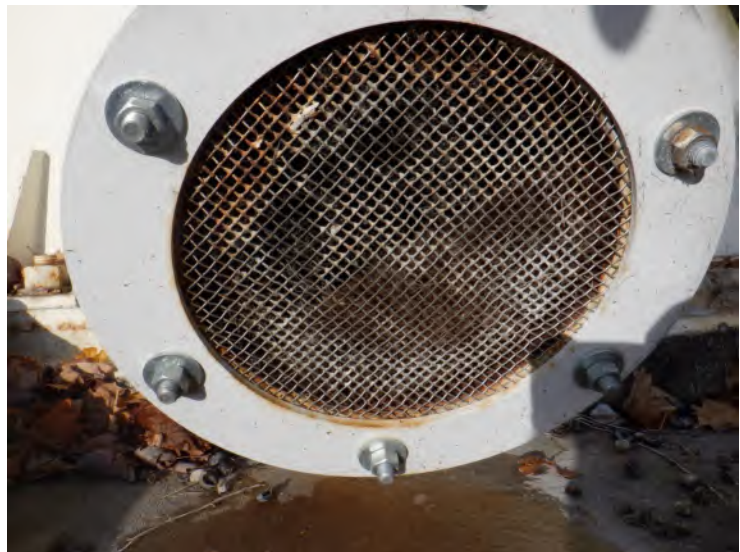
5) The screen at the overflow pipe discharge is intact with no gaps.

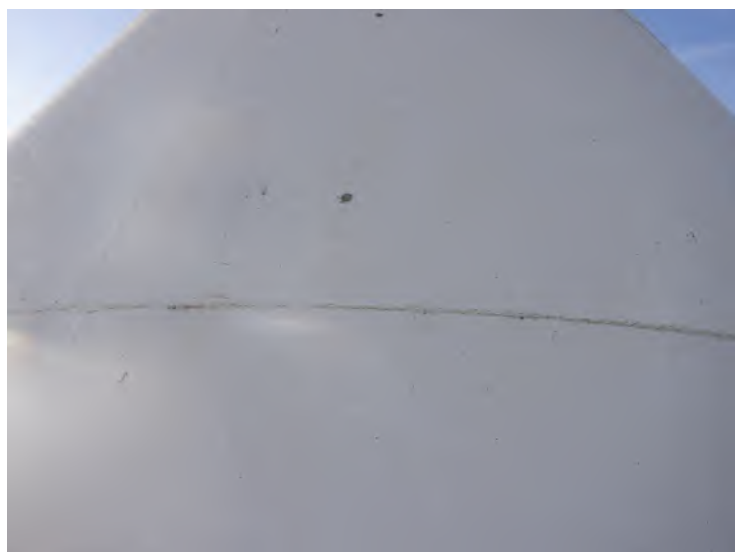
9) Same.

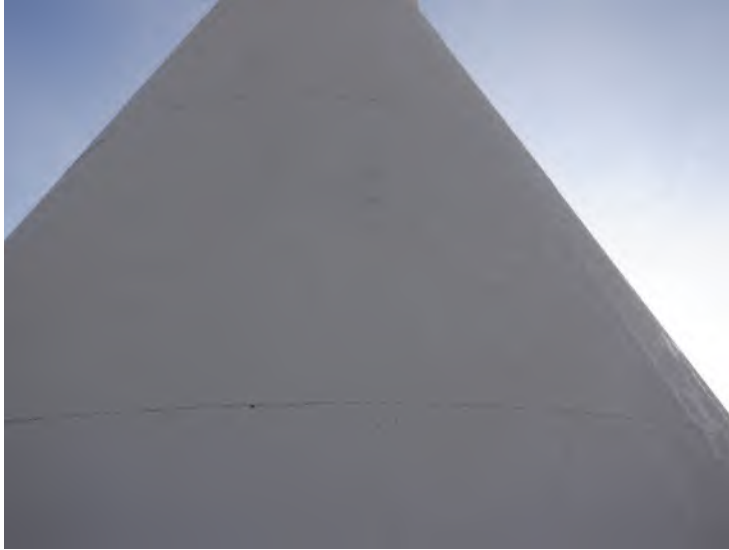
10) The basebell coating is in fair condition overall.

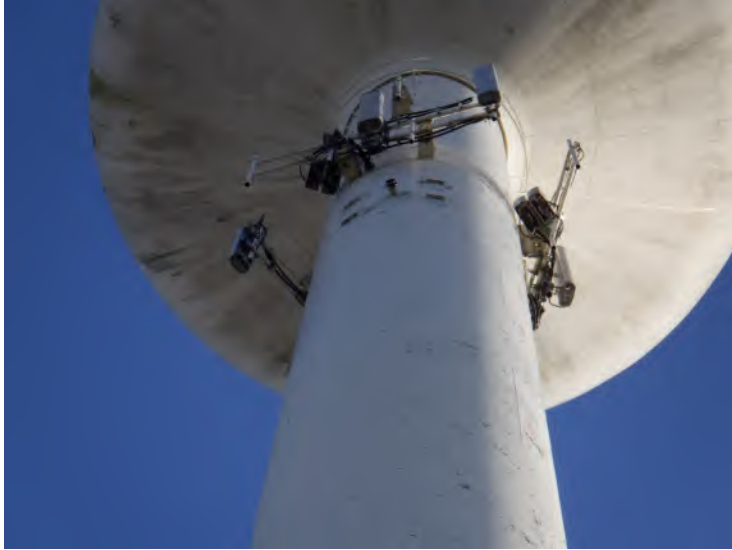
13) Same.

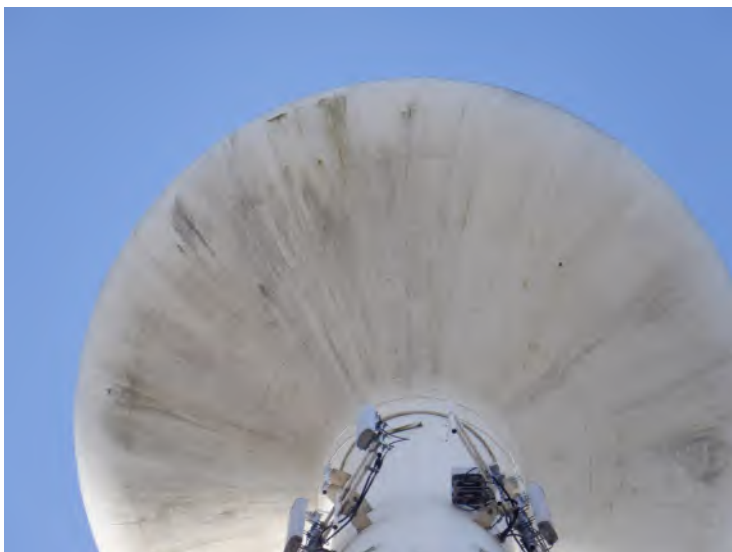
15) Same.

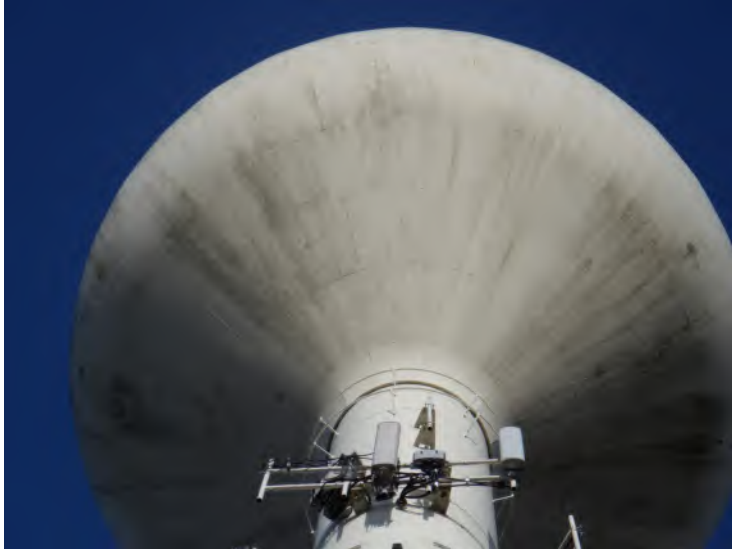
16) The bowl is covered with moderate mildew growth.

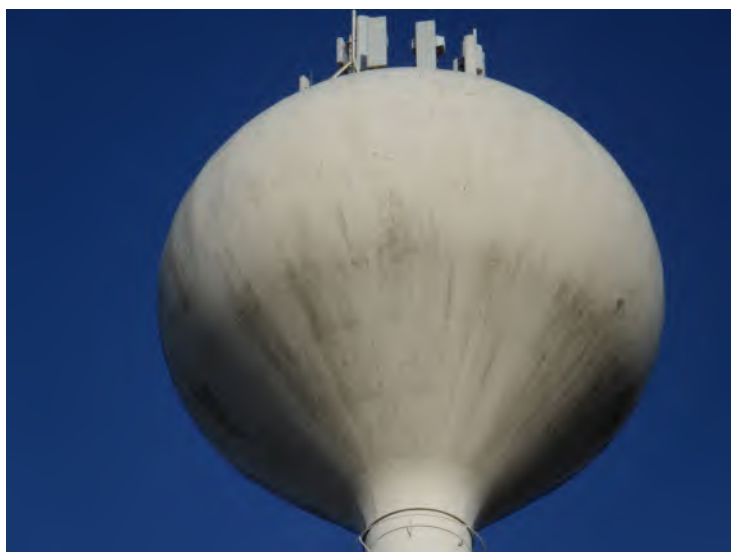
18) The sidewall coating is in good condition overall.

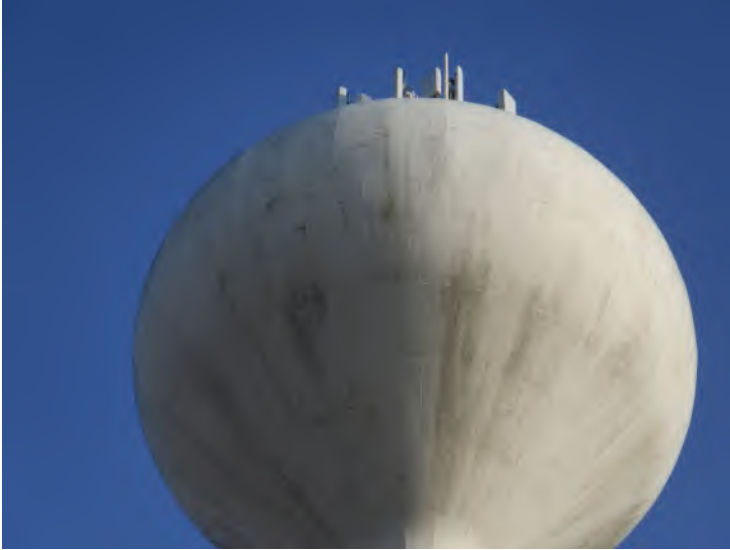
19) Same.

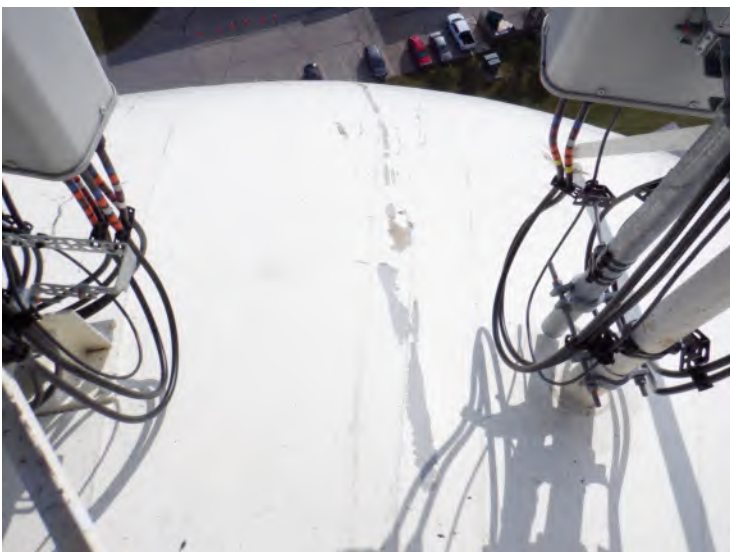
21) Same.

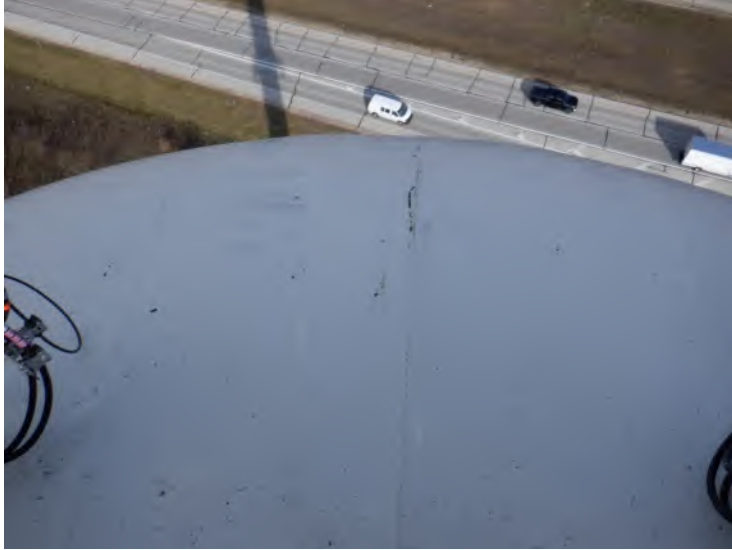
22) Same.

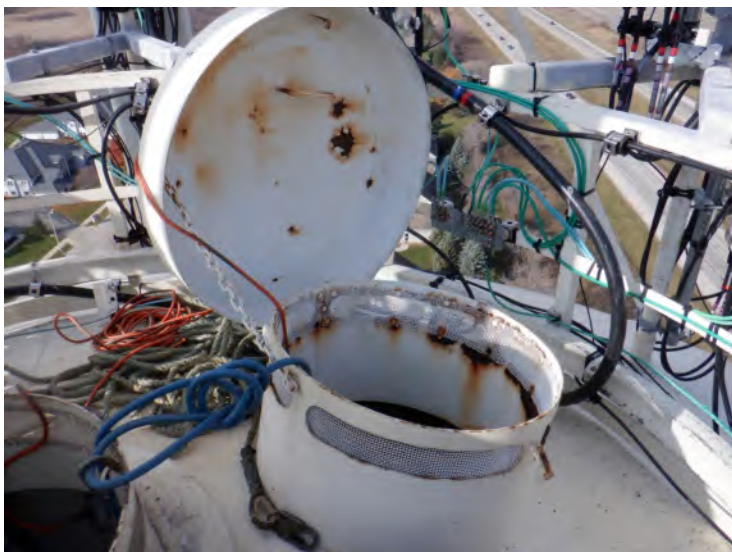
24) There is not a gasket on the wet interior roof hatch.

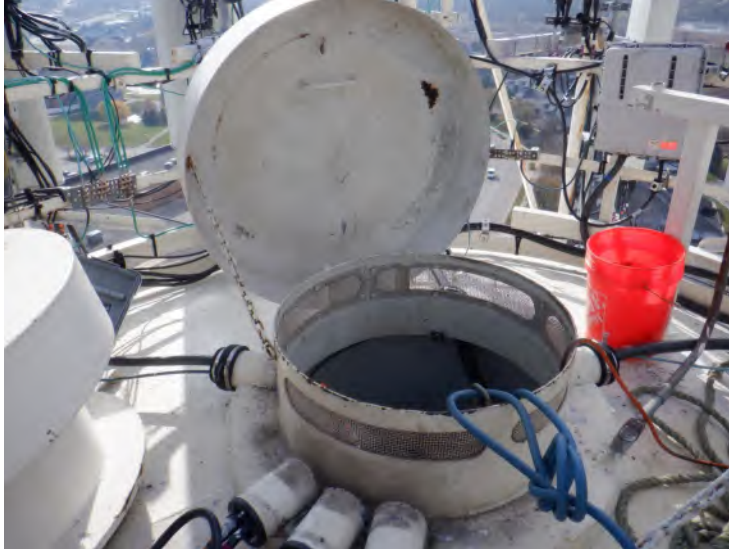
25) The dry interior roof hatch is in good condition.

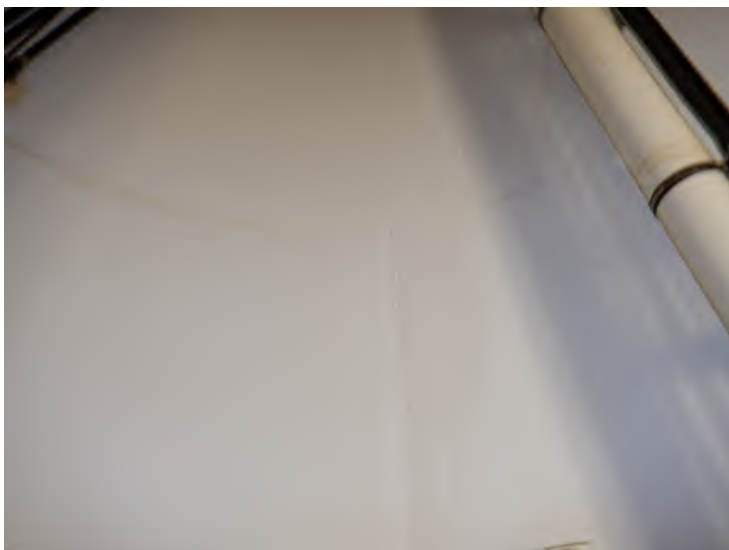
30) The dry interior basebell coating is in good condition overall.

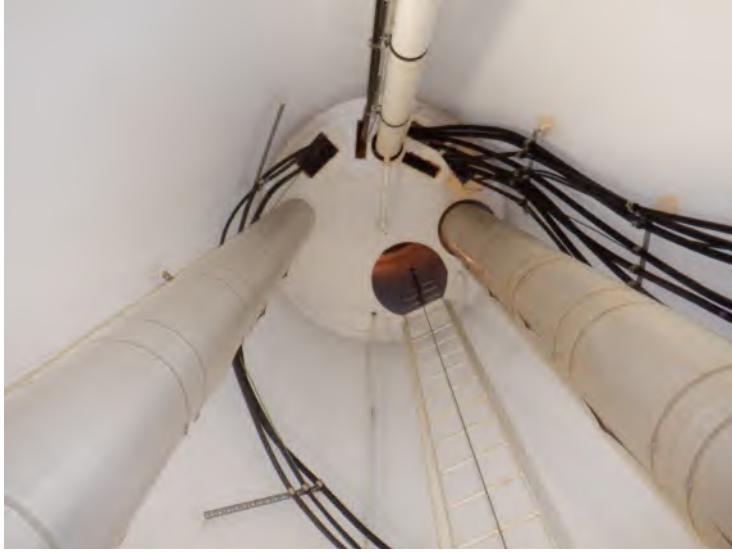
31) Same.

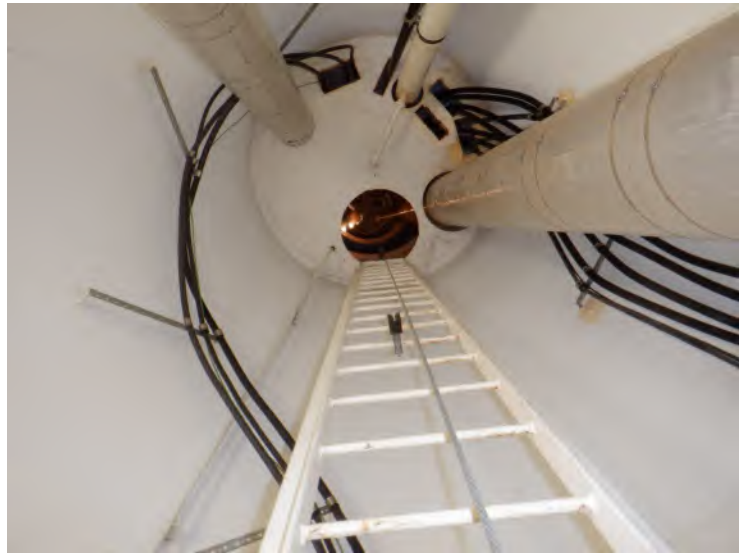
32) The basebell ladder is in good condition. The ladder is equipped with a fall prevention device.

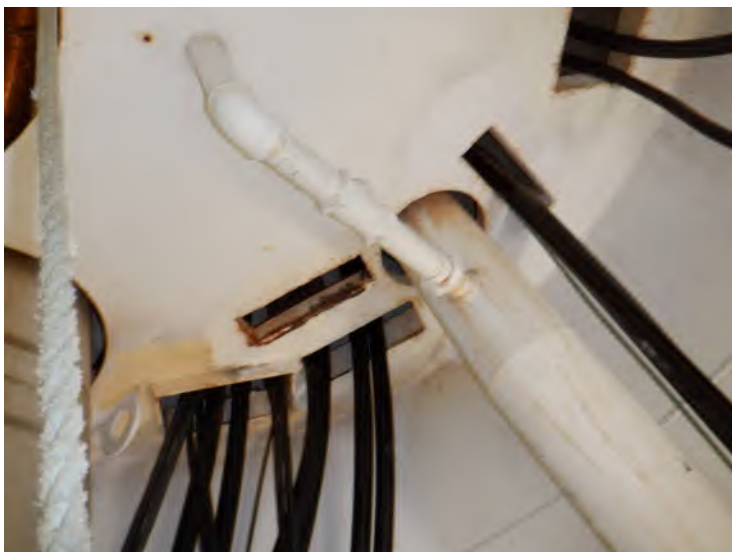
33) There is a check valve on the condensate platform drain.

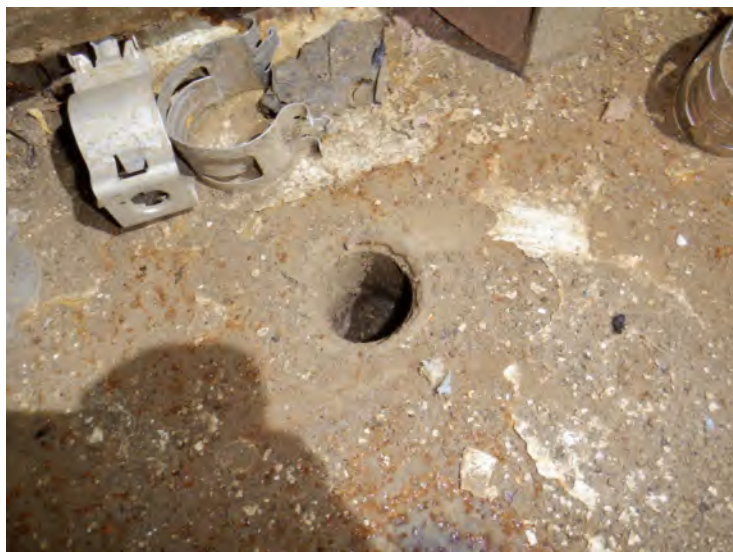
36) Same.

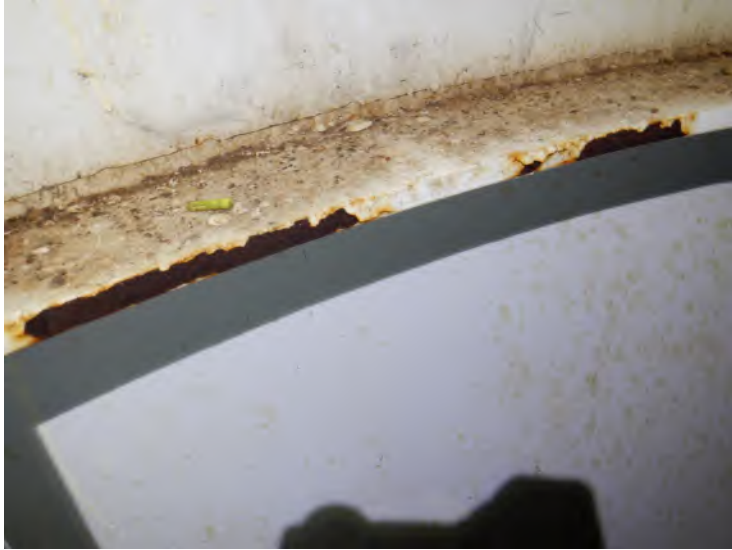
37) Coating failure on a stiffener in the dry riser.

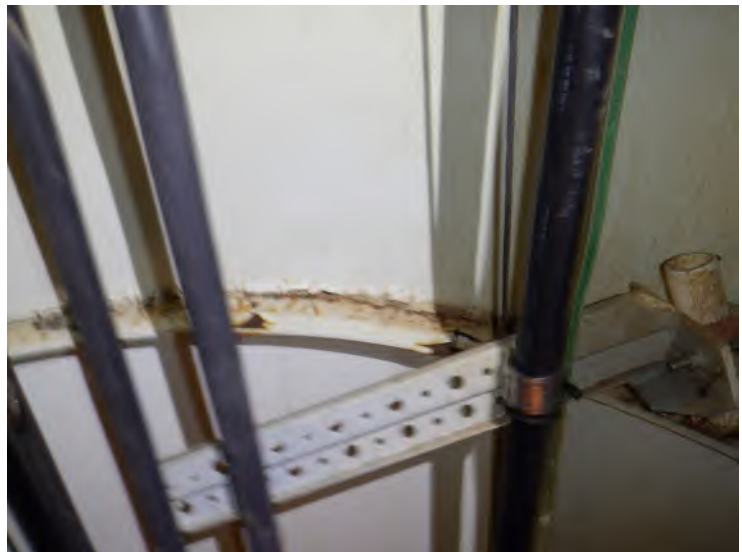
38) Same.

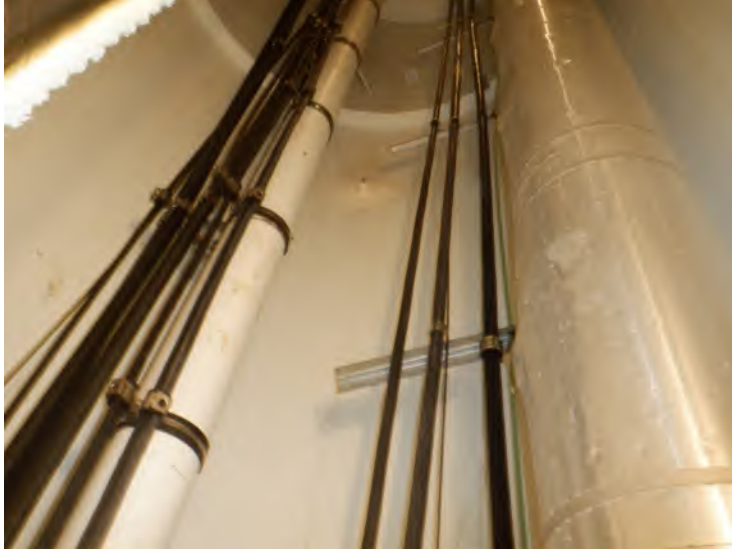
40) The fill/draw pipe insulation and aluminum cover are in good condition.

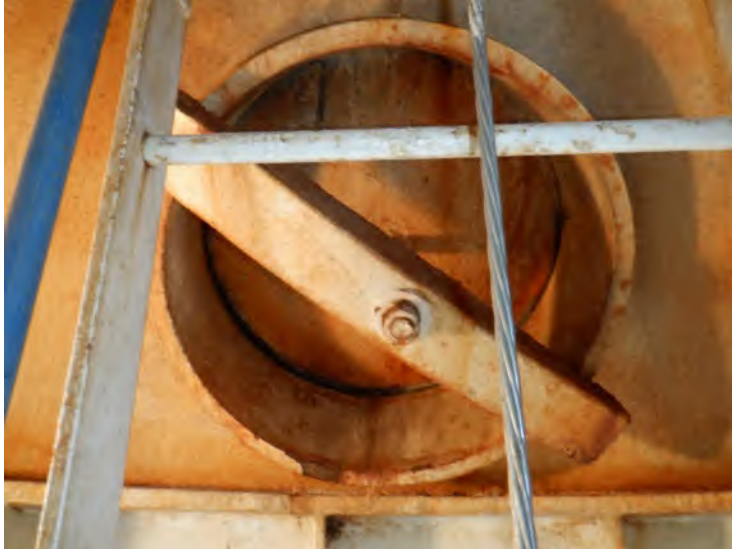
46) Coating failures on the wet interior manway. The manway is in the transition cone.

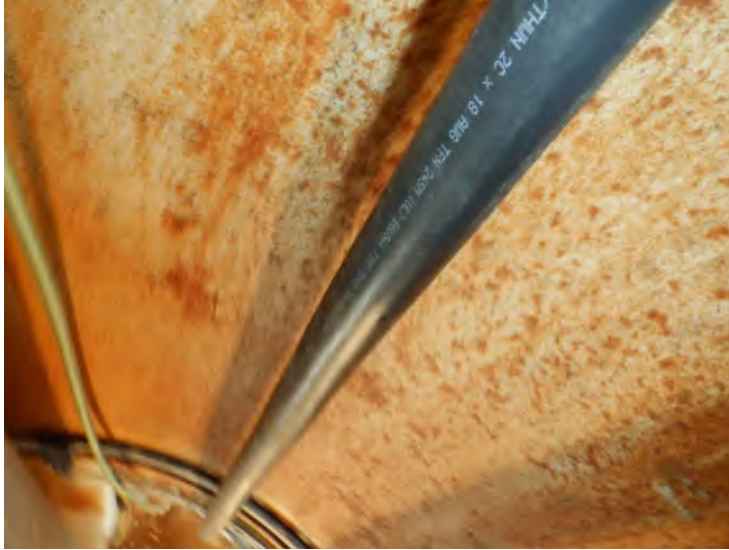
49) Same.

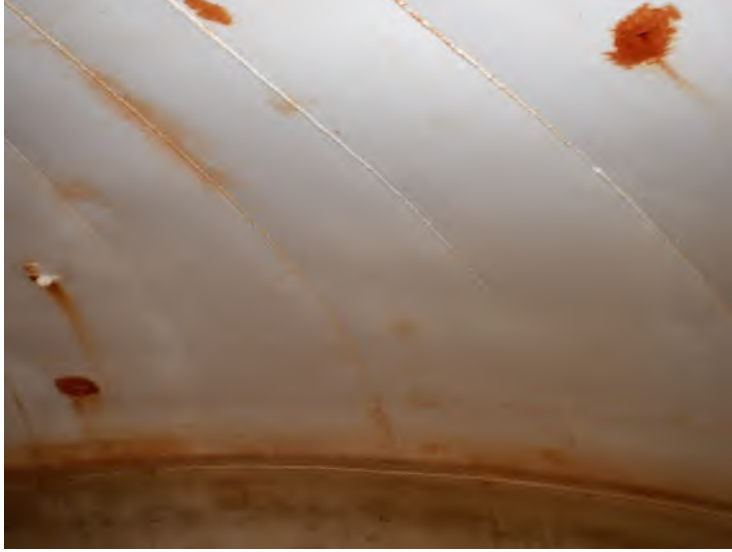
52) Same.

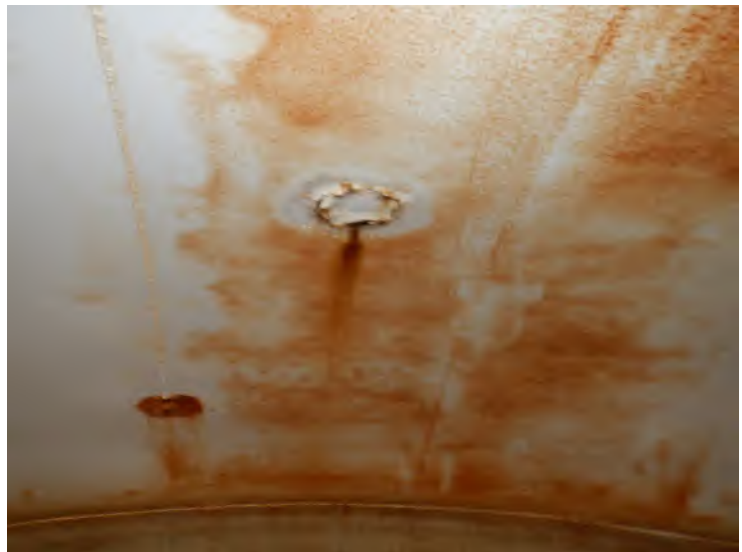
53) Same.

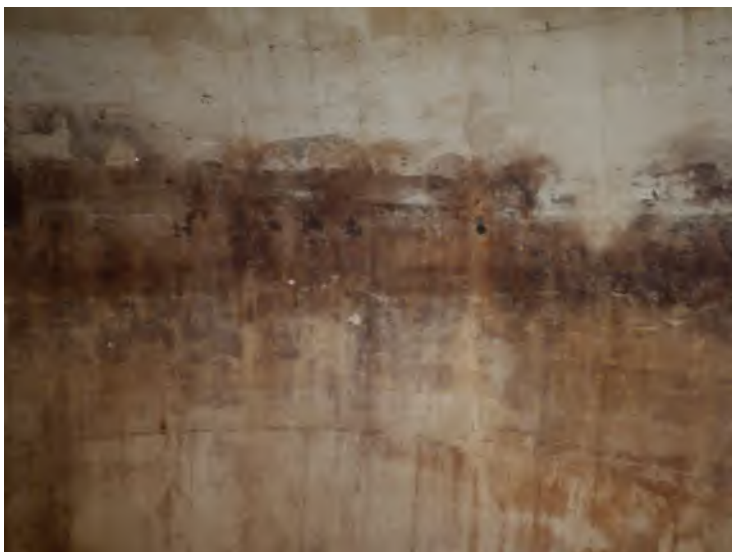
54) The wet interior sidewall coating is in poor condition overall.

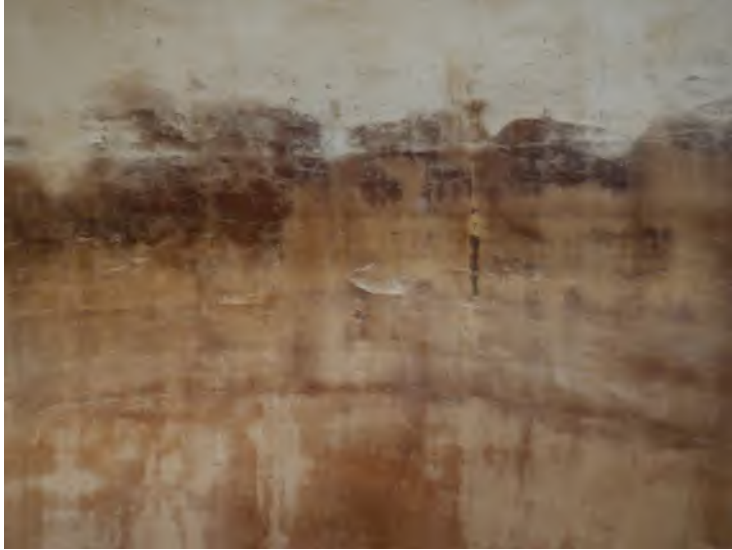
55) Same.

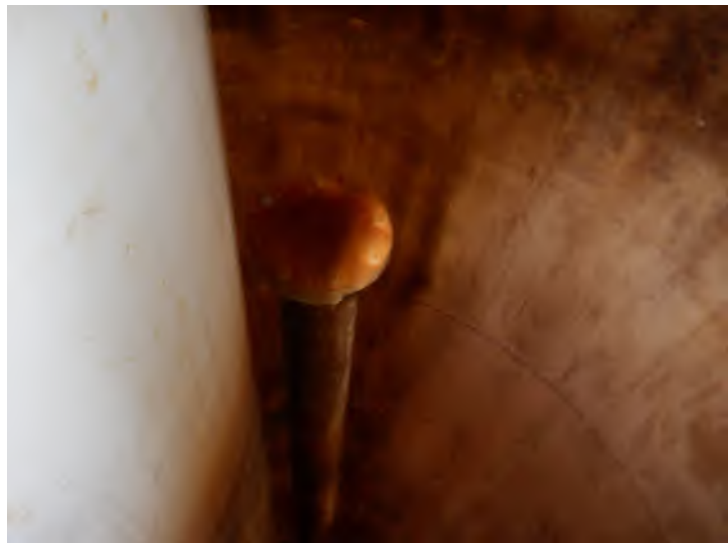
56) There is an abandoned pipe with a blind flange in the wet interior that extends up near the high-water level.
