Water System Master Plan

June 7, 2022

PREPARED FOR:
Village of Pewaukee
235 Hickory Street
Pewaukee, WI 53072

PREPARED BY:
Ruekert & Mielke, Inc.
W233 N2080 Ridgeview Parkway
Suite 300
Waukesha, WI 53188

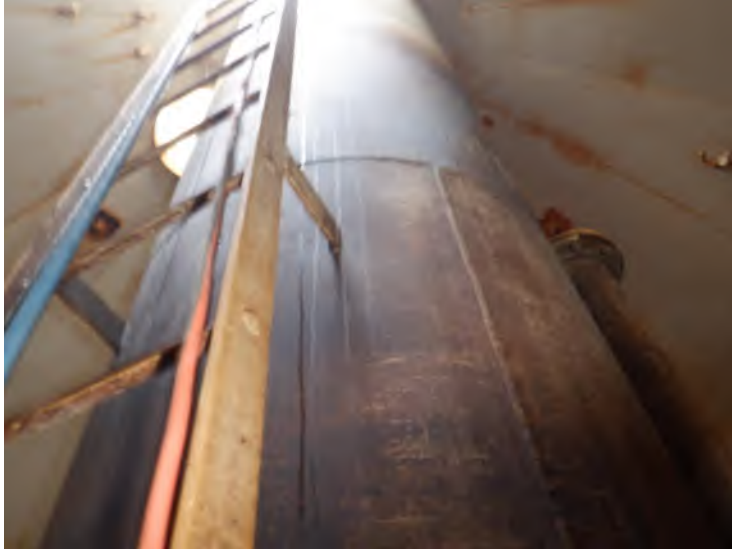
58) The wet interior ladder is in good condition overall. The ladder is equipped with a fall prevention device.

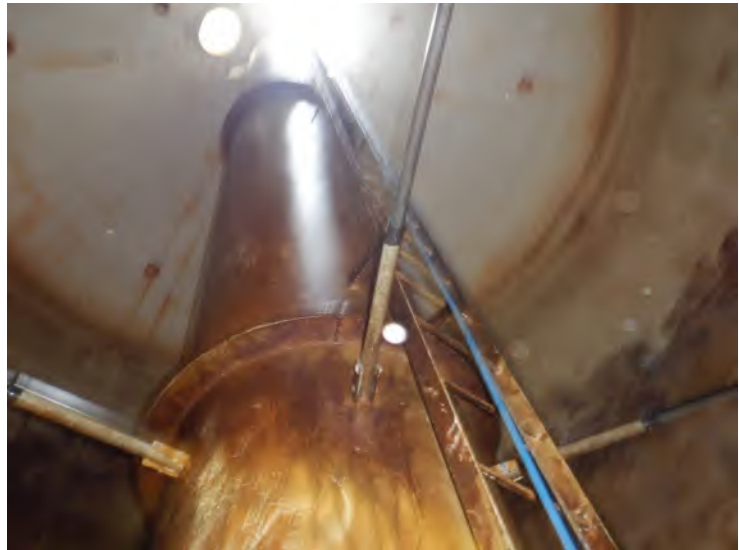
59) There is no significant coating deterioration on the access tube.

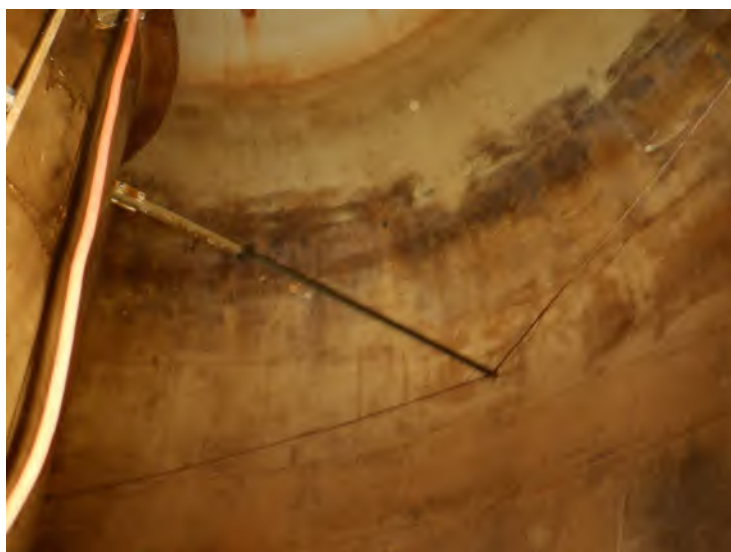
60) The cathodic protection system appears to be in good condition.

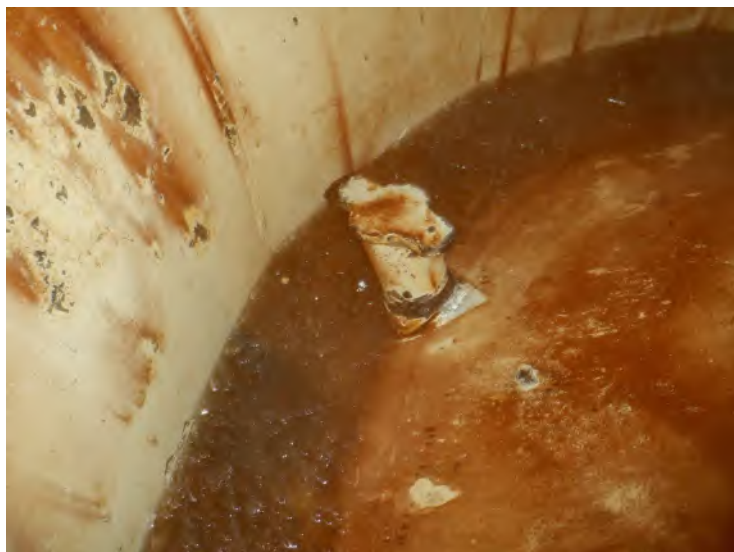
63) There is a threaded drain plug in the bowl.me.

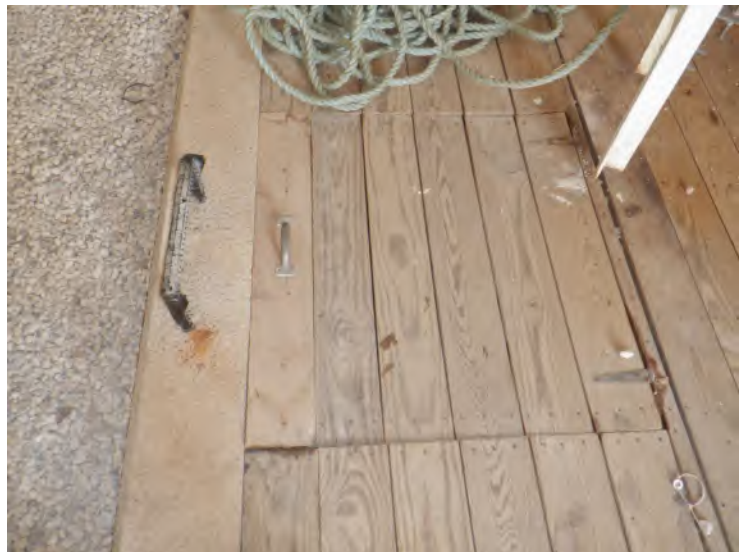
65) The wooden cover on the pit is in good condition.

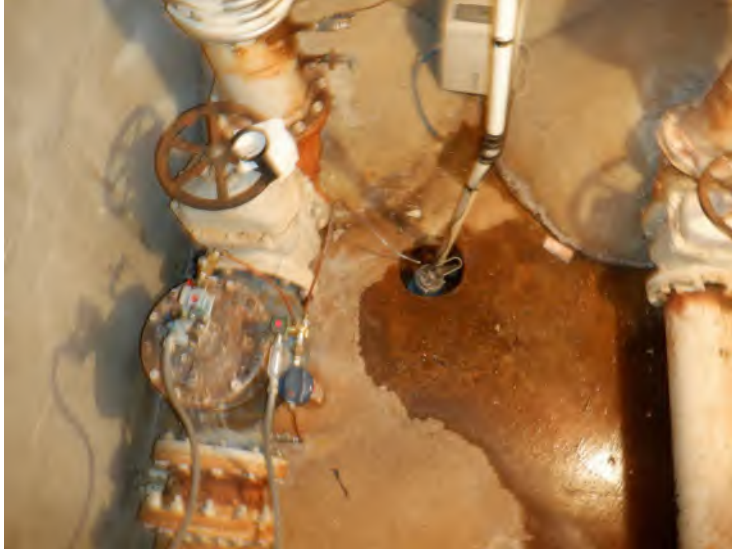
67) Same.

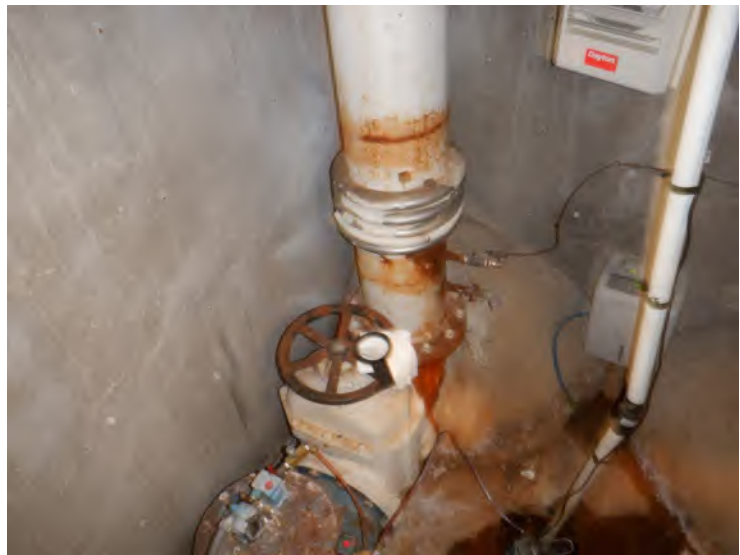
68) The bellow type expansion joint is in good condition.

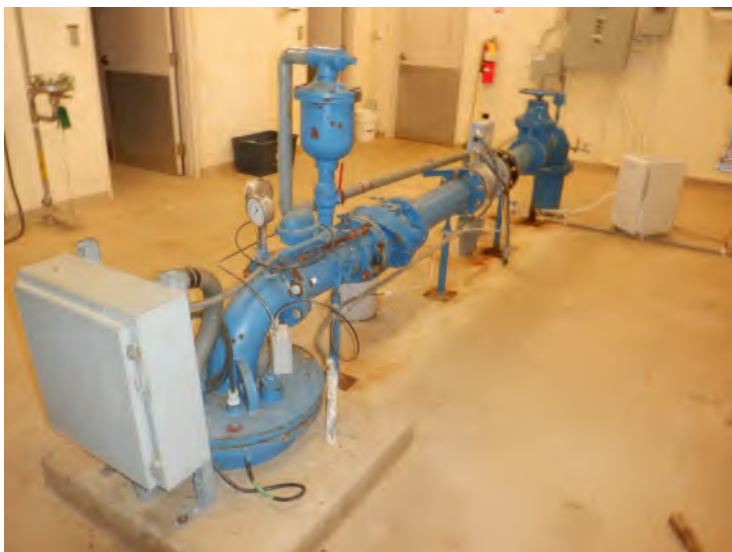
69) Coating on the piping in the building is in fair condition.

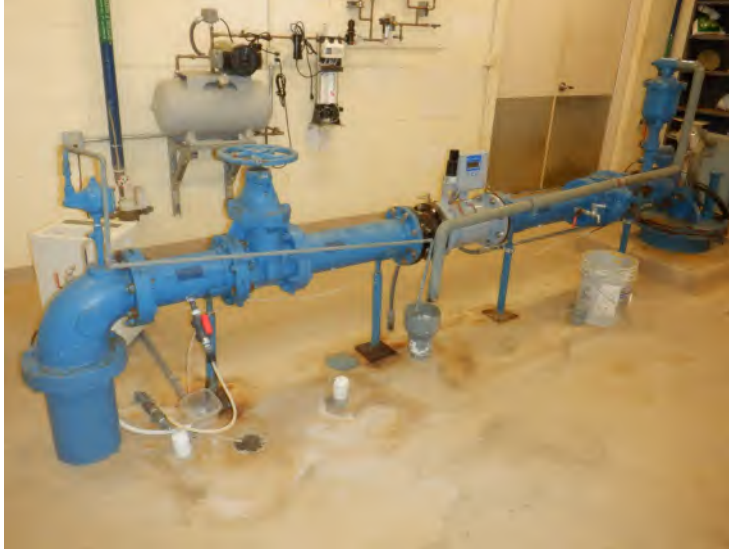
70) Same.

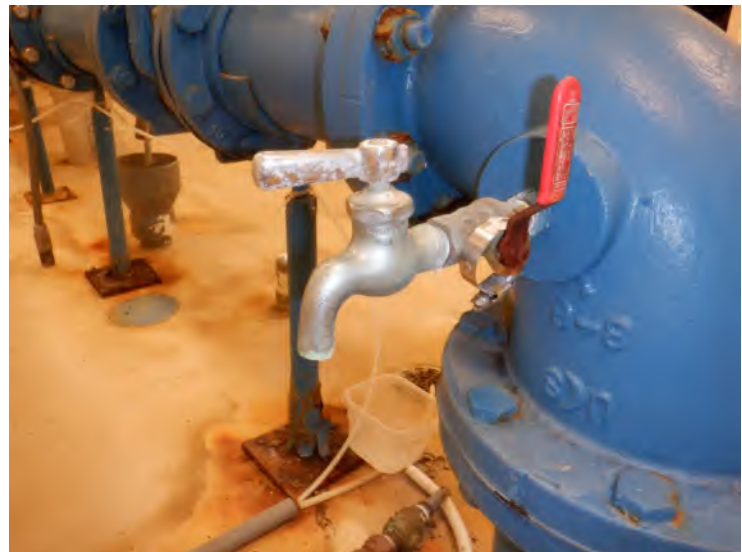
71) The sample tap in the building is in good condition.

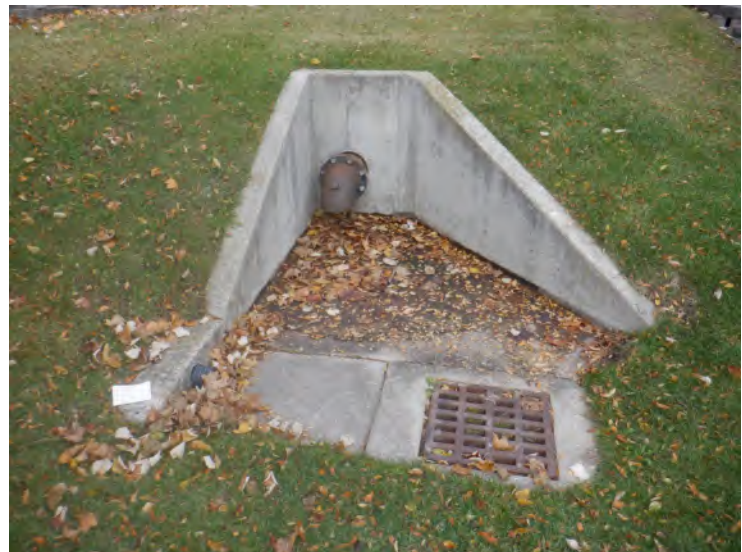
2) The overflow pipe discharges to a catch basin.

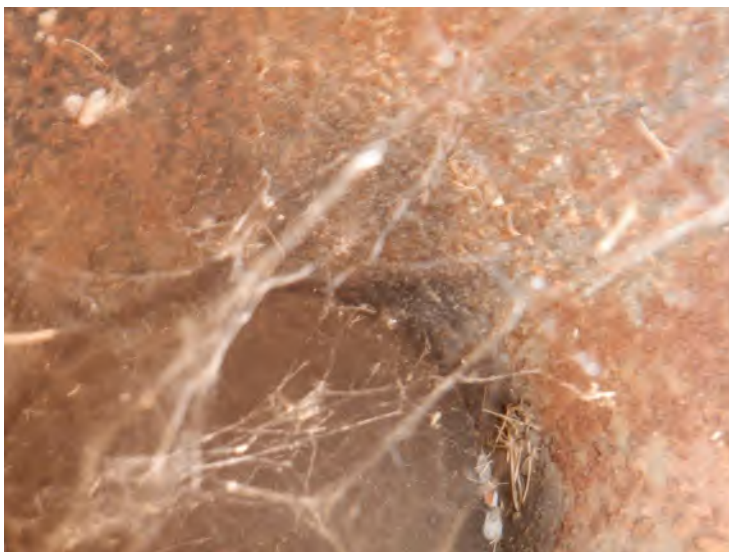
3) The screen at the overflow discharge is intact with no gaps or holes.

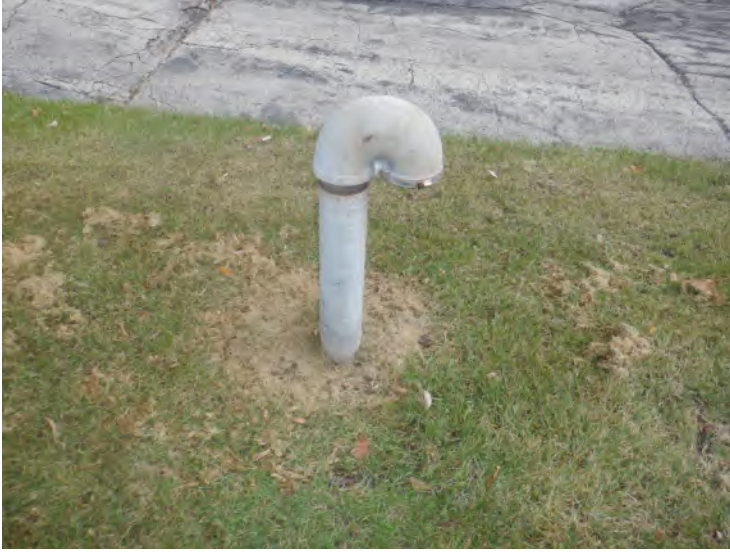
4) The goose neck roof vent is in good condition.

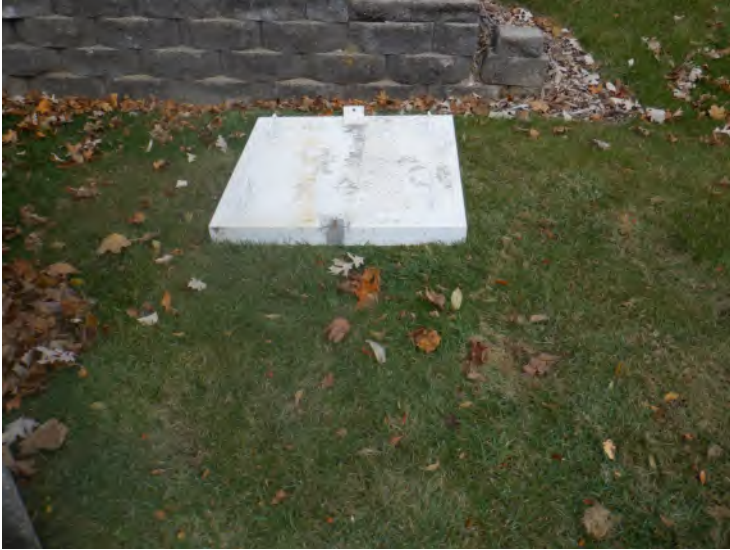
7) The roof hatch covers are in good condition with some coating erosion.

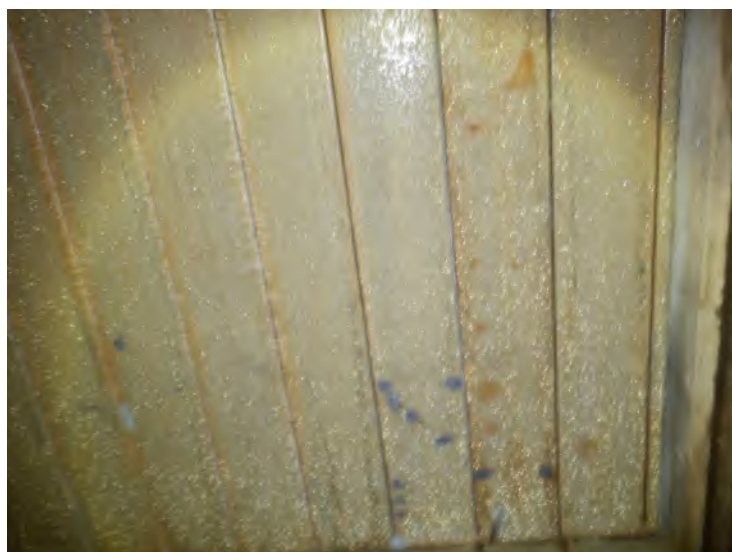
The roof is in good condition overall with no significant deterioration. There is some rusting at the surface from rebar chair bases and rebar.

9) Rusting at the surface of the wet interior roof.

Abrasive blast clean the exposed rebar in the wet interior and coat with an epoxy system. The repair is intended to extend the life of the structure by protecting the exposed rebar. The exposed rebar is due to lack of concrete cover during construction. The rebar near the surface has expanded and created a spall exposing the steel. There may be more exposed areas that will appear in the future. The estimated cost is \$5,000.

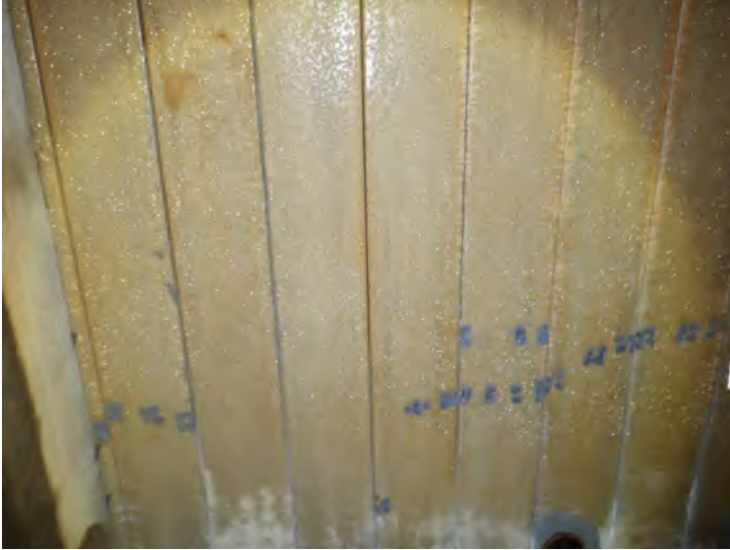
10) Same.

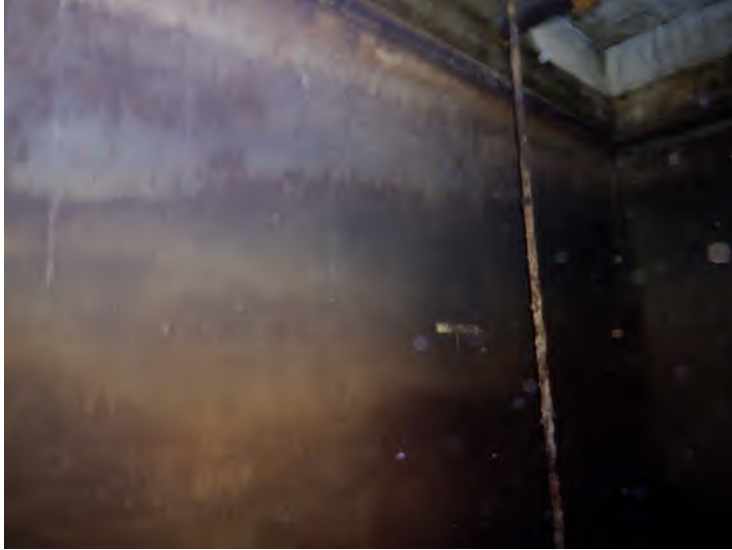
It is not known when the wet interior was last coated. The coating is likely an elastomeric system. The coating is located on the floor and sidewalls and is in fair condition. There are areas of delamination, spot failures, and erosion.

13) Elastomeric coating failures on the wet interior sidewall.

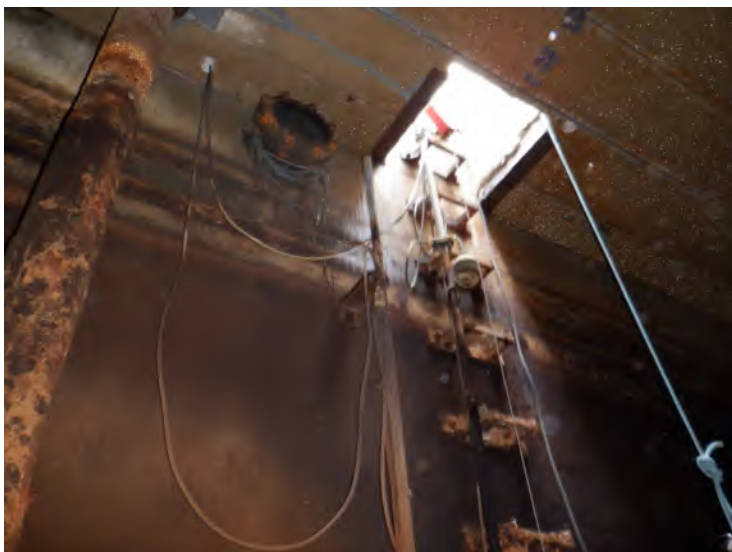
15) The metal wet interior appurtenances are not coated.

Abrasive blast clean the wet interior piping and repaint with an epoxy system. The piping could be allowed to deteriorate and then be replaced once it no longer operates properly, replacement could be performed by in-house personnel. The estimated to repaint the piping is \$10,000.

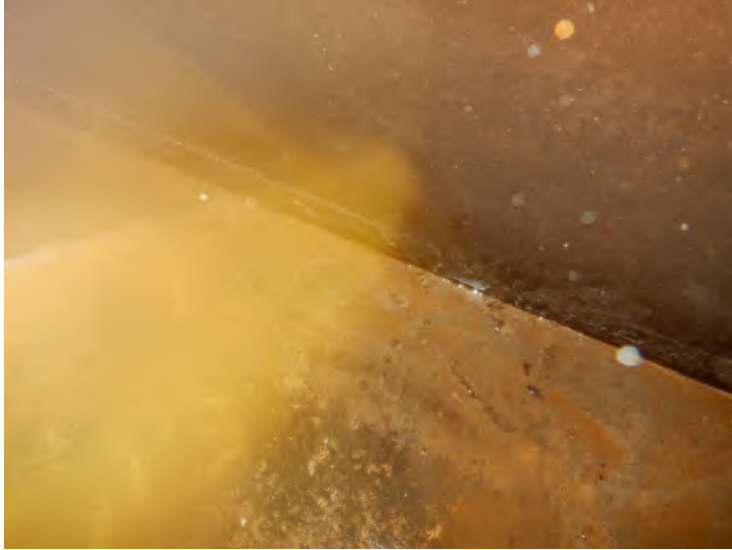
16) The wall to floor joint is in good condition.

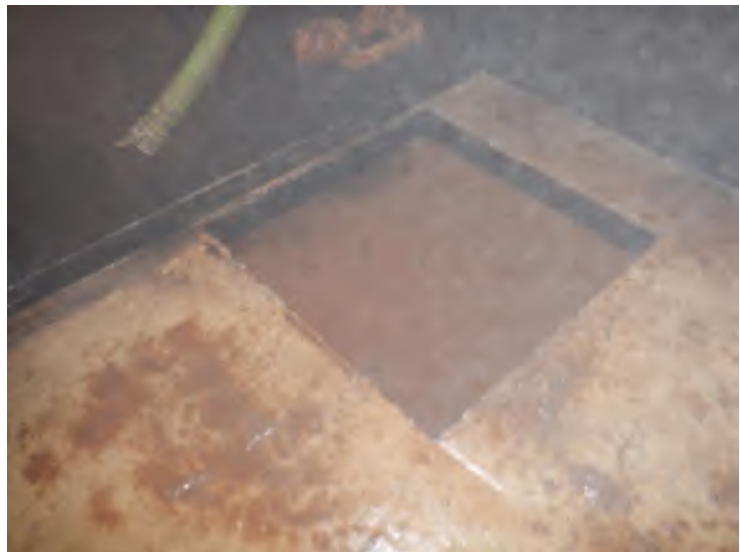
17) There is no deterioration of the concrete floor.

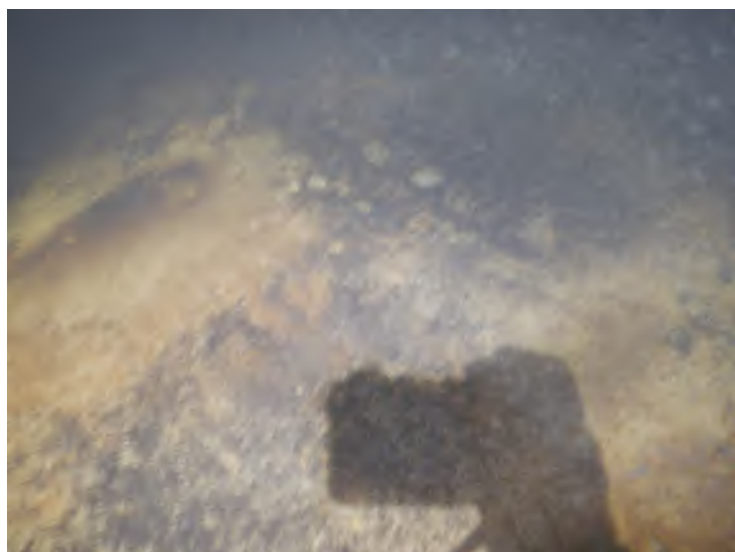
18) There is some erosion of the elastomeric coating on the floor.

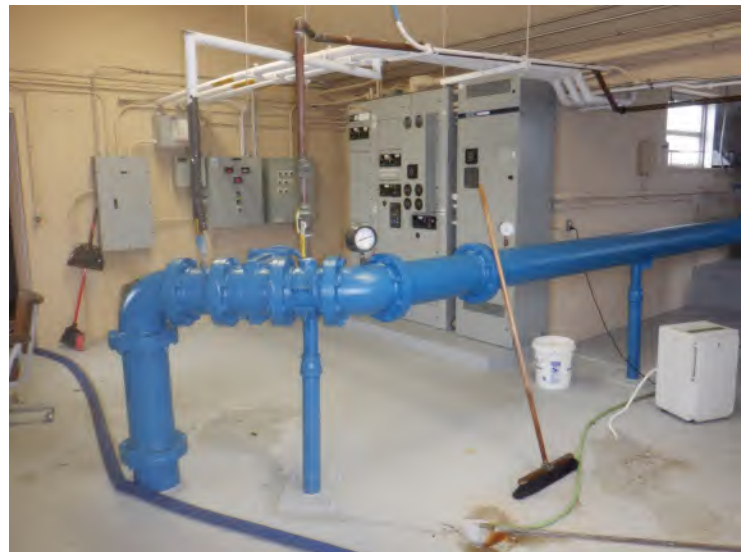
20) Same.

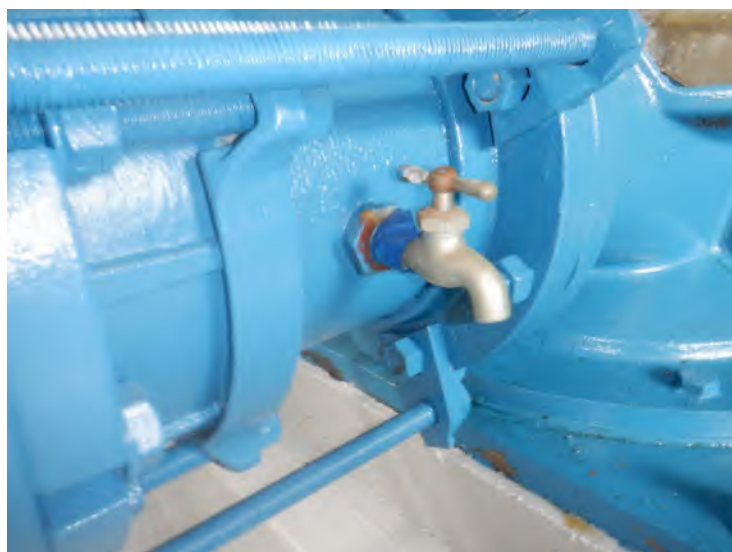
21) The sample tap in the pumphouse is in good condition.

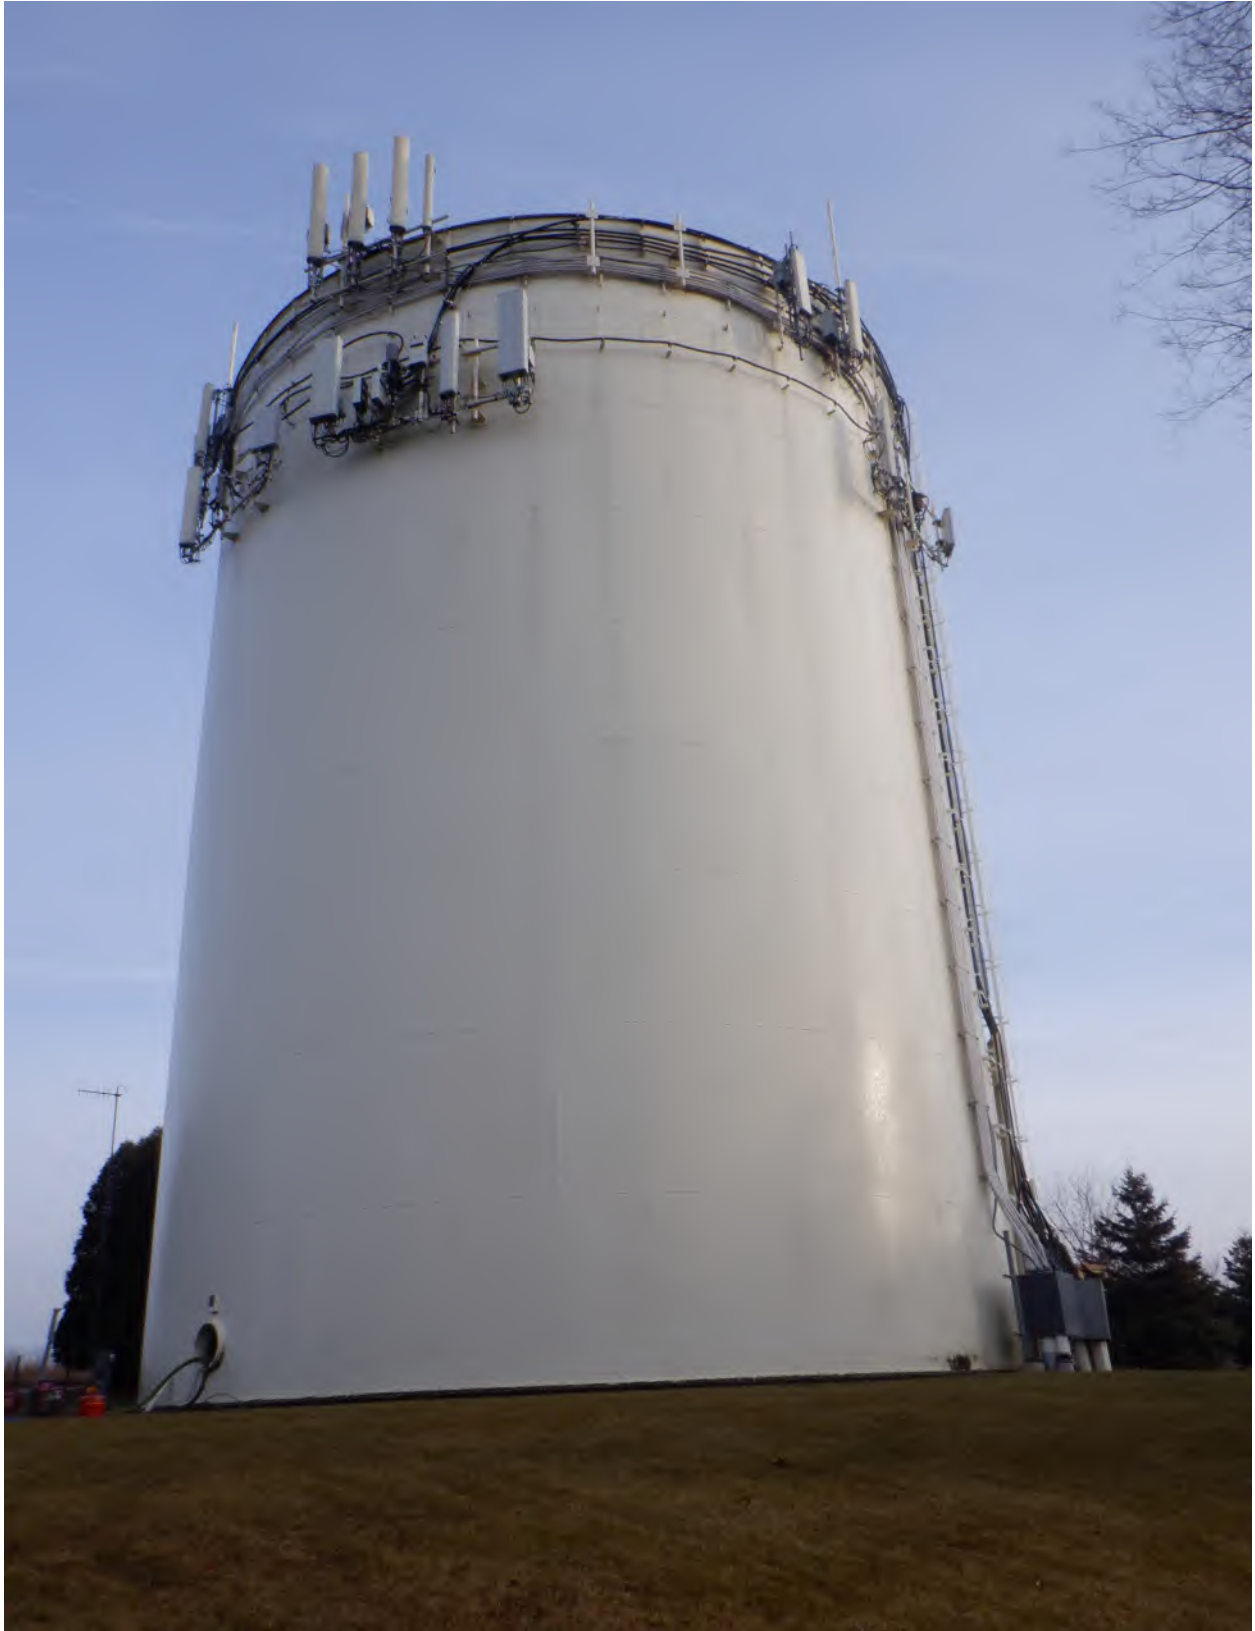
1,000,000 gallon standpipe (Sunnyridge) located in the Village of Pewaukee, Wisconsin.

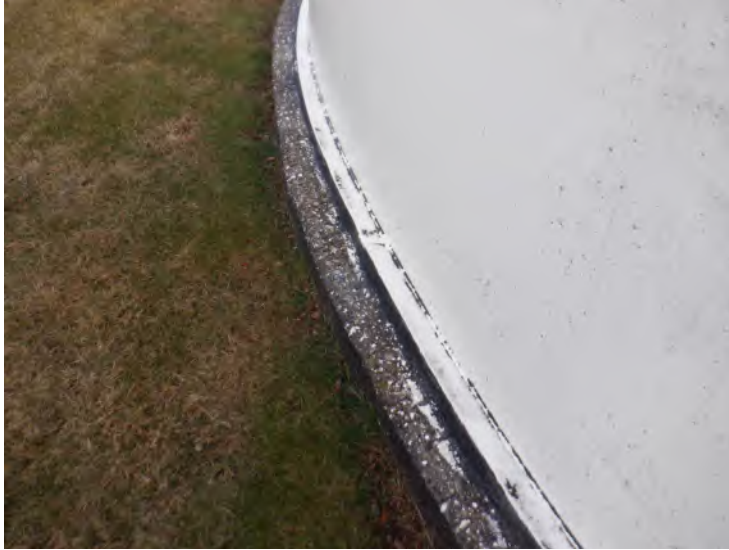
1) The foundation is in good condition overall.

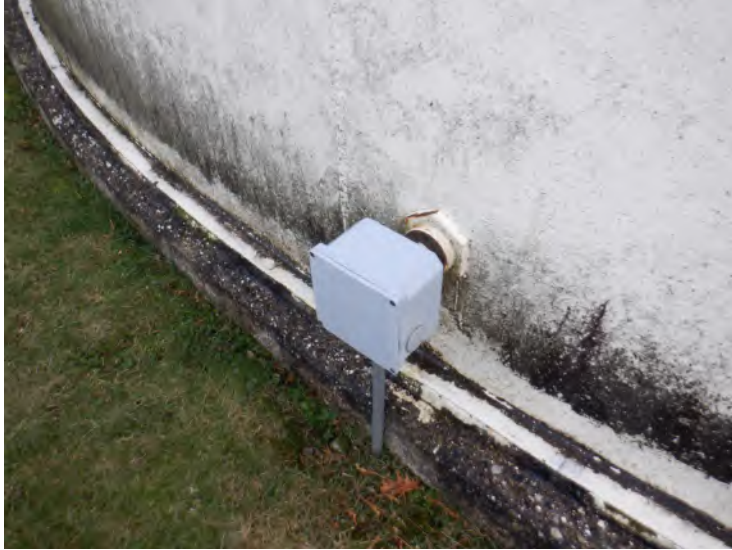
4) The cathodic protection pressure fitting is in good condition.

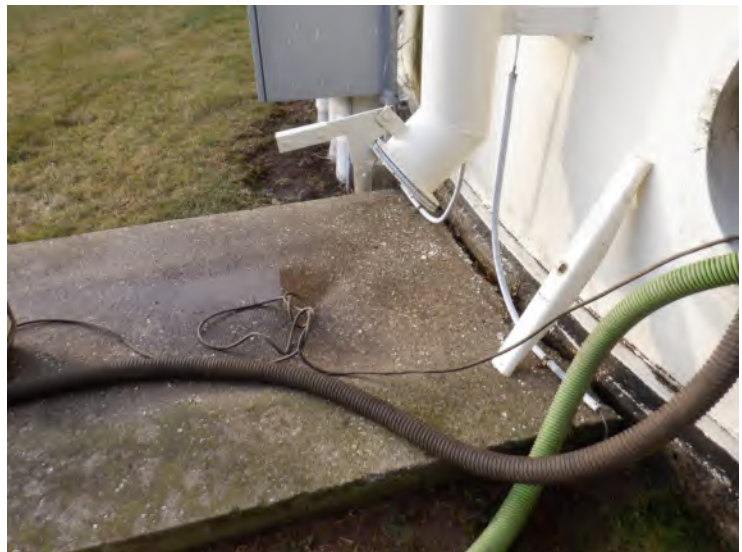
5) The overflow pipe discharges to a concrete splash pad.

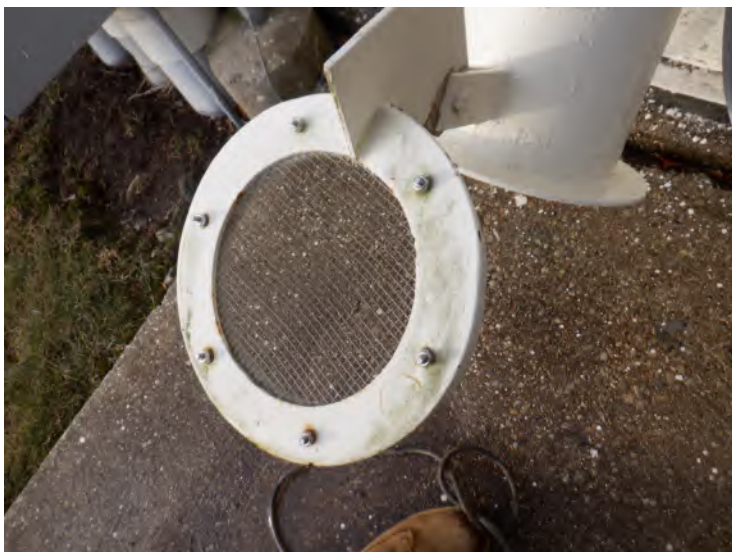
6) The screened flap gate is in good condition.

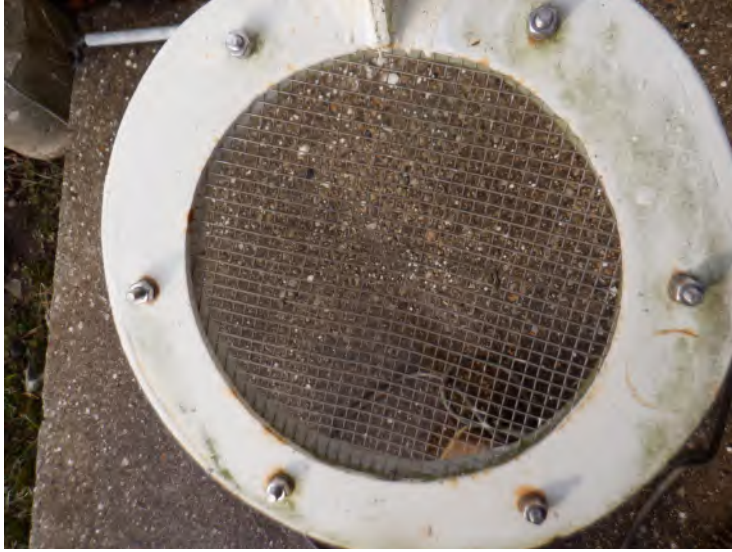
7) The screen is in good condition.

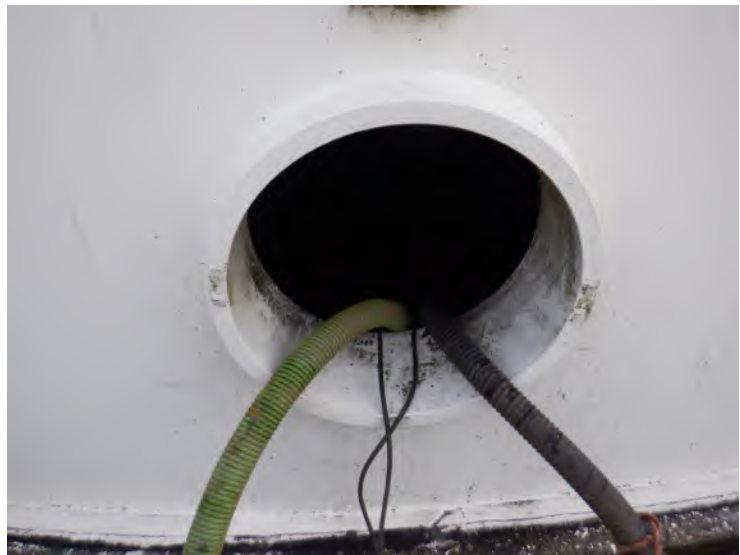
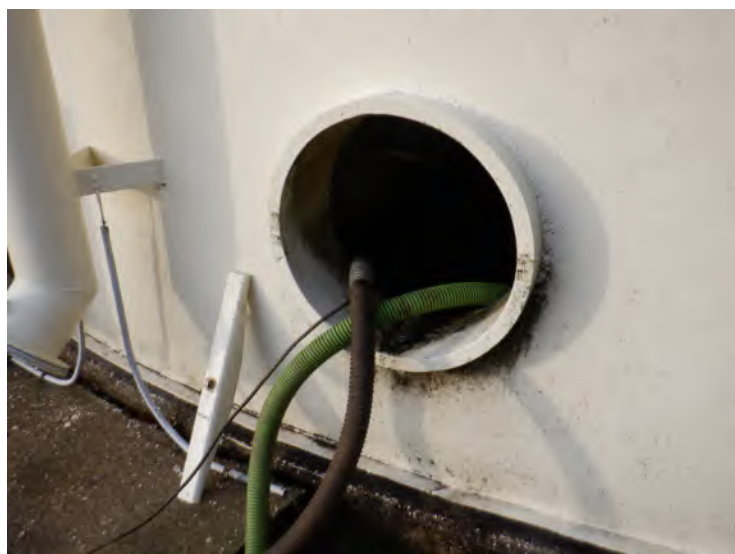
8) The two sidewall manways are in good condition.

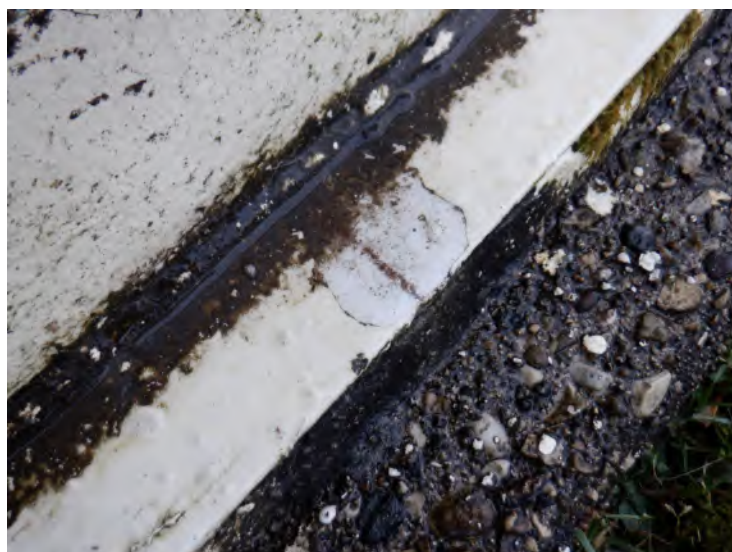
14) Same.

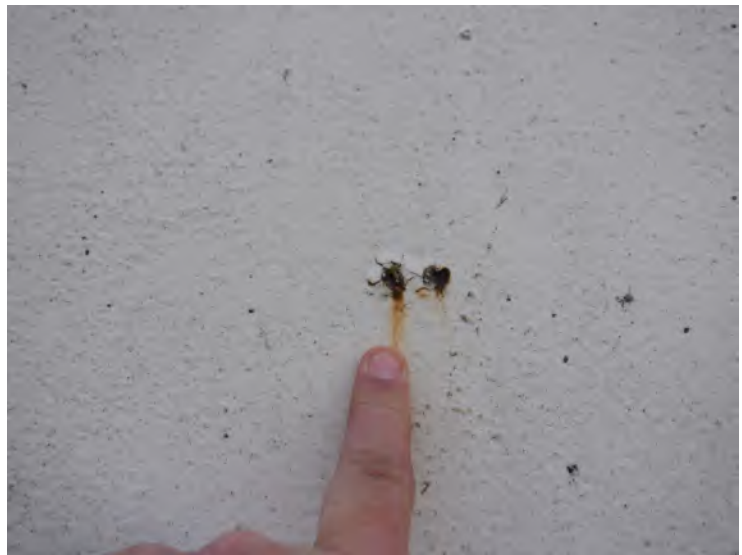
Sidewall comments: **There are approximately ten small spot coating failures that are ¼ inch diameter or less and one spot of delamination that is 2 inch diameter on the baseplate**

16) There are several small spot coating failures on the sidewall.

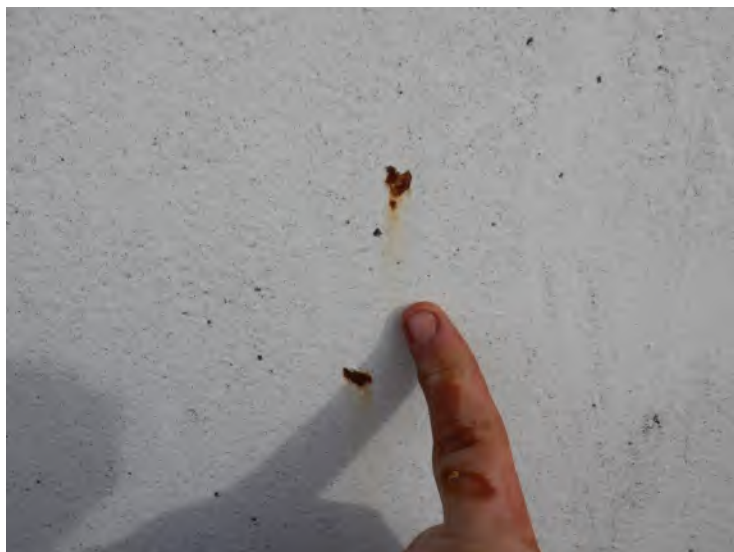
17) Same.

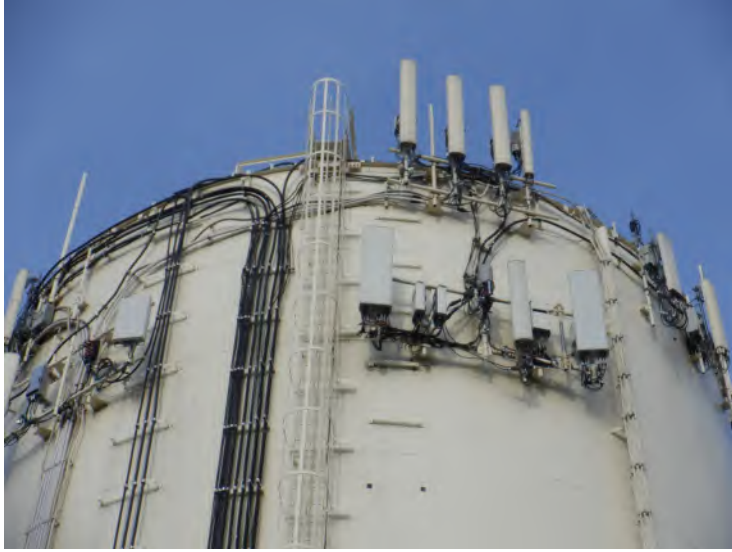
18) Same.

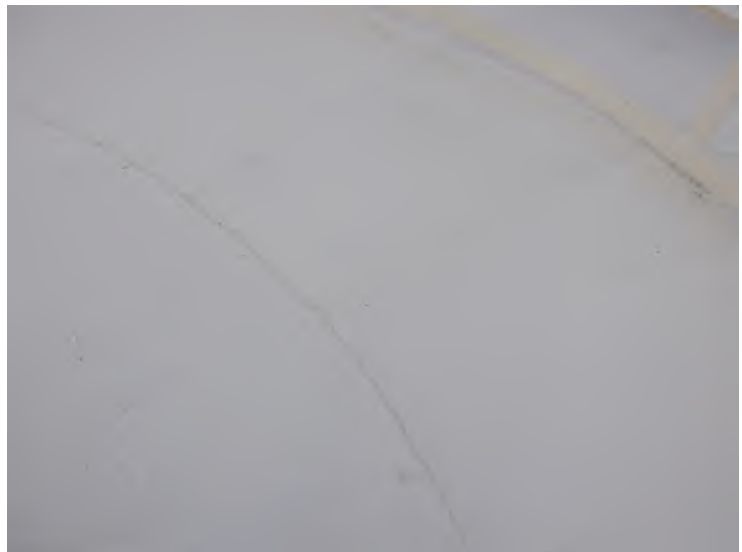
19) There are antennas mounted at the top of the sidewall.

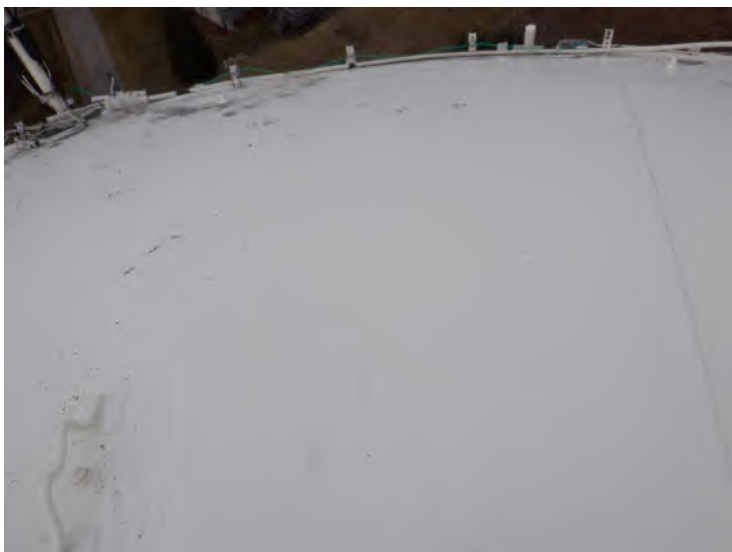
20) The coating on the roof is in good condition overall.

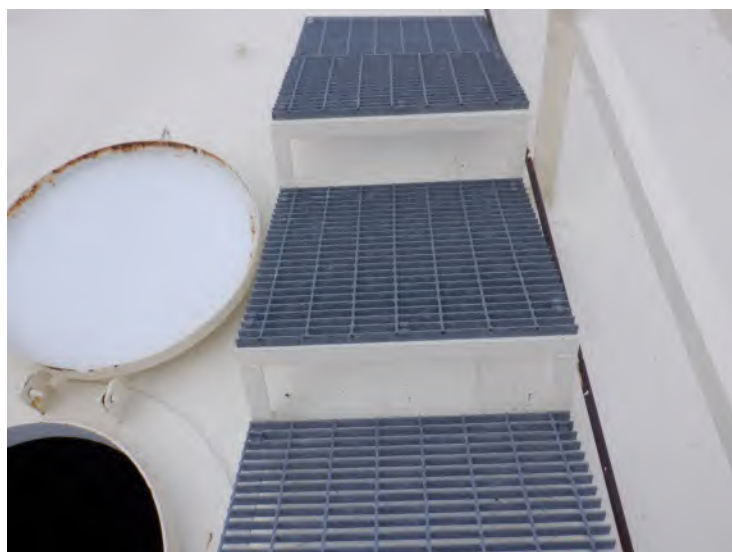
23) The step-off platform is in good condition.

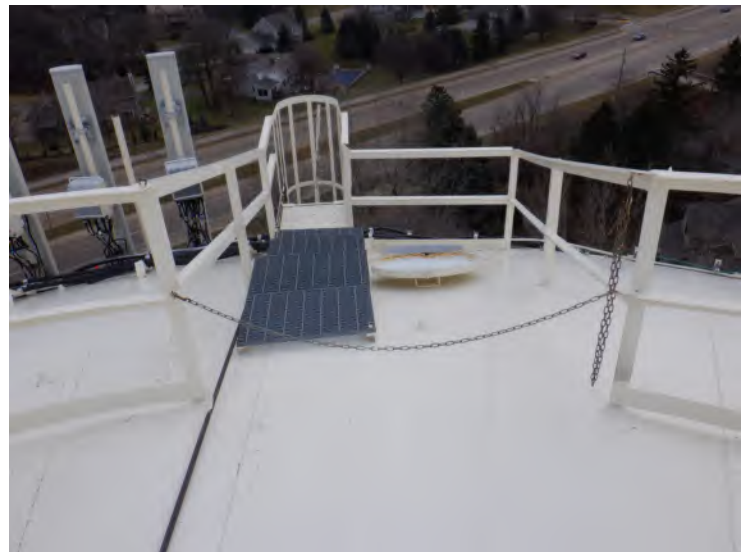
25) There are safety chains at the opening to the center handrail.

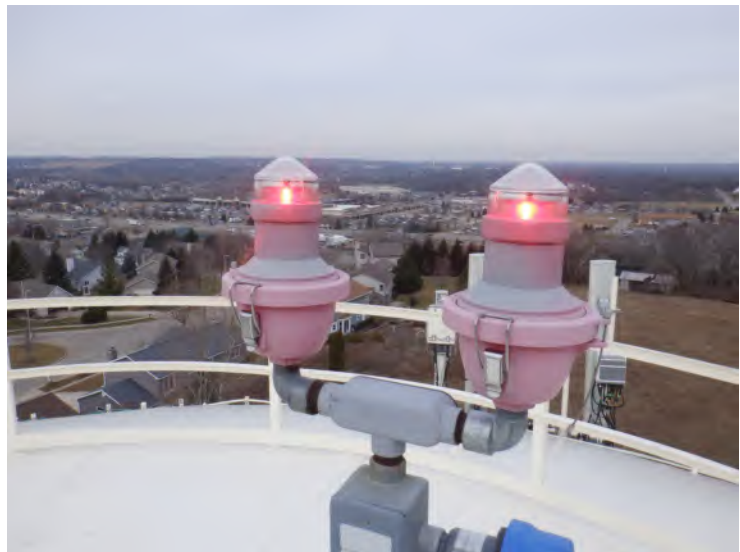
31) The double aviation light is in good condition.

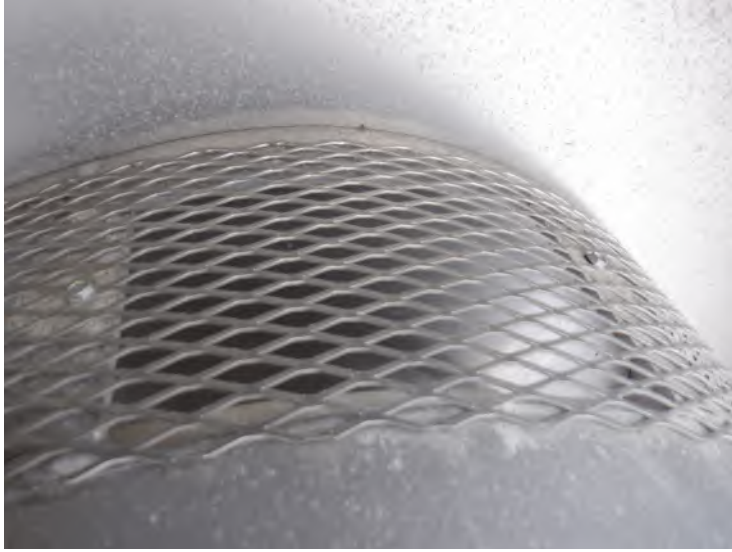
33) The roof vent is in good condition.

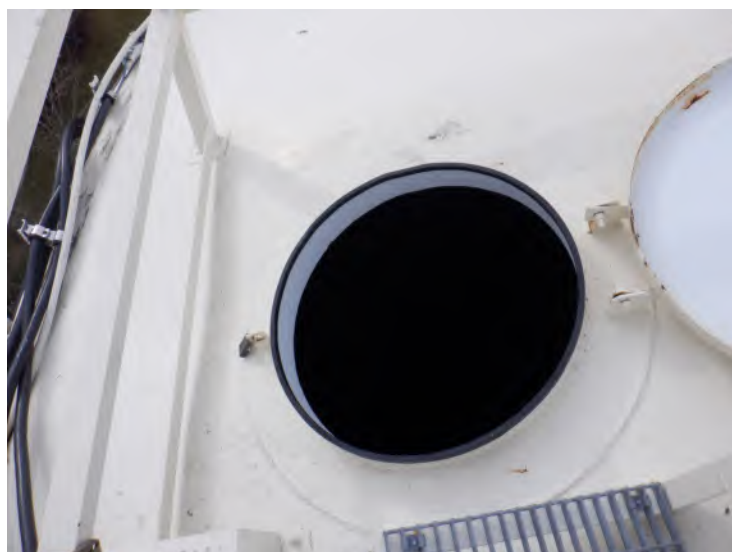
38) The roof hatch is in good condition.

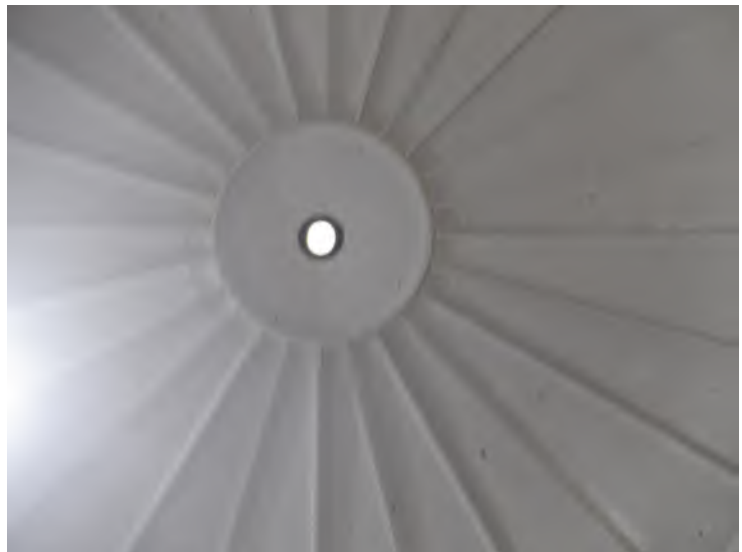
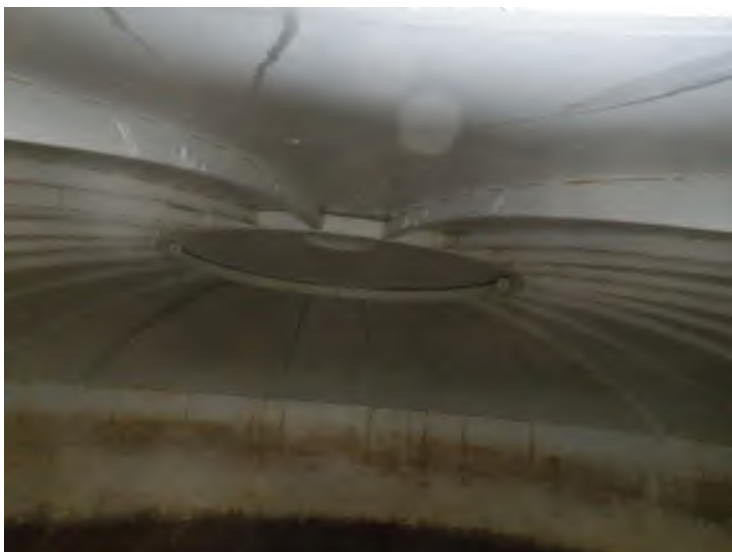
40) The coating on the roof is in good condition overall.

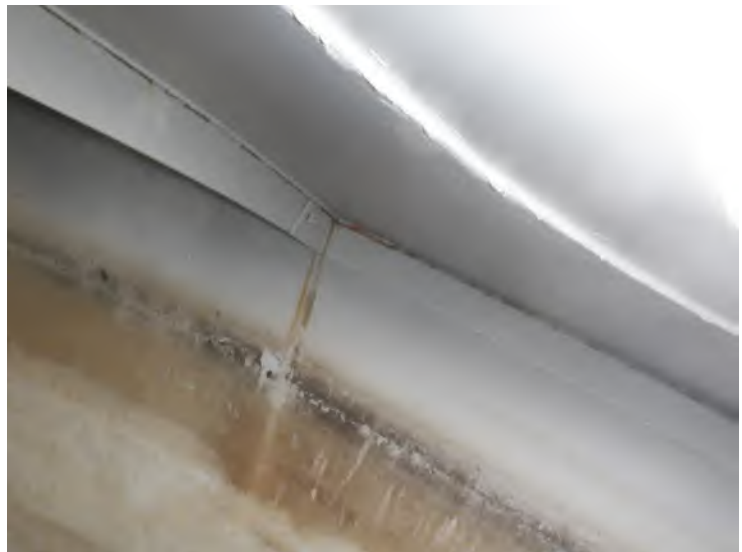
43) The roof stiffeners are in good condition.

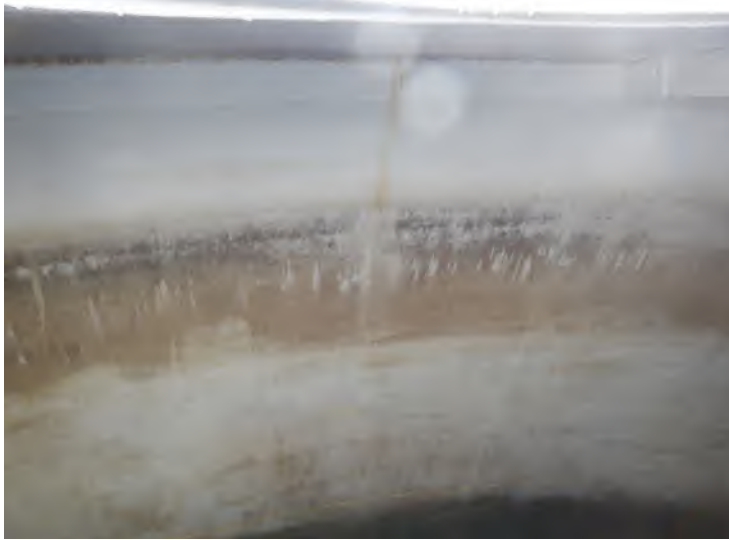
45) The overflow elbow is in good condition.

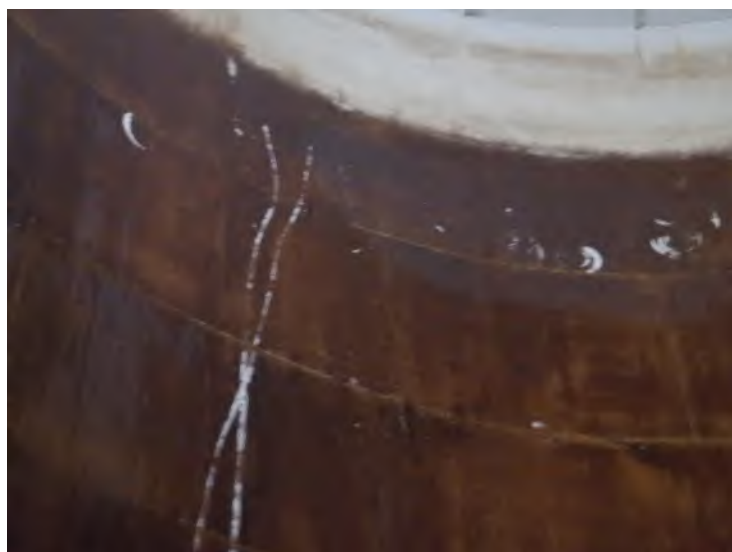
48) There are scratches in the mineral staining near the high-water level.

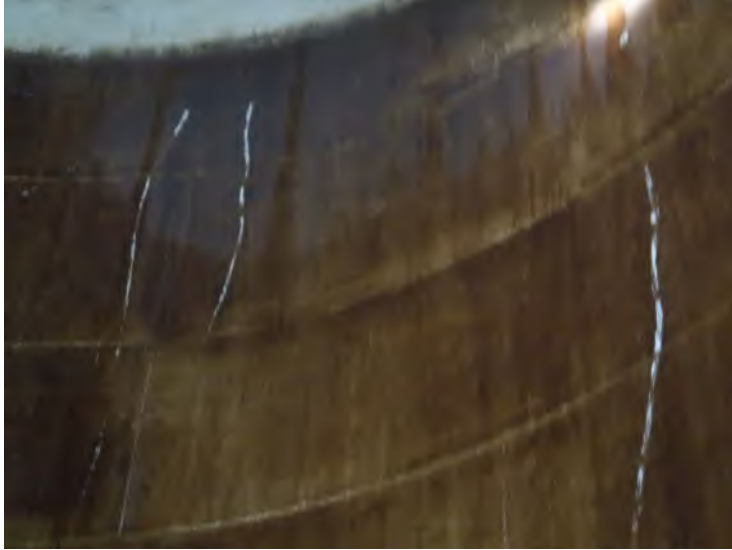
49) The scratches could be a sign of ice movement.

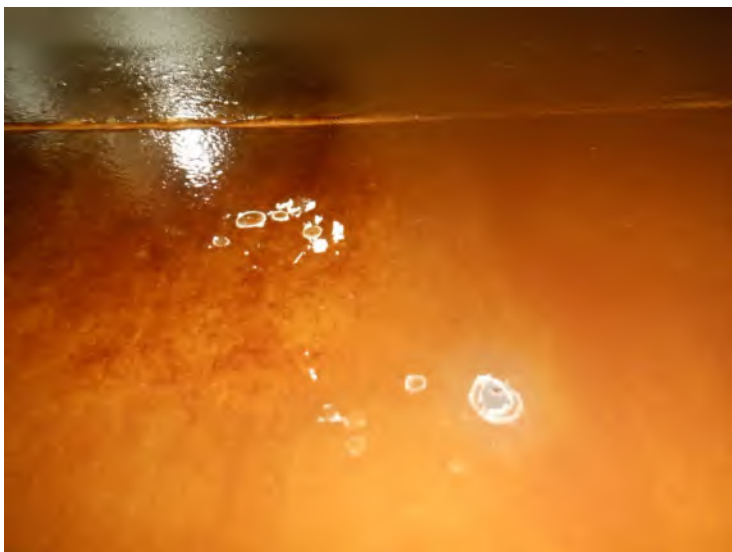
51) Same.

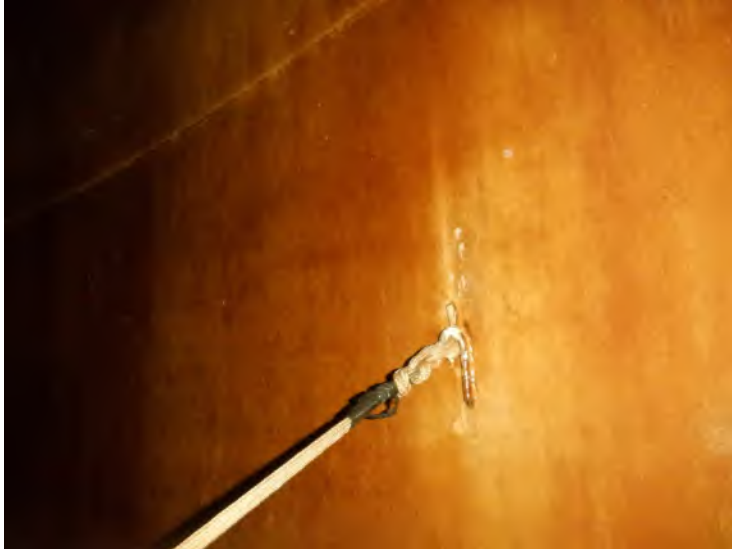
52) There are cathodic protection clips on the sidewall.
