Water System Master Plan

June 7, 2022

PREPARED FOR:
Village of Pewaukee
235 Hickory Street
Pewaukee, WI 53072

PREPARED BY:
Ruekert & Mielke, Inc.
W233 N2080 Ridgeview Parkway
Suite 300
Waukesha, WI 53188

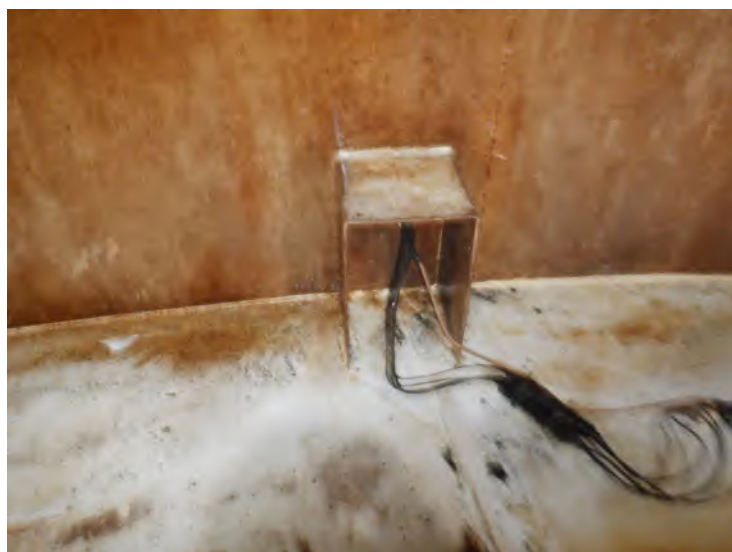
54) The cathodic protection pressure fitting has a deflector plate around it.

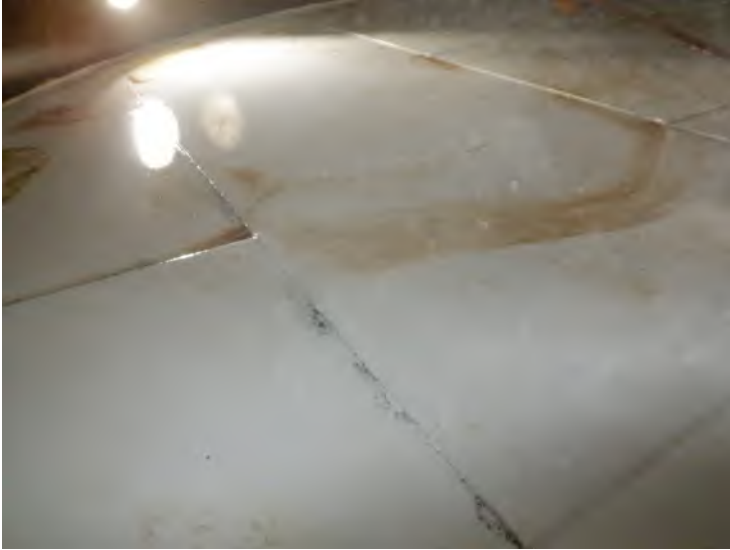
55) The coating on the floor is in good condition.

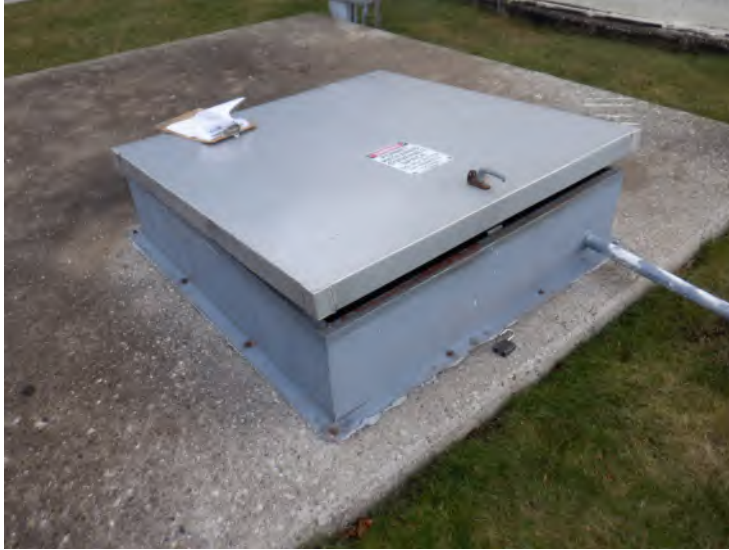
61) There is a pit adjacent to the tank. The pit has a metal hatch that is in good condition.

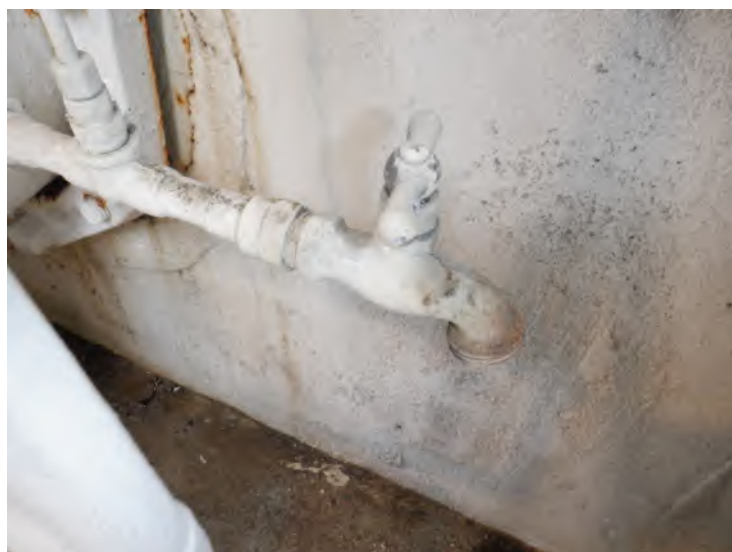
63) The sample tap is in good condition but has a threaded end.

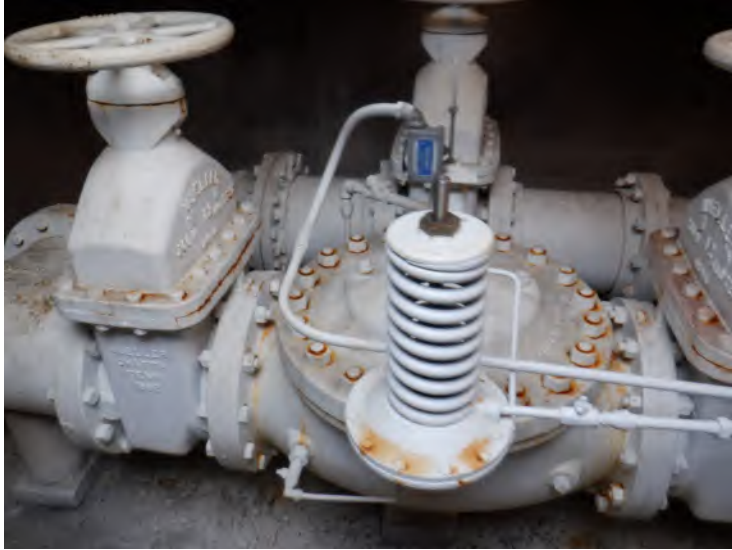
64) The coating on the piping is in good condition overall.

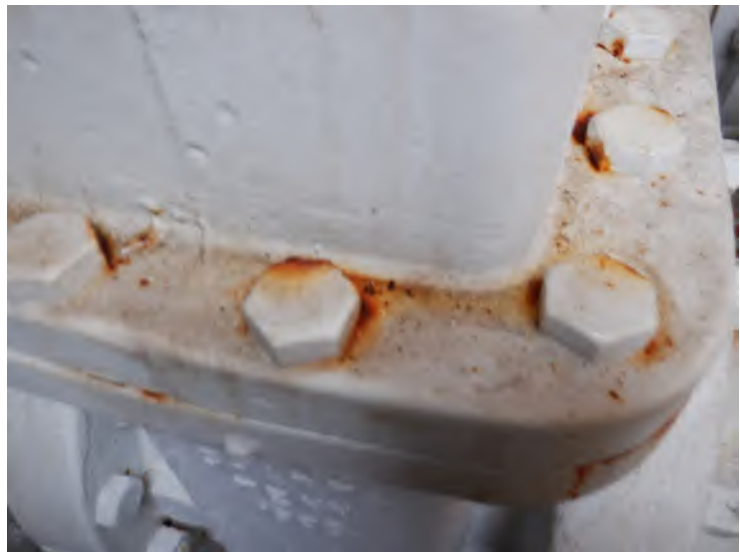
65) There are spot coating failures on the bolts and flanges.

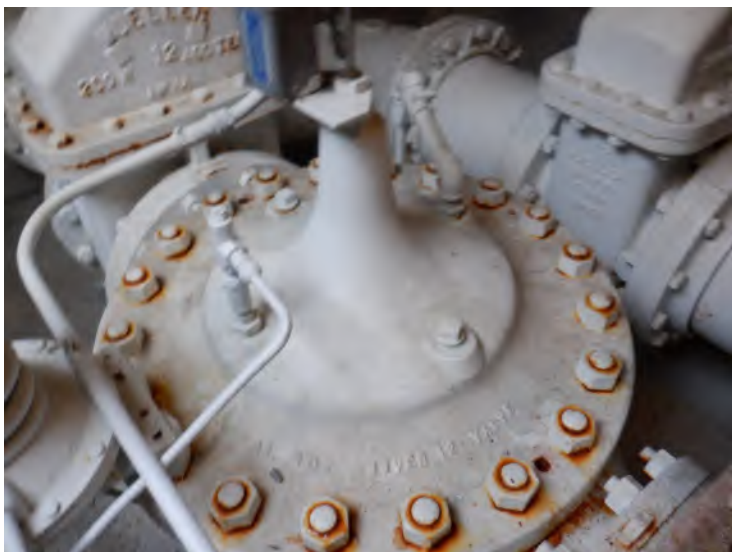
66) Same.
